Aviation Investigation Final Report

Location:	Compton, California	Accident Number:	WPR19FA095
Date & Time:	March 13, 2019, 18:50 Local	Registration:	N5440F (A1); N48962 (A2)
Aircraft:	North American T28 (A1); Cessna 152 (A2)	Aircraft Damage:	Minor (A1); Destroyed (A2)
Defining Event:	Runway incursion veh/AC/person	Injuries:	1 None (A1); 1 Fatal, 1 Serious (A2)
Flight Conducted Under:	Part 91: General aviation - Personal (A1); Part 91: General aviation - Instructional (A2)

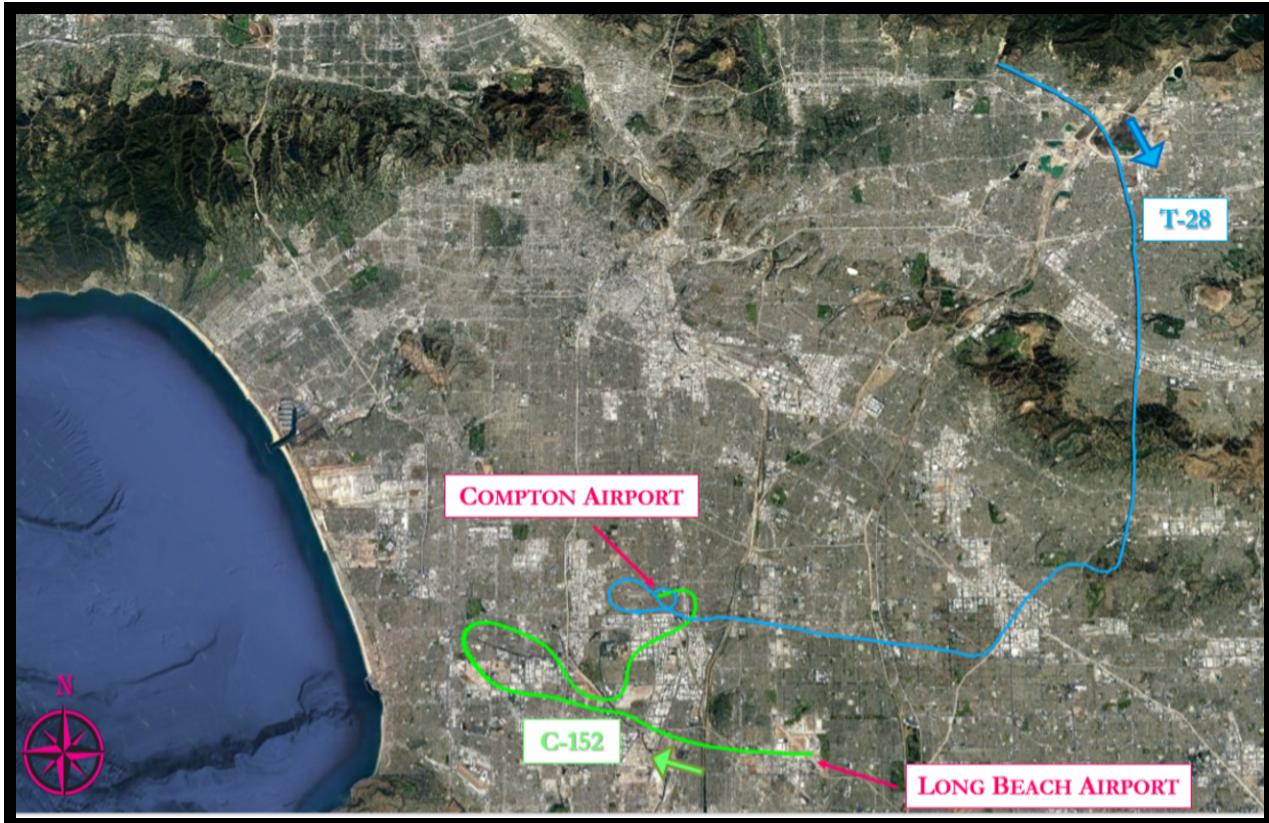
Figure 1. Recorded radar data of both airplanes

Review of radar data revealed two discrete secondary beacon code targets that were correlated to the two airplanes as they approached Compton/Woodley Airport (CPM); the Cessna from the south-southwest and the T-28 from the north/east. (See figure 1.) The instructor onboard the Cessna stated that he and the student were simulating a diversion to CPM. He was seriously injured during the accident and could not recall the details of the flight but stated that the student would have made all radio calls over the airport's common radio frequency. Radar indicated that the Cessna entered the airport traffic pattern on the downwind leg at an altitude about 950 ft above ground level (agl), then proceeded to fly the base and final legs of the traffic pattern for runway 25 left (25L).

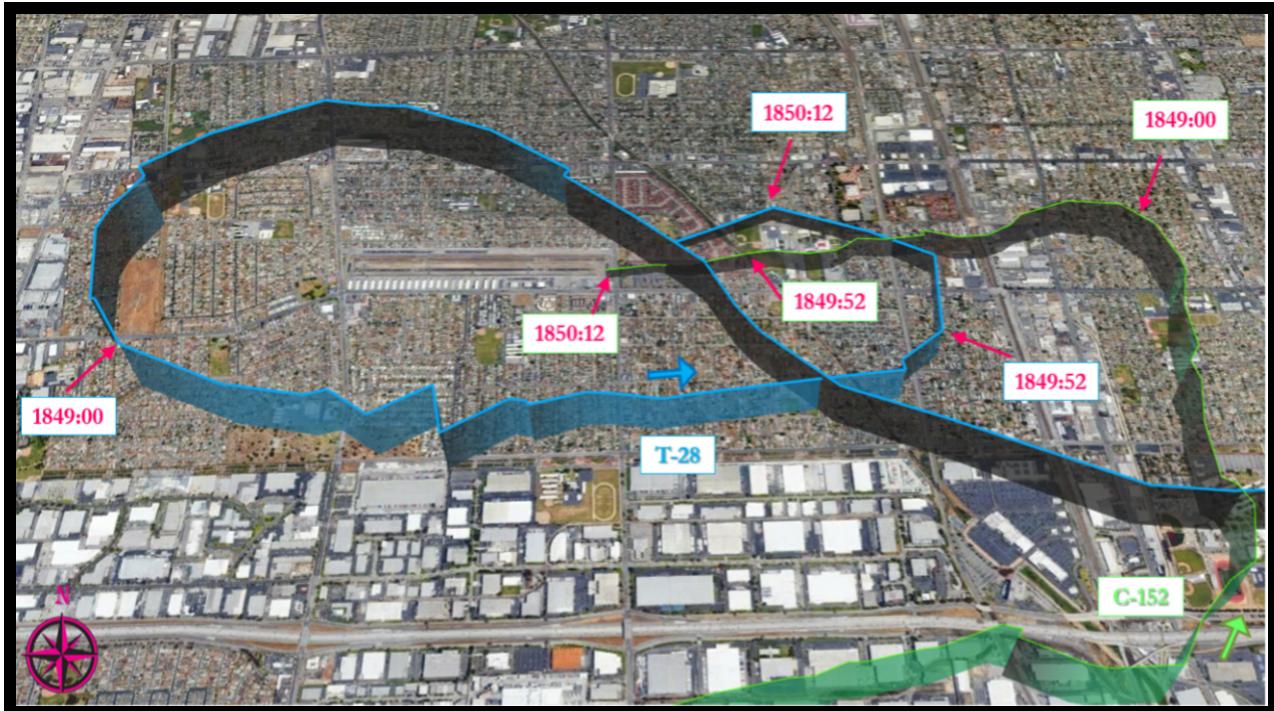
Figure 2. Radar data

Radar data indicated that the T-28 approached CPM from the east, overflowed the airport about 700 to 750 ft agl, then entered the left downwind leg of the traffic pattern for runway 25L. (See figure 2.)

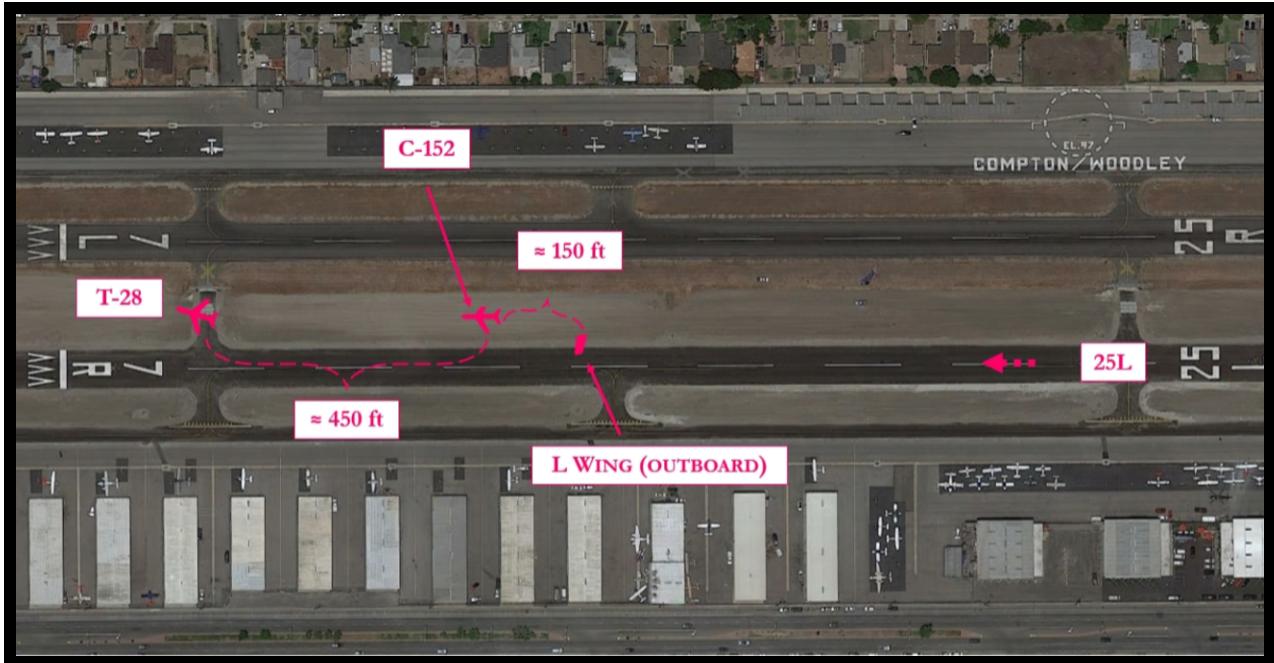
Figure 3. Compton Airport accident diagram

The T-28 pilot stated that as he turned from the base to final legs, the bright sun and the haze created a glare on the windscreen that obscured his forward vision, making it difficult for him to see directly ahead. As he descended toward the runway, the glare became worse and he realized he was between runways 25L and 25R. He side-stepped to runway 25L and the airplane touched down on the runway surface. Several seconds later, the pilot saw the Cessna on the runway ahead of him. He applied hard braking and felt the impact with the other plane and resulting explosion immediately thereafter. The T-28 continued about 1,000 ft before coming to rest off the right side of runway 25L. (See figure 3.)

The Cessna came to rest on the north side of runway 25L, about 150 ft west of the left outboard wing. The T-28 was 450 ft further west of the Cessna. The marks on runway revealed no indications of braking by the T-28 before the collision.

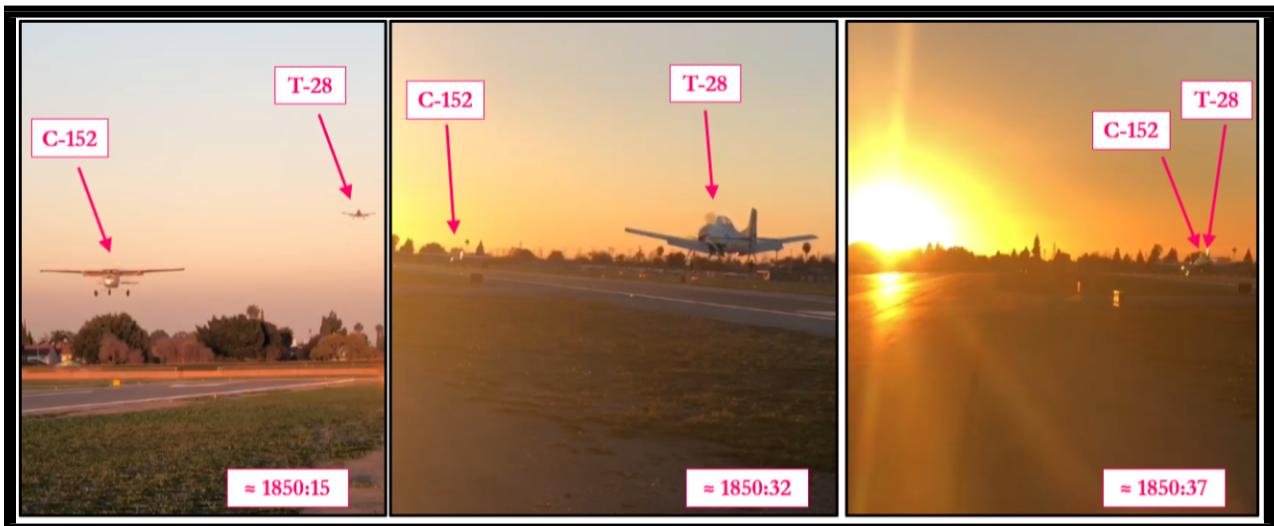
Figure 4. Video frames of the airplanes before impact

Multiple video recordings captured the accident (see figure 4); review of the footage revealed that the Cessna touched down on runway 25L and continued its landing roll. The T-28 crossed the runway threshold about 10 seconds after the Cessna and subsequently touched down about 1850:36. On the landing roll, adjacent to the runway halfway point sign, the T-28 impacted the Cessna.

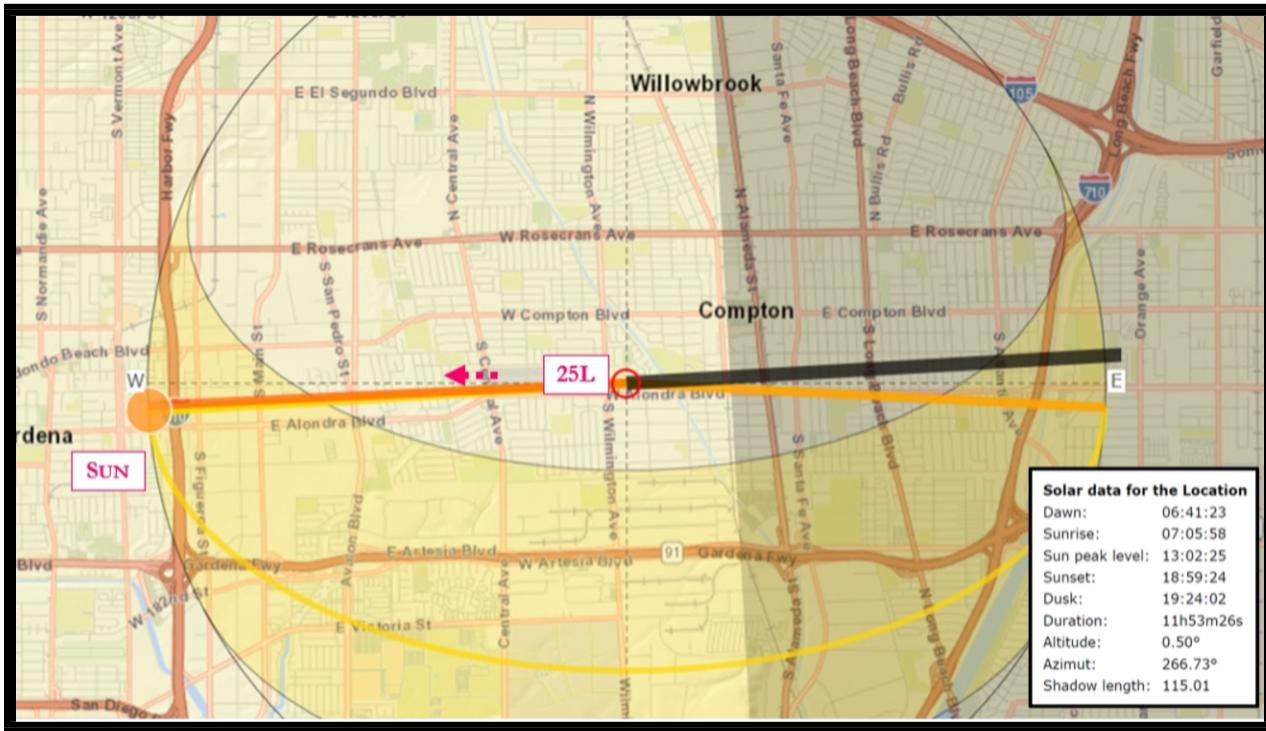
Figure 5. Sun information

The time of sunset was 1859:24. The sun's azimuth at the time of the accident was 267° (see figure 5) and the elevation was slightly above the horizon at 0.50°.
