# Aviation Investigation Final Report

<b>Location:</b>	Overgaard, Arizona	<b>Accident Number:</b>	WPR19FA026
<b>Date &amp; Time:</b>	November 16, 2018, 15:46 Local	<b>Registration:</b>	N322JL
<b>Aircraft:</b>	Zenith CH601	<b>Aircraft Damage:</b>	Substantial
<b>Defining Event:</b>	Controlled flight into terr/obj (CFIT)	<b>Injuries:</b>	2 Fatal
<b>Flight Conducted Under:</b>	Part 91: General aviation - Personal

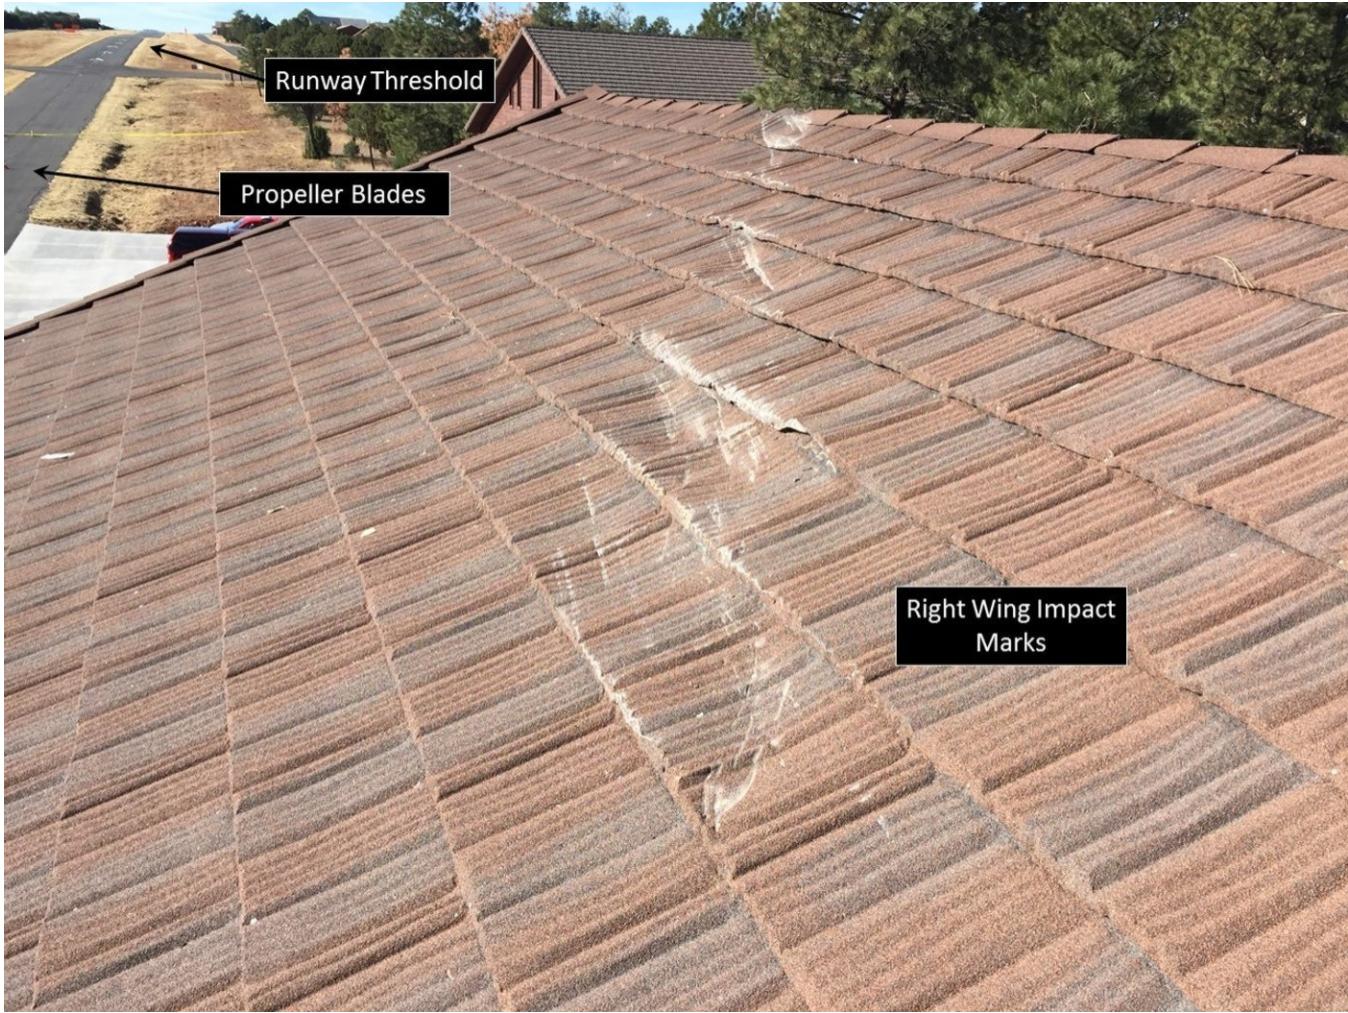
Examination of the accident site revealed the first identified point of contact (FIPC) was the top of an 80-ft-tall tree on the direct centerline view of runway 21 and about 1,500 ft from the runway threshold. A broken tree limb and a wingtip light assembly were found near the FIPC. About 226 ft from the FIPC, a wing impact mark and cuts consistent with rotating propeller blades were found on the roof of a house. (See figures 3 and 4). A propeller blade was found in several sections about 170 ft from the house. The airplane then impacted a second tree before impacting the ground in the taxi area between house. The empennage separated from the main wreckage and remained lodged in the second tree about 20 ft above the ground. The main wreckage was found inverted with leading-edge impact damage to the right wing and buckling to both wings. The fuselage was twisted, and the engine remained partially attached. Fuel was drained from the right wing during the recovery of the wreckage.

Figure 3-Right wing impact marks and runway location.

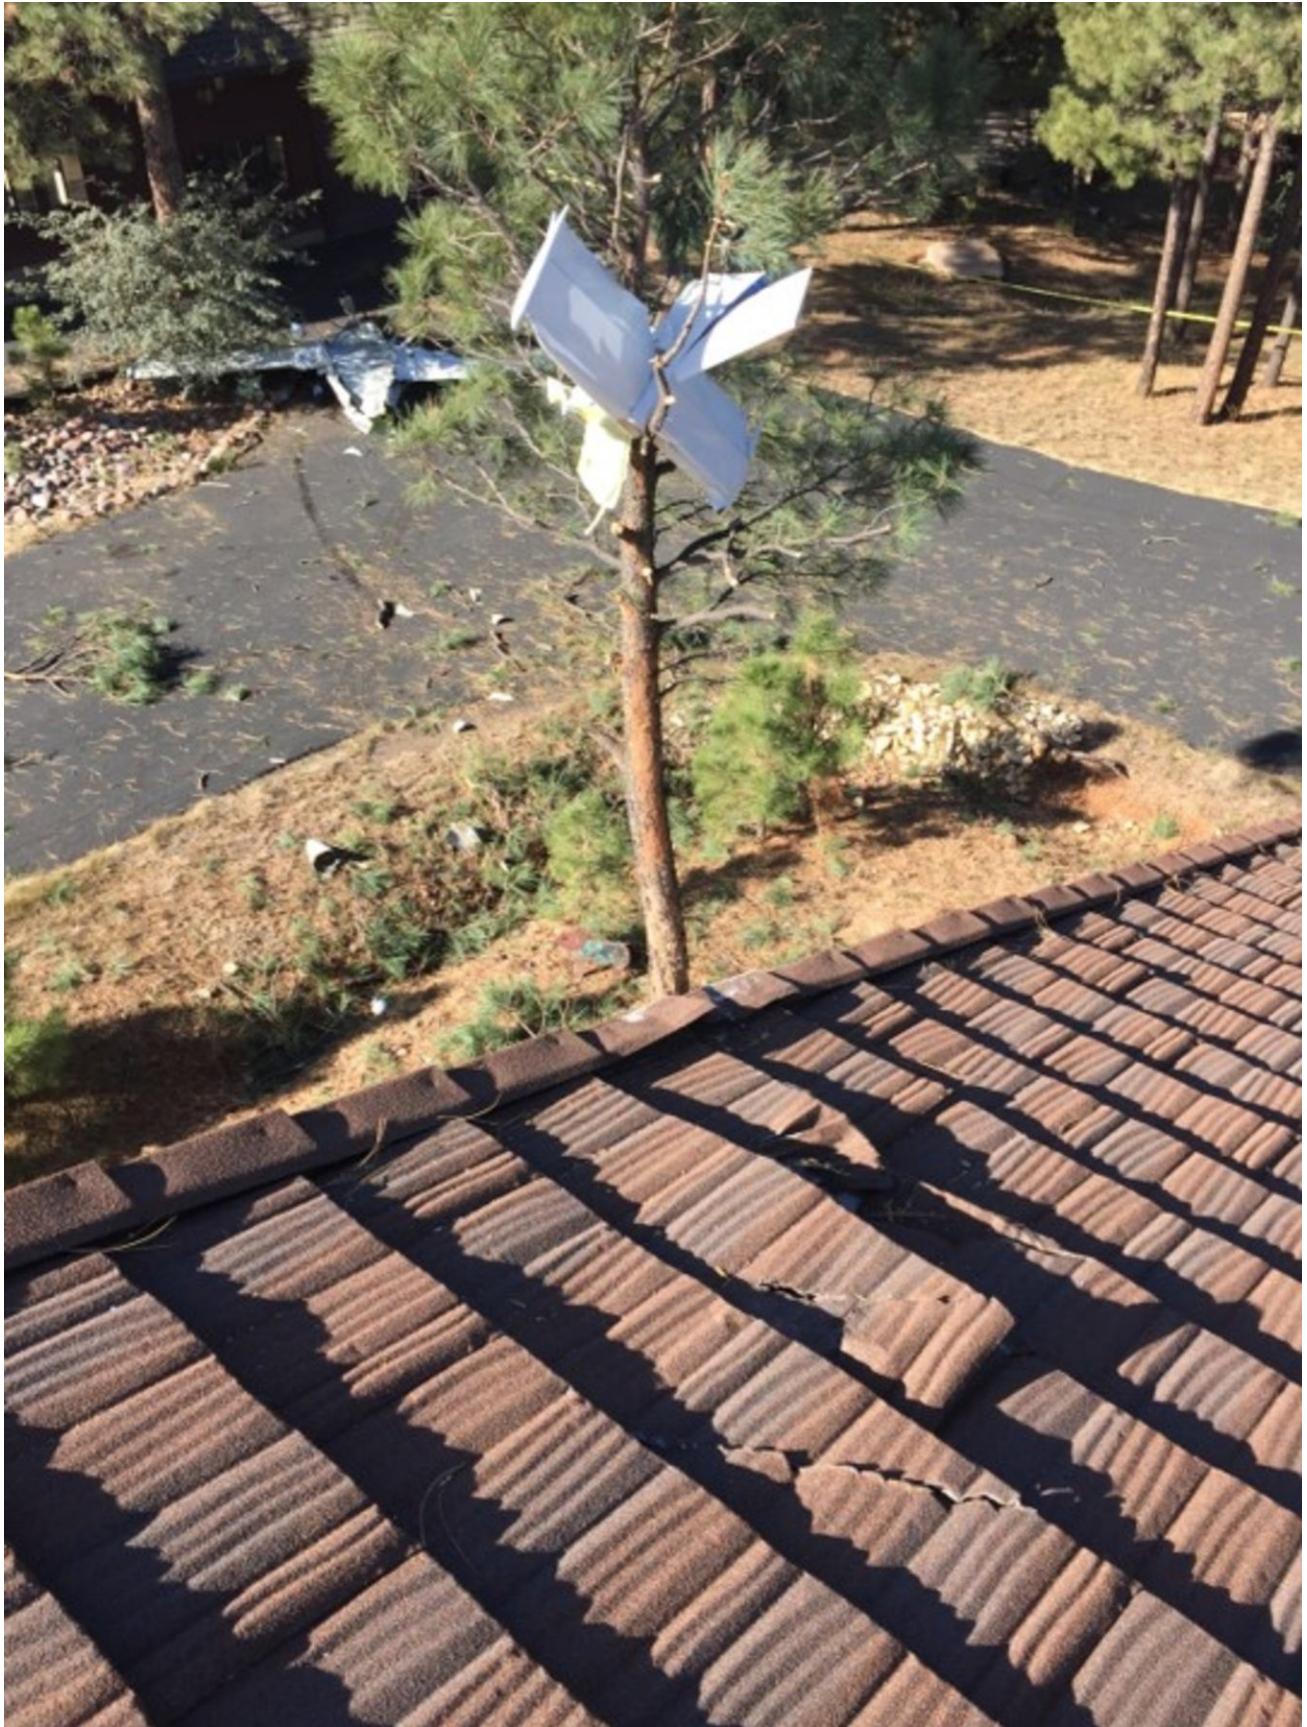
**Figure 4-Propeller strike marks and main wreckage.**
