# PROPERTY INSPECTION REPORT FORM

Buyer Name <i>Name of Client</i> 1234 Denton Texas 76201	01/21/2023 9:00AM <i>Date of Inspection</i>
Address of Inspected Property <i>Name of Inspector</i> Clayton Worley	TREC license # 22745 <i>TREC License #</i>
Name of Sponsor (if applicable)	<i>TREC License #</i>

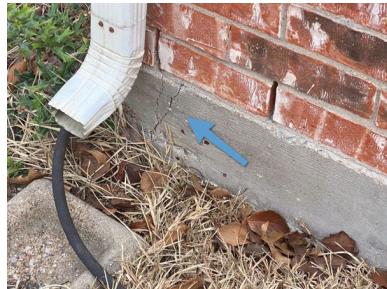
Foundation corner fracture(s) existed, which are generally the result of differential movement between the masonry walls (expanding) and the concrete foundation (shrinking). Although this condition did not appear to adversely affect the structure, sealing these cracks may be desired as they could provide hidden access for wood destroying insects. Please note that the corners should be examined periodically. If the fracturing worsens and the corner(s) break off then the brick veneer may lack proper support and repair would be needed.

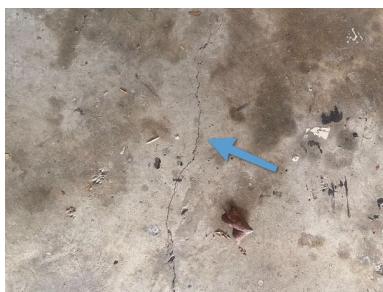
Common cracks were observed in the exposed areas of the slab. This commonly occurs as the result of settling and/or surface checking. Surface checking occurs when concrete is poured in a dry state, which increases tensile strength. The dry state results in differential curing causing the surface areas to fracture. This is normal with concrete slabs. Cracks should be monitored for disjoining and/or separations and evaluated if adverse conditions are observed.

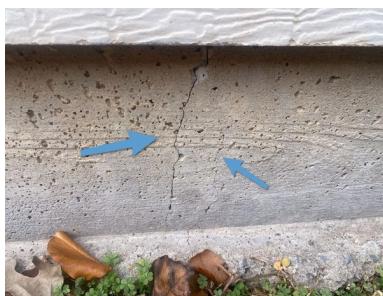
### 3: Common Foundation Wall Cracks

Cracks were observed in the foundation wall at one or more locations. This is a common occurrence as the home settles. Recommend monitoring for further shifting/displacement.

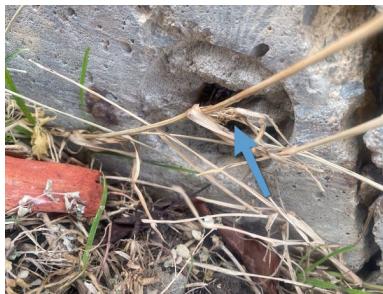
### 4: Exposed Post Tension Cables

Exposure to the elements can cause rusting and reduced strength. The cables should be cleaned and covered over with a non-shrink/non-metallic grout. The grout used for this repair should not contain any chemicals known to be destructive to the prestressing steel. Contact a qualified service company for corrective action. Please note that some areas of the perimeter beam(s) may be hidden from view by soil or vegetation; therefore, other exposed/rusted cable tendons may exist.

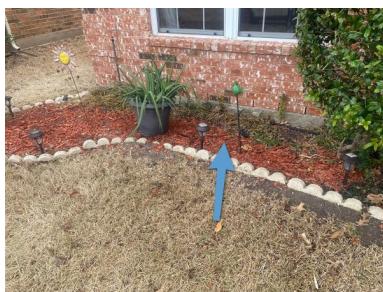
The grading near the foundation appears to be inadequately sloped. Proper grading should drop at least 6 inches per 10 feet away from the foundation, according to current standards. This area should be monitored for ponding water and the grading improved if necessary.

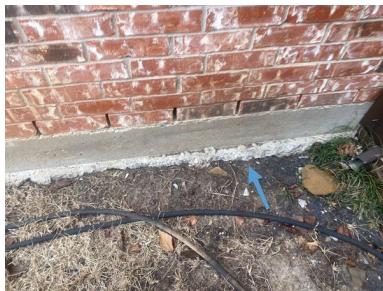
**3: Footing is partially exposed****☒ Minor Concerns/Maintenance Items/FYI**

The foundation footing is partially exposed at one or more locations. Those areas should be backfilled, leaving 4 to 6 inches of the foundation exposed, and the soil sloped away from the foundation for proper moisture runoff.

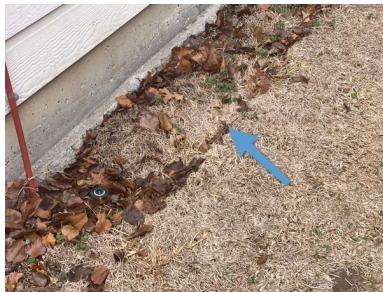
**4: Soil erosion from roof runoff****☒ Minor Concerns/Maintenance Items/FYI**

There is soil erosion from roof runoff on the sides of the house where there are no gutters in place. Roof gutters may need to be installed/cleaned out to help prevent soil erosion and to help divert drainage away from the foundation. This is reflected in the International Residential Building Code as follows: R801.3 Roof drainage. In areas where expansive or collapsible soils are known to exist, all dwellings shall have a controlled method of water disposal from roofs that will collect and discharge roof drainage to the ground surface at least 5 feet (1524 mm) from foundation walls.

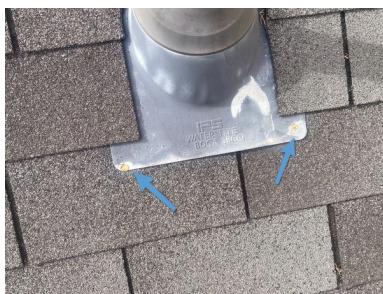
There are exposed fasteners on the roof. Sealant should be applied to exposed fastener heads to prevent moisture from penetrating the roof in those areas.

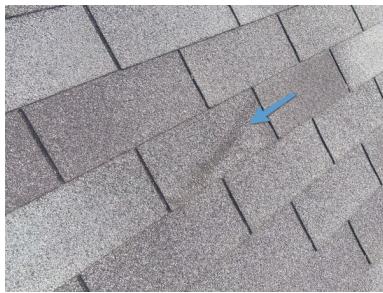
Damaged shingles were observed at one or more locations. This appears to be inadvertent or accidental mechanical damage that occurred during installation or maintenance. Damaged shingles should be monitored and repaired or replaced if necessary.

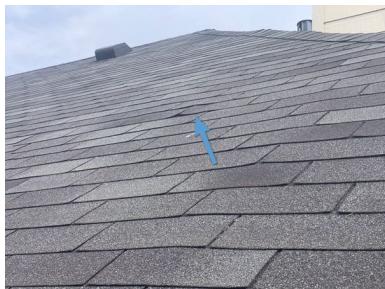
There are one or more shingles that do not lay flat. This may indicate the fasteners under the shingles are improperly installed and pushing up the edge of the shingle. The affected shingles are more susceptible to wind damage as a result. Repair is advised.

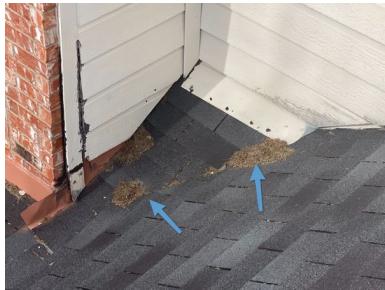
There is tree litter on the roof at one or more locations. The roof should be maintained free of tree litter to ensure the roof sheds water as intended.

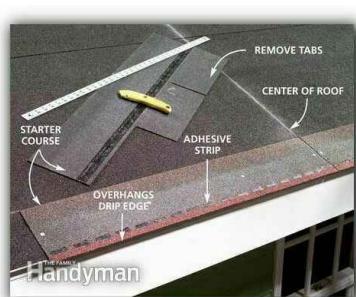
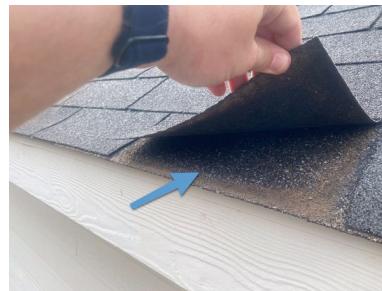
#### **6: Starter course improperly installed**

The starter course of shingles is not properly installed. To properly create a starter course, the shingle tabs are cut off a course of shingles and the course is placed at the edge of the roof with the adhesive strip close to the edge of the roof. This will allow the adhesive on the top of the shingle to adhere to the tabs on the first course of shingles. A properly installed starter course is designed to help prevent wind damage. In many cases, a short cut is taken and the shingle tabs are not removed from the starter course. The adhesive strip is not at the edge of the roof as a result. This can make the first course of shingles susceptible to wind damage.

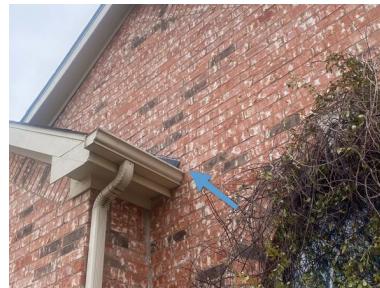
Base flashing against a vertical sidewall shall be continuous or step flashing and shall be a minimum of 4 inches (102 mm) in height and 4 inches (102 mm) in width and shall direct water away from the vertical sidewall onto the roof and/or into the gutter. Where siding is provided on the vertical sidewall, the vertical leg of the flashing shall be continuous under the siding. Where anchored masonry veneer is provided on the vertical sidewall, the base flashing shall be provided in accordance with this section and counter flashing shall be provided in accordance with Section R703.7.2.2. Where exterior plaster or adhered masonry veneer is provided on the vertical sidewall, the base flashing shall be provided in accordance with this section and Section R703.6.3.

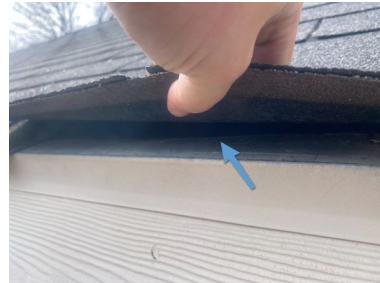
### 8: Drip edge improperly installed

The drip edge appears to be improperly installed. The drip edge is installed on top of the felt underlayment at the roof hips. The underlayment should be on top of the drip edge at the roof hips to ensure water sheds off the underlayment properly. This is reflected in the 2012 International Residential Code, as follows: R905.2.8.5 Drip edge.

A drip edge shall be provided at eaves and gables of shingle roofs. Adjacent pieces of drip edge shall be overlapped a minimum of 2 inches (51 mm). Drip edges shall extend a minimum of 0.25 inch (6.4 mm) below the roof sheathing and extend up the roof deck a minimum of 2 inches (51 mm). Drip edges shall be mechanically fastened to the roof deck at a maximum of 12 inches (305 mm) o.c. with fasteners as specified in Section R905.2.5. Underlayment shall be installed over the drip edge along eaves and under the underlayment on gables. Unless specified differently by the shingle manufacturer, shingles are permitted to be flush with the drip edge.

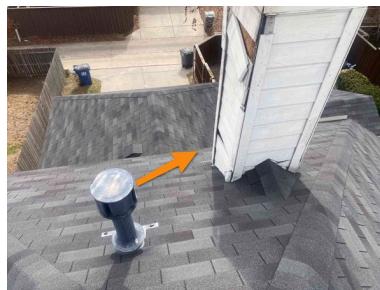
### 9: Gas Vent(s) - Inadequate Clearance

One or more gas fired appliance vents do not appear to have the proper roof clearance. Gas vents that are 12 inches (305 mm) or less in size and located not less than 8 feet (2438 mm) from a vertical wall or similar obstruction shall terminate above the roof in accordance with G2427.6.3. Further evaluation by a qualified contractor is advised.

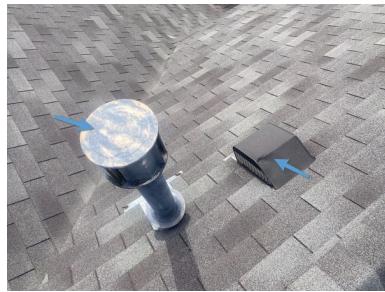
Hail strikes were observed on the vent covers. This does not appear to be affecting the operational performance of the vent cover at this time.

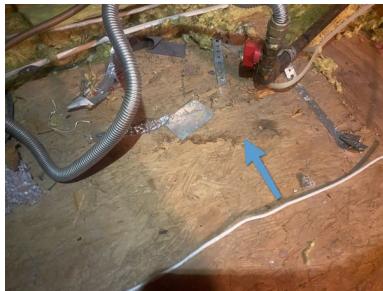
**2: Water stains at HVAC**

Water marks were observed on the attic flooring near the cooling equipment condensate drain pipes. This commonly occurs when condensation forms on the pipe and drips onto the flooring. Installing insulation on the pipes can help prevent condensation formation from occurring.

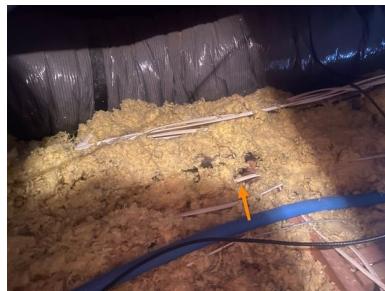
There is evidence of rodent activity in the attic. Recommend a pest control specialist to further evaluate and/or treat.

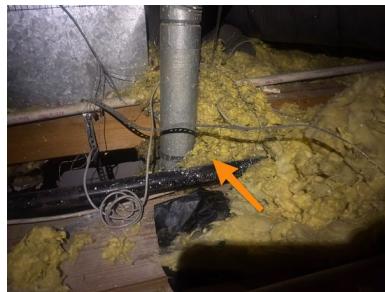
The attic insulation is in contact with a gas appliance flue vent. This may cause a buildup of heat in this area. The insulation should be removed and a barrier installed to help prevent this from reoccurring.

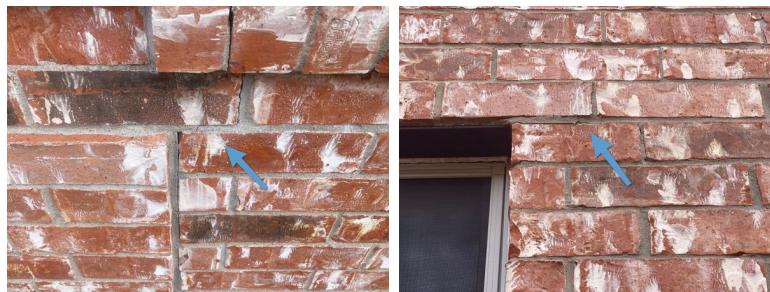
One or more common cracks were observed on the brick/stone veneer. This may be due to normal settling and/or thermal movement of the building materials. These areas should be sealed to prevent moisture penetration and monitored for further signs of movement.

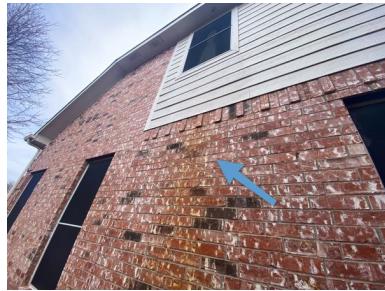
**2: ECD Rust stains on wall****Minor Concerns/Maintenance Items/FYI**

Rust stains were observed on the veneer. This appears to be the result of drainage from the cooling equipment emergency condensate drain. A siding professional should be retained to determine the best method of cleaning the veneer.

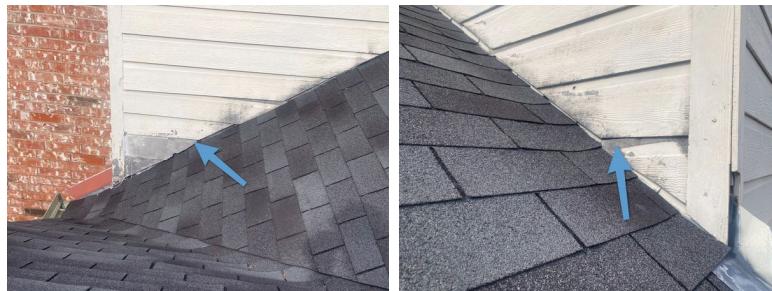
**5: Delaminated/rotted siding****Minor Concerns/Maintenance Items/FYI**

The siding is partially delaminated or has partial wood rot at one or more locations. This is a common condition that occurs as moisture wicks into the edges of the siding over time.

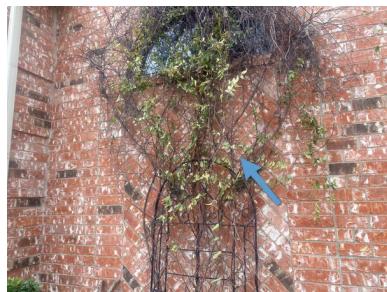
There is foliage in contact with the exterior walls. Foliage should be trimmed and maintained away from the house to prevent damage to the exterior wall coverings and to eliminate a conducive condition for wood destroying insects.

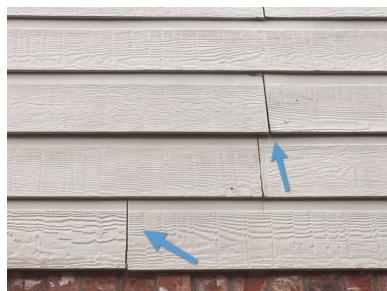
**8: Siding maintenance**

There are cracks and separations at the caulk joints in the siding at one or more locations. The siding needs to be sealed at the joints to prevent moisture penetration in those areas.

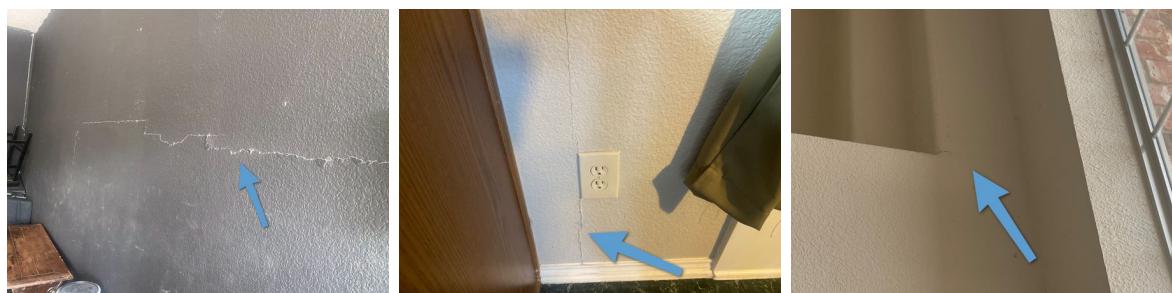
**9: Interior Wall Common Cracks**

Common cracks were observed on the interior walls. This may be due to normal settling and/or thermal movement of the building materials. These areas should be monitored for further signs of movement. These areas can be patched and painted as desired for a better appearance.

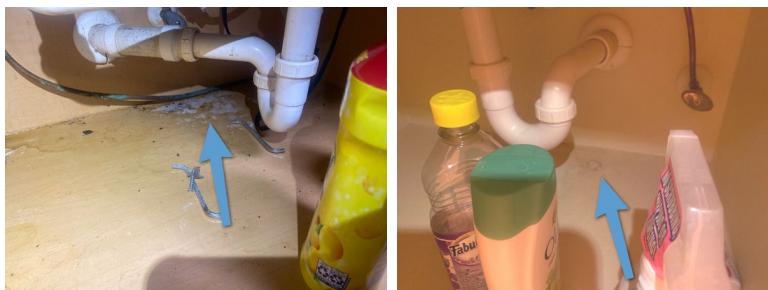
**10: Moisture damage under sinks**

There is moisture damage under one or more sinks. This could be due to spills and/or may indicate a previous leak in that area. The cabinetry can be repaired or replaced as desired.

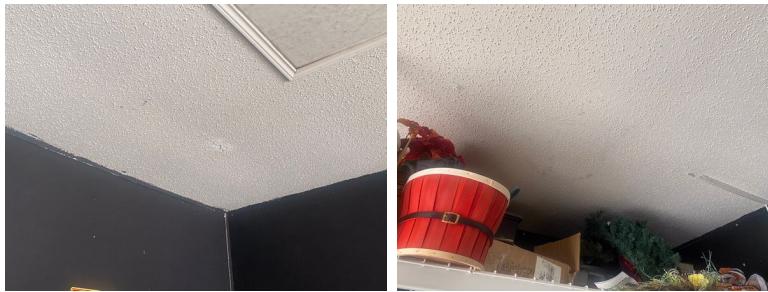
Previous repairs were observed on the ceiling. The cause or reason for repairs are unknown and the quality of the repairs are beyond the scope of this inspection. Contact sellers for more information.

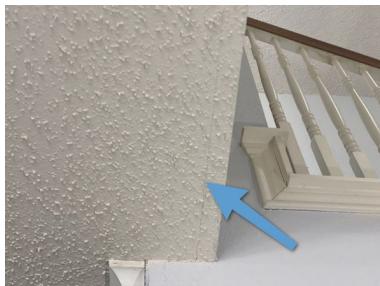
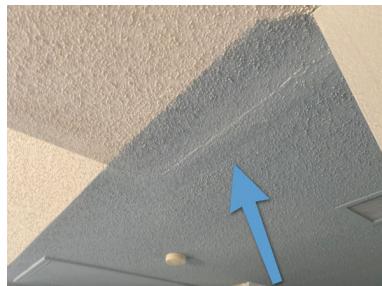
There are common cracks on the ceilings. This can be caused by expansion and contraction of construction materials and/or structural movement. Repair as necessary.

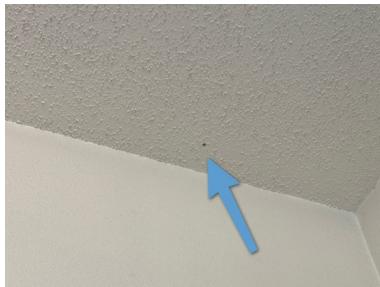
## 2: Ceiling Nail Pops

There are nails backing out of the ceilings at one or more locations. This is a common occurrence usually related to expansion and contraction of the roof rafters and/or seasonal structural movement.

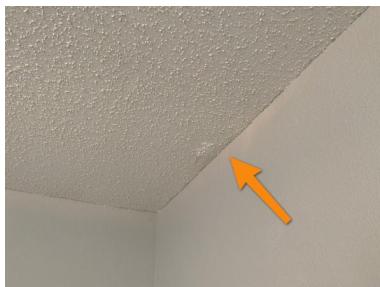
## 3: Ceiling Water Stains/damage

Water stains/damage were observed on the ceiling at one or more locations. This may indicate previous moisture penetration in that area. The extent of damage, if any, is beyond the scope of this inspection. Further information from the home owner and further evaluation of the water stain is recommended.

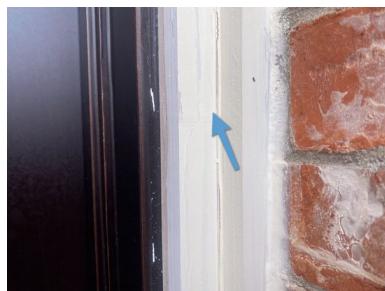
One or more exterior door frames are not sealed to the exterior wall covering. The door frames should be sealed to the exterior wall coverings to help prevent moisture and/or pest intrusion in those areas.

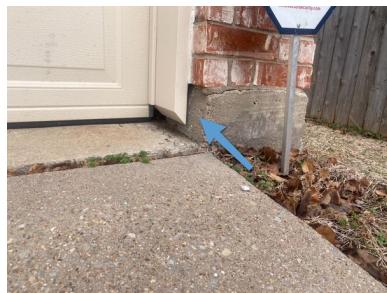
Openings were observed at the garage door casing. The areas should be sealed to prevent pest intrusion.

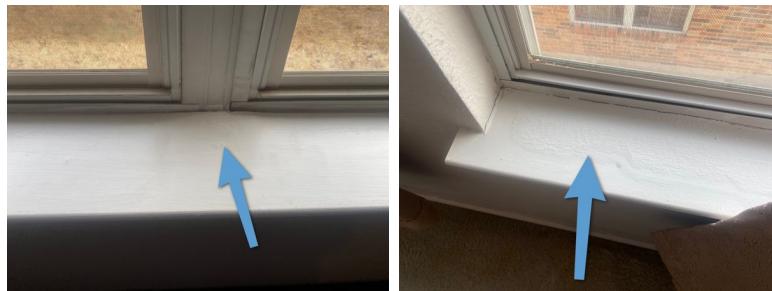
## 2: Water Stains / Damage at Window Returns

The window stools have water stains / moisture damage at one or more locations. This commonly occurs as a result of moisture penetration and/or as a result of condensation forming on the window frames and wicking into the stool cap. In some cases this may indicate a hidden leak. Repair or replace as necessary.

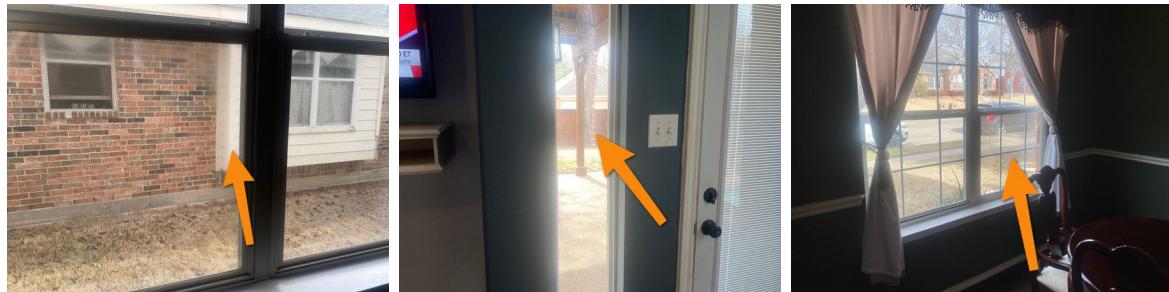
## 3: Failed thermal window seals

There are one or more window(s) with visible evidence of a broken thermal window seal. This causes condensation to form between the window panes leaving water deposits that cause discoloration between the panes over time. This does not materially affect the performance of the windows. Most of the identified windows were marked with a black X if easily accessible at the time of the inspection. All of the windows should be checked by a window specialist to determine if there are any more broken seals to properly estimate repair costs.

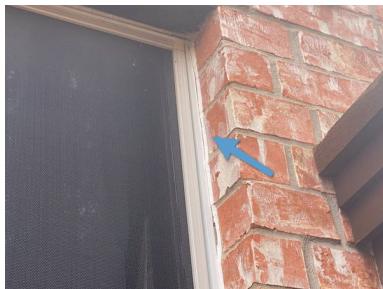
There are separated caulk joints around the exterior window frames at one or more locations. This may indicate settling and/or seasonal movement in those areas. The caulk should be touched up or replaced to exclude pests and moisture from those areas. Where deteriorating caulk is noted it should be assumed that some moisture penetration has occurred and that some hidden damage may be present.

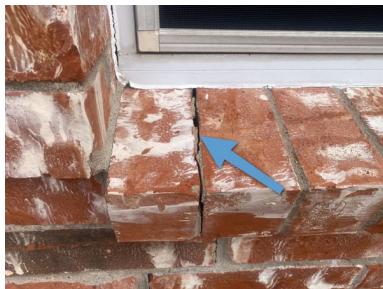
The mortar is cracked/deteriorated at one or more exterior window ledges. Sealant should be applied to these areas to prevent moisture penetration.

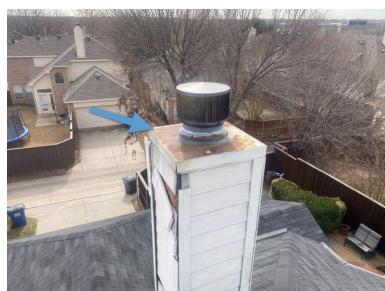
There is evidence of pooling water and/or rust on the chimney crown. This may indicate the crown is not shedding water as intended. The crown should be repaired to ensure it sheds moisture properly and to help prevent deterioration and/or moisture penetration.

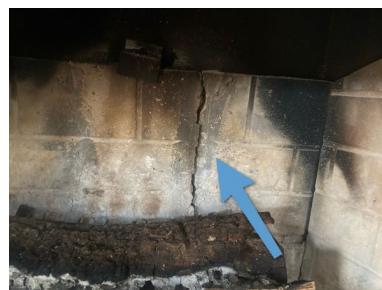
**3: Deteriorated/Cracked refractory panels****Minor Concerns/Maintenance Items/FYI**

The refractory panel at the back of the firebox is deteriorated and/or cracked. The panel should be replaced to ensure heat is properly deflected out of the firebox. Further evaluation and/or repair is advised.

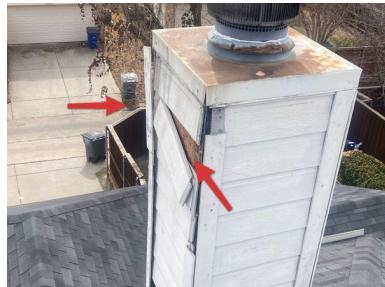
**4: Loose/Damaged Siding****Significant/Major Concerns**

The chimney siding is loose and damaged at several locations. The siding should be replaced by a qualified contractor to prevent moisture in this area.
