# Home Inspection Report

Comprehensive Property Assessment

251 N Bristol Ave, Los Angeles, CA 90049

Inspection Date: August 8, 2025

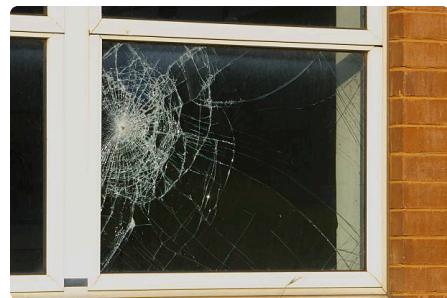
**5.5.2 CRACKED WINDOW PANE****(i) Recommendation**

The damaged glass pane may expose sharp edges and reduce the thermal barrier against the elements. Further evaluation by a qualified contractor is recommended to repair or replace the damaged window as needed. Recommend window.

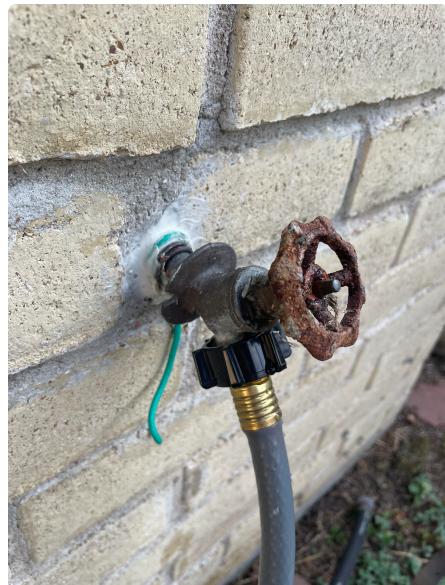
### 5.8.6 RECOMMENDED

Inspector recommends repairing or replacing the exterior hose bib to make it fully operational. Confirm functionality after repair and check for leaks. Obtain quotes from a licensed plumber or qualified contractor as needed.

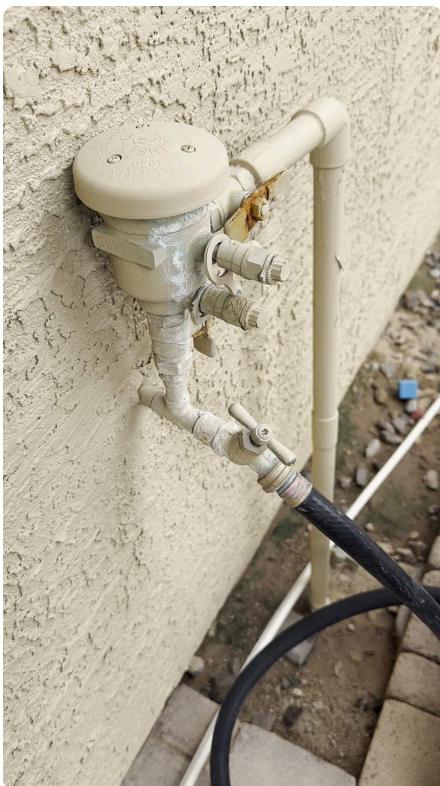
### 5.8.8 HOSE BIB HANDLE DAMAGED OR MISSING

The handle for the exterior spigot was damaged or missing. Repairs or replacement as needed are recommended to be performed by a qualified individual to ensure proper operation. Recommend handyman-diy.

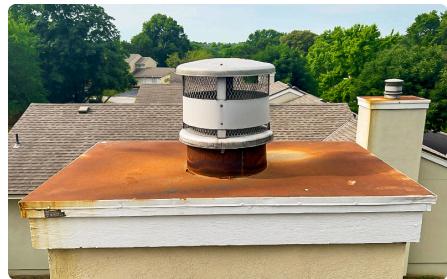
### 5.9.1 CORRODED CHIMNEY CAP

The chimney cap displayed signs of corrosion. Regular maintenance, such as sealing, is recommended to prevent further damage and extend its longevity.

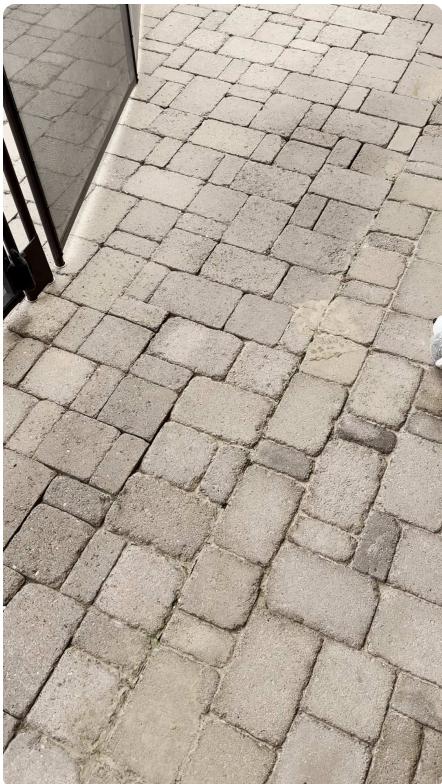
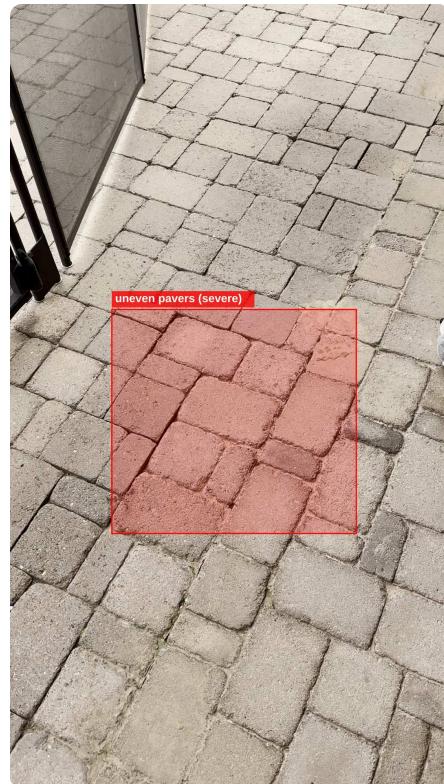
### 5.17.1 UNEVEN PAVERS — TRIP HAZARD

Uneven paver stones were observed in the backyard, creating a potential trip hazard to occupants and visitors. This condition presents an immediate safety concern and should be corrected. Recommend evaluation and repair by a qualified hardscape contractor or landscaper to re-level, reset, or replace affected pavers to eliminate the trip hazard.

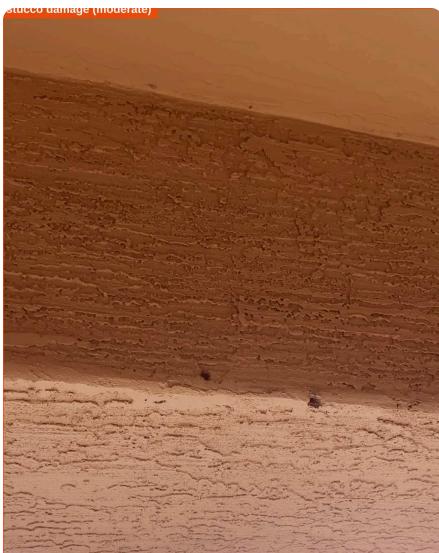
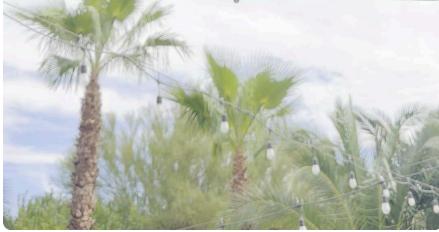
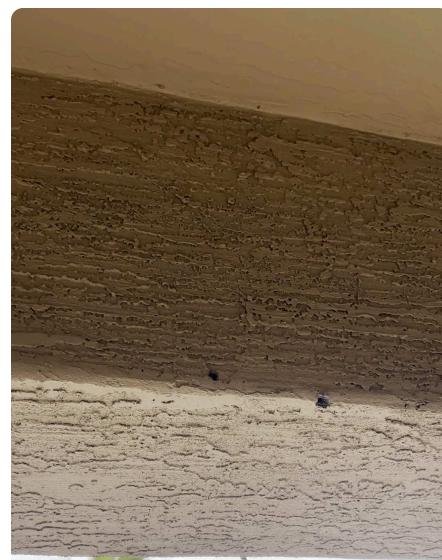
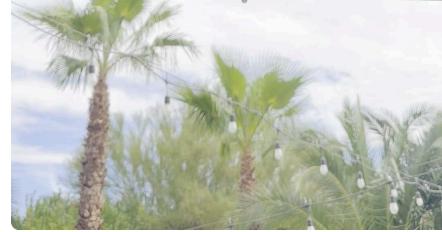
#### 5.18.2 STUCCO CRACKS/DAMAGE

Stucco damage was observed. Gaps or cracks in stucco can allow for moisture intrusion, accelerating deterioration. It is recommended that a qualified contractor evaluate and perform necessary repairs. Recommend stucco.

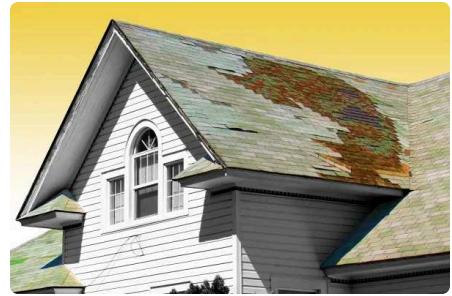
#### 6.1.2 LIFESPAN - REPLACEMENT RECOMMENDED

Based on the age and type of shingle, the roof has exceeded its expected service life. Even with current repairs, the design of the shingle is beyond its intended lifespan. It is recommended to consult a qualified roofing professional for suggestions and quotes regarding roof replacement. Recommend roof.

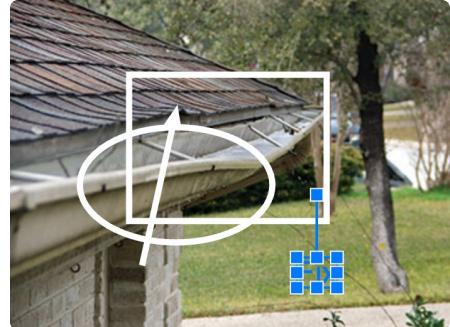
### 6.5.2 MISSING OR DAMAGED GUTTER HANGER

A gutter hanger was observed to be missing or damaged. It is recommended to properly secure or replace the gutter hangers to ensure the intended stability and proper alignment of the gutter system.

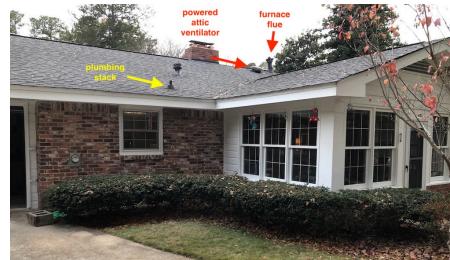
### 6.6.1 INADEQUATE PLUMBING VENT CLEARANCE NEAR ROOFTOP DECK

The plumbing vent displayed insufficient clearance from a rooftop deck. For proper ventilation and to prevent sewer gases from entering recreational areas, vents should typically extend at least 6 feet above a rooftop deck. It is recommended to consult with a licensed professional to ensure appropriate vent height and mitigate potential health concerns.

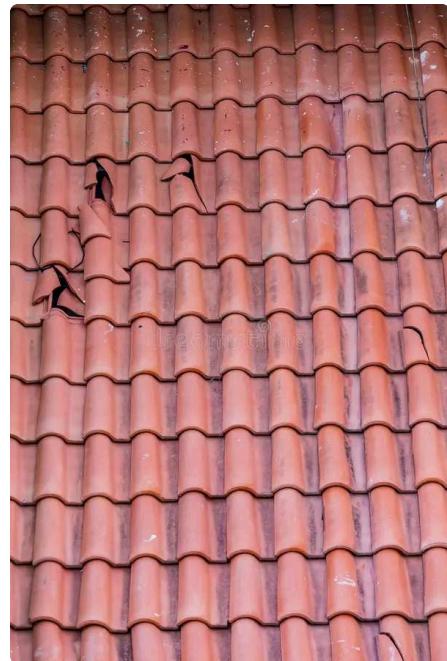
### 6.8.1 CRACKED ROOF TILES

Cracked tiles were observed in various locations on the roof. It is recommended that a qualified roofing contractor assess and repair these areas as necessary. This type of roofing system typically benefits from annual evaluations and prompt repairs. Recommend pro.

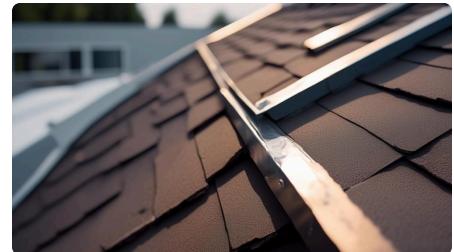
Observations indicate the presence of openings or gaps within the flashing or sealant materials. Such breaches can compromise the water-resistant barrier of the roof, potentially leading to water penetration. It is recommended to engage a certified roofing contractor to address and repair these areas to prevent future moisture intrusion.

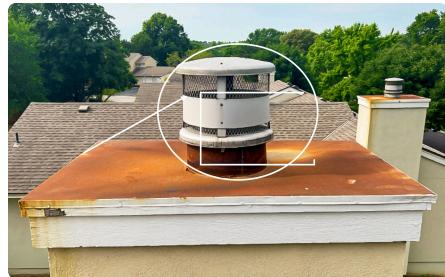
### 7.2.1 VENT COVER DAMAGED OR MISSING

A damaged or missing vent cover could allow debris and small pests to enter. It is recommended to repair or replace the vent cover to ensure proper operation.

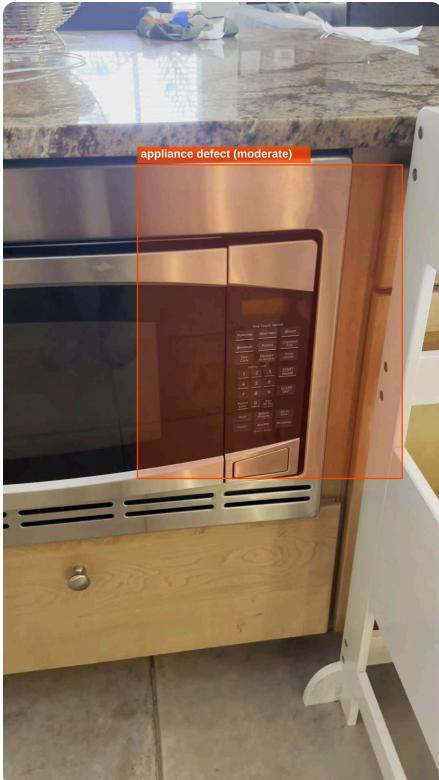
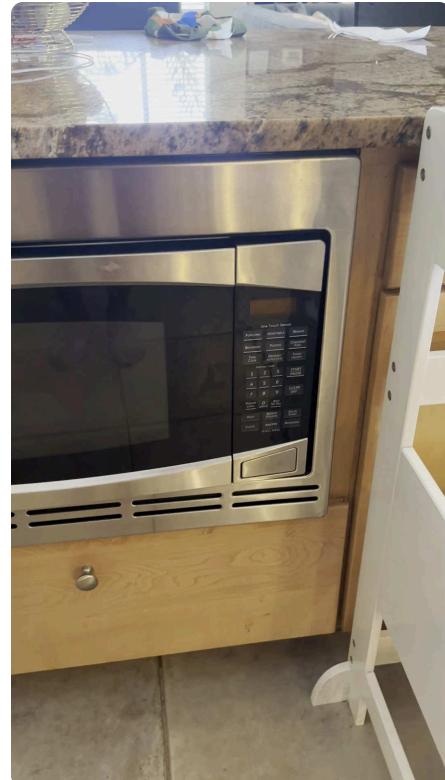
**7.11.1 UNIT NON-FUNCTIONAL OR MALFUNCTIONING****Recommendation**

The microwave oven appeared to be non-operational or was malfunctioning. It is advised that a qualified appliance technician evaluate and perform necessary repairs or replacement. Recommend appliance.

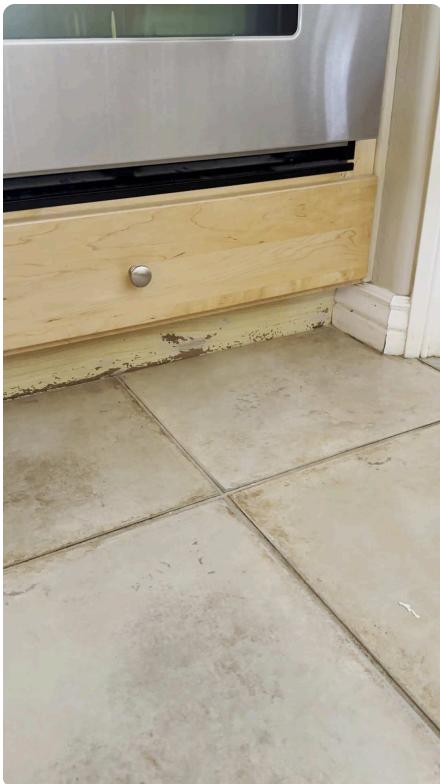
### 8.3.3 FAILING OR PEELING PAINT

The paint finish exhibited signs of failure or peeling in one or more locations. It is recommended that a qualified contractor perform the necessary repairs. Recommend paint.

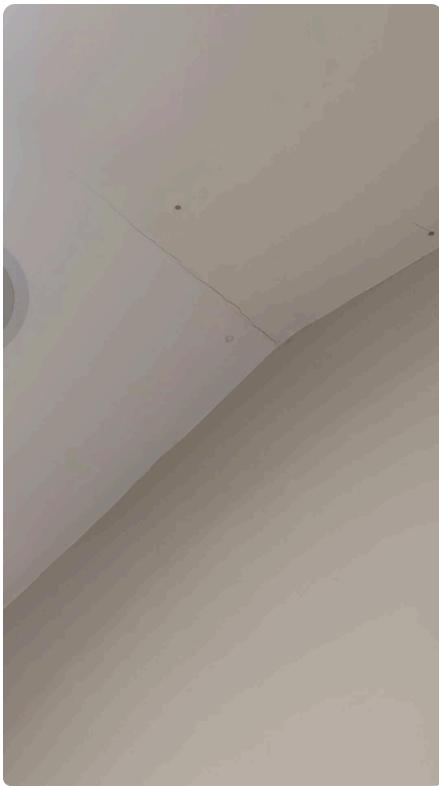
#### 8.10.1 SIGNIFICANT DRYWALL CRACKING

Significant drywall imperfections, including damage, cracking, or inconsistencies, were noted in the referenced area(s). It is advisable to inquire with the current homeowner(s) regarding any past alterations. Repairs should be undertaken by a drywall contractor as desired. Recommend concrete.

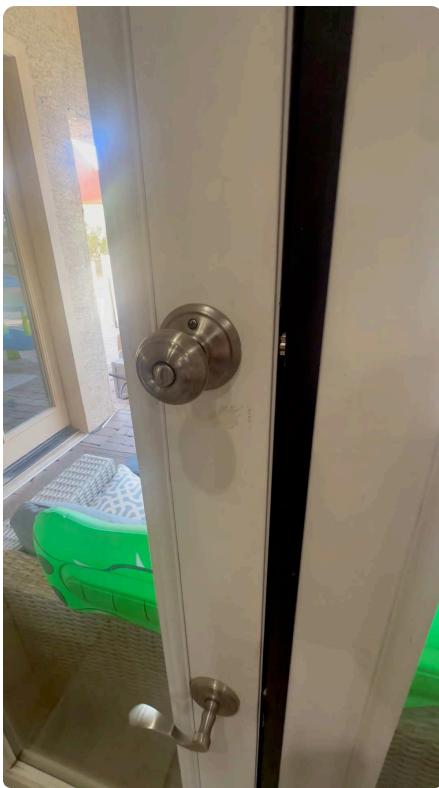
#### 8.12.2 LOOSE, DAMAGED, OR MISSING DOOR HARDWARE

Various exterior door hardware components, including locksets, hinges, and pulls, were observed to be inoperable, damaged, loose, or absent. It is advised that a qualified contractor perform necessary repairs or replacements. Recommend handyman-diy.

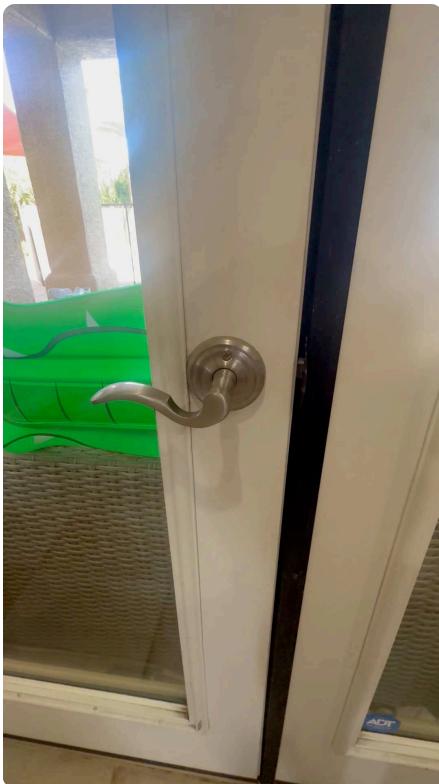
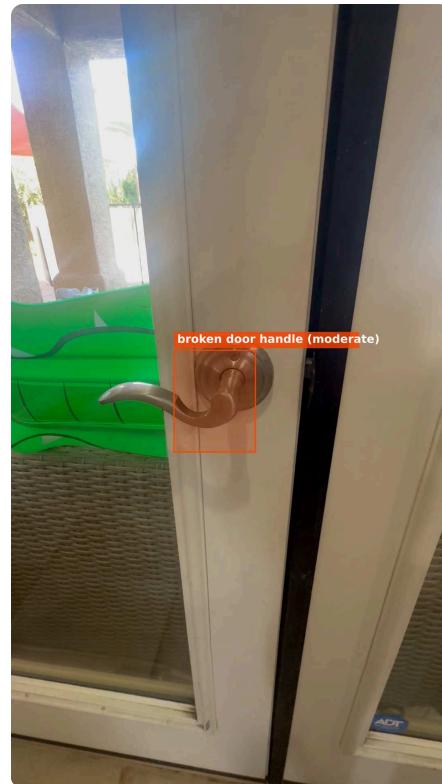
**8.12.3 DAMAGED OR MISSING DOOR HARDWARE****(i) Recommendation**

The door handle is either damaged or missing. It is recommended that a qualified professional evaluate and repair or replace it as necessary. Recommend gc.

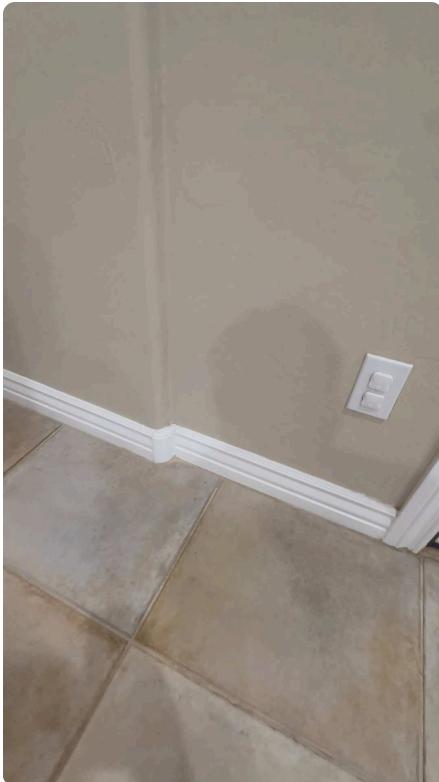
### 9.1.1 SUBFLOORING WATER DAMAGE

Water damage was observed on the subflooring during the assessment. This damage may signify a historical or ongoing leak. It is advised to consult with the seller regarding the nature of the damage and any prior repairs. Alternatively, monitor the affected area for any subsequent deterioration. Recommend pro.

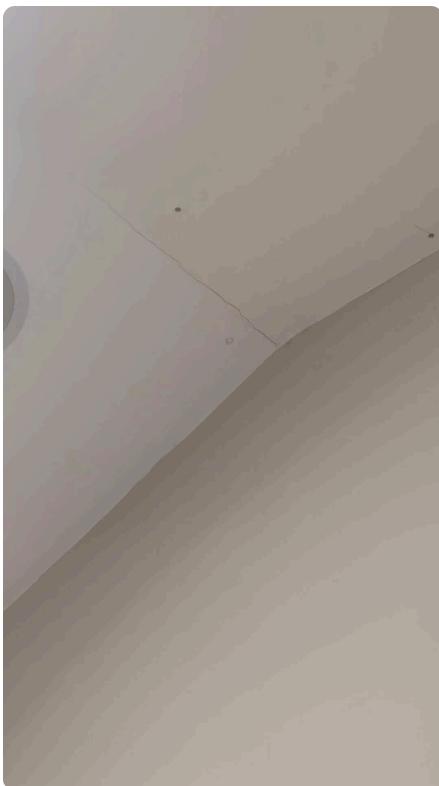
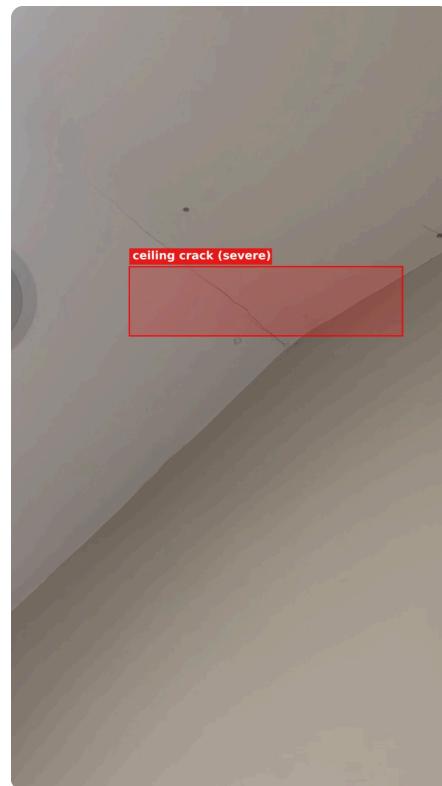
### 9.5.1 CEILING CRACK — POSSIBLE STRUCTURAL CONCERN

Significant cracking was observed in the ceiling in the Living Room that may indicate underlying structural movement or damage. A licensed contractor or structural engineer should be engaged to evaluate the extent and cause of the cracking and to recommend necessary repairs. This condition may represent a safety risk and should be addressed promptly.

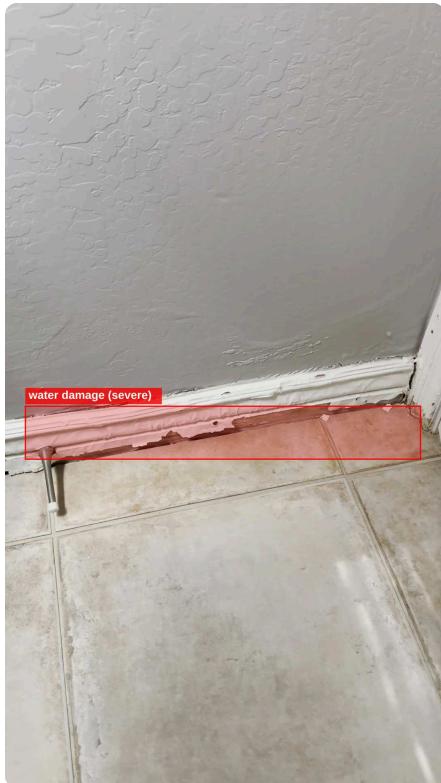
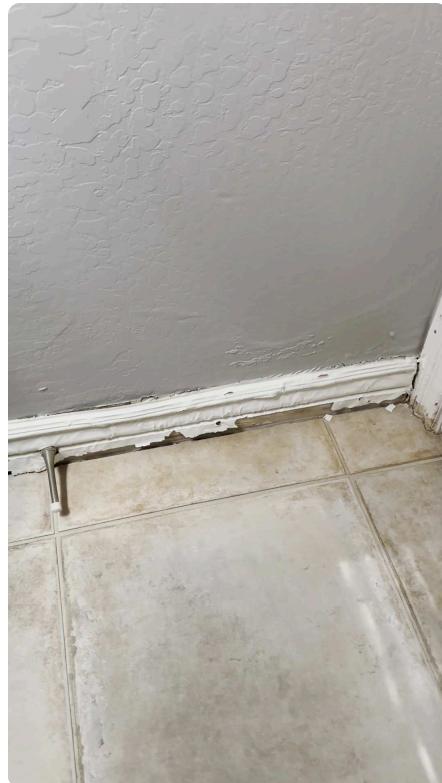
### 12.5.1 EVIDENCE OF ACTIVE MOISTURE INTRUSION

The observed leakage could cause additional damage to the framing member and floor decking. Water staining and dampness were noted in one or more areas, as confirmed by a moisture meter. This condition increases the risk of insect infestation, mildew, and decay. It is recommended to consult a licensed contractor to identify and rectify the source of the dampness, which may involve improving exterior drainage, installing a waterproofing system, or sealing foundation cracks. Recommend waterproof.

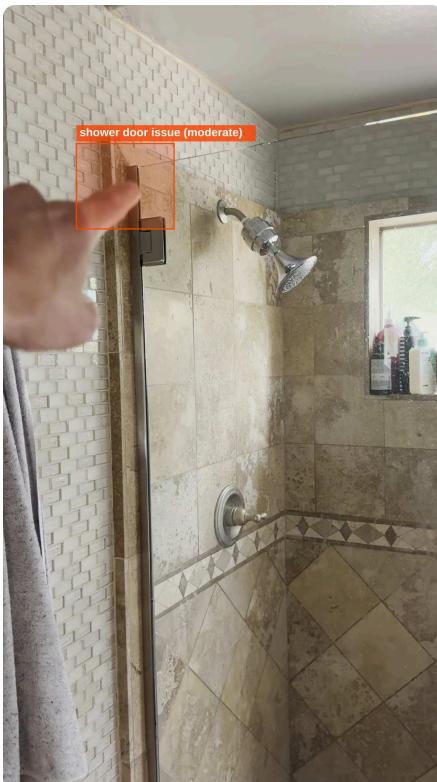
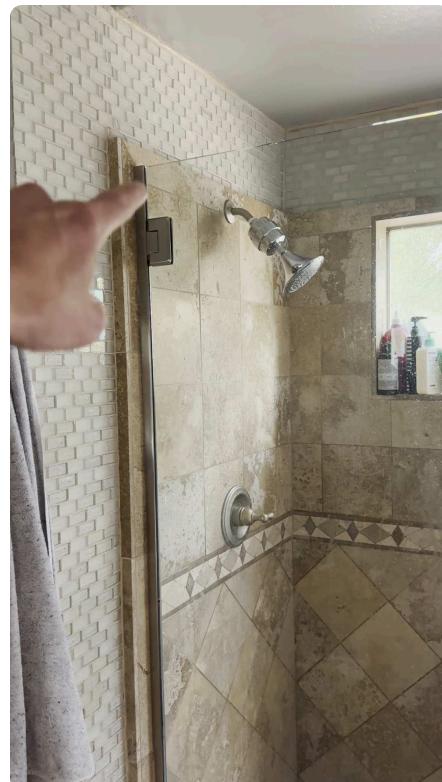
**12.5.2 SHOWER DOOR MISALIGNMENT / IMPACTING GLASS****(i) Recommendation**

The shower door was observed to be striking the adjoining glass and is misaligned. This condition can cause damage to the glass or hardware and may lead to failure if not corrected. It is recommended that a qualified glass/frameless-shower contractor or handyman evaluate the door alignment, adjust hinges or track, and install additional support or reinforcement as necessary to prevent further damage.

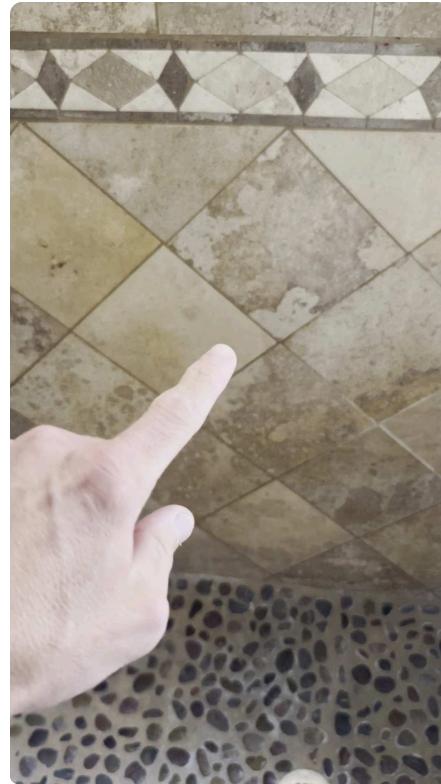
**12.5.3 LOOSE SHOWER WALL TILES — SAFETY HAZARD****⚠ Safety Hazard**

Loose tiles were observed in the master bathroom shower and were reported as a potential safety hazard. Loose or detached tiles can fall or create sharp edges and often indicate compromised substrate or prior water intrusion. It is recommended to discontinue use of the shower until a qualified tile contractor or licensed plumber assesses the condition, secures or replaces loose tiles, and evaluates the underlying substrate for moisture damage or continued leaks. Prompt repair is advised to prevent injury and further deterioration.
