# PROPERTY INSPECTION REPORT FORM

Binsr Demo	08/13/2025
Name of Client	Date of Inspection
251 N Bristol Ave, Los Angeles, CA 90049	
Address of Inspected Property	
Binsr	x1eV652bbBfgZutt6FUgWpNfGp42
Name of Inspector	TREC License #
XYZ Inspections	222b0f0f0c647b5f549373d4495a72ed60e473
Name of Sponsor (if applicable)	TREC License #

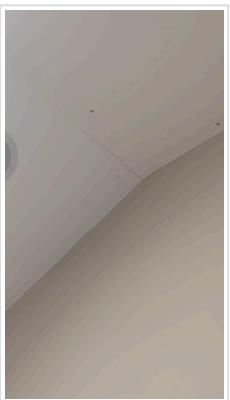
*Original image: ceiling crack at Living Room*

Significant cracking was observed in the ceiling in the Living Room that may indicate underlying structural movement or damage. A licensed contractor or structural engineer should be engaged to evaluate the extent and cause of the cracking and to recommend necessary repairs. This condition may represent a safety risk and should be addressed promptly.

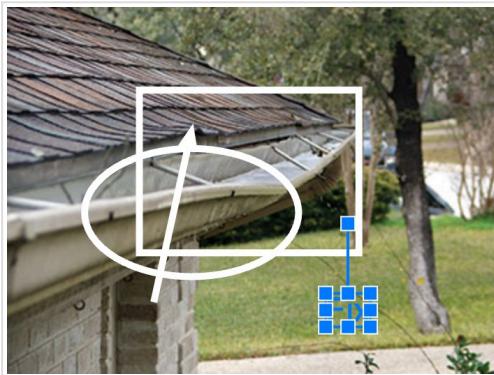
#### Location: Roof

A gutter hanger was observed to be missing or damaged. It is recommended to properly secure or replace the gutter hangers to ensure the intended stability and proper alignment of the gutter system.

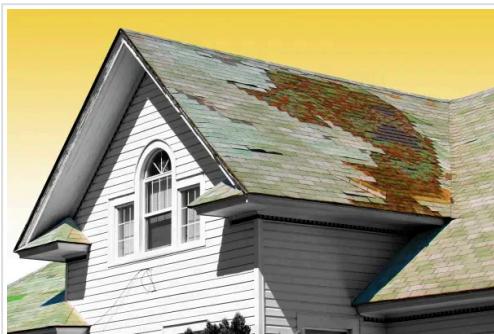
### **Location:** Roof

Based on the age and type of shingle, the roof has exceeded its expected service life. Even with current repairs, the design of the shingle is beyond its intended lifespan. It is recommended to consult a qualified roofing professional for suggestions and quotes regarding roof replacement.

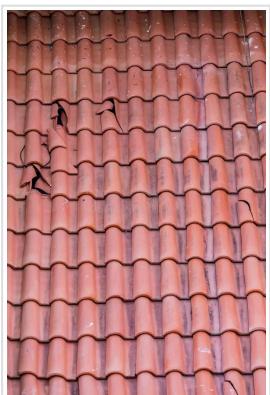
### **Location:** Roof

Cracked tiles were observed in various locations on the roof. It is recommended that a qualified roofing contractor assess and repair these areas as necessary. This type of roofing system typically benefits from annual evaluations and prompt repairs.

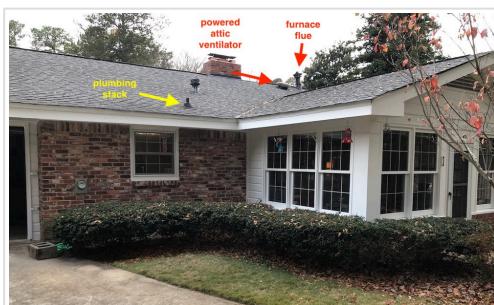
**Location:** Dining Room

The plumbing vent displayed insufficient clearance from a rooftop deck. For proper ventilation and to prevent sewer gases from entering recreational areas, vents should typically extend at least 6 feet above a rooftop deck. It is recommended to consult with a licensed professional to ensure appropriate vent height and mitigate potential health concerns.

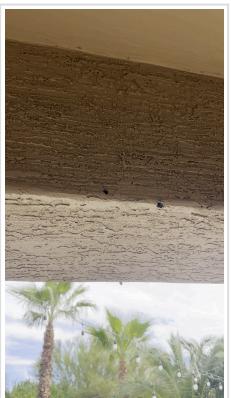
*Original image: stucco damage at Back Yard*

Stucco damage was observed. Gaps or cracks in stucco can allow for moisture intrusion, accelerating deterioration. It is recommended that a qualified contractor evaluate and perform necessary repairs.

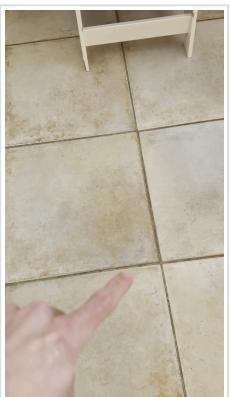
Annotated image: cracked tile at Kitchen

Two small cracks were observed in the kitchen floor tile. Cracked tile can allow moisture to penetrate the substrate and may deteriorate further over time. Recommend repair or replacement of the affected tile(s) by a qualified flooring contractor and verify the integrity of the surrounding substrate and grout. Obtain estimates as needed.

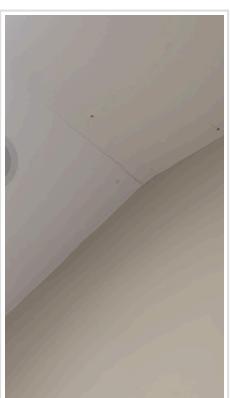
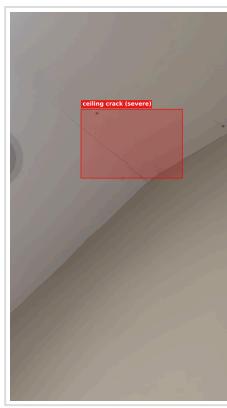
Original image: ceiling crack at Living Room

Significant drywall imperfections, including damage, cracking, or inconsistencies, were noted in the referenced area(s). It is advisable to inquire with the current homeowner(s) regarding any past alterations. Repairs should be undertaken by a drywall contractor as desired.

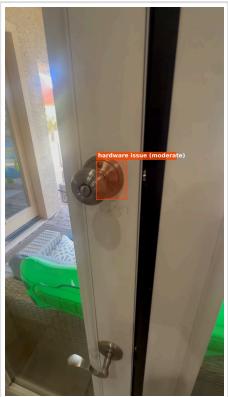
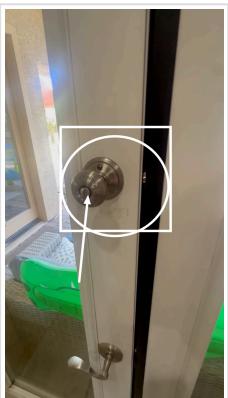
*Annotated image: hardware issue at Living Room*

The handle lock on one or more exterior entryways was found to be inoperable or challenging to use. Replacement of the locking doorknob by a qualified professional is recommended.

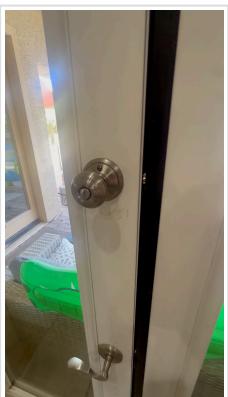
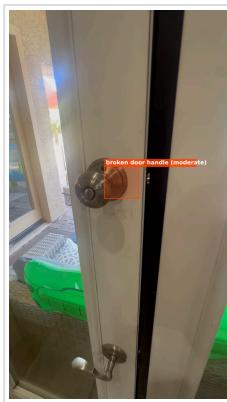
*Original image: broken door handle at Living Room*

Various exterior door hardware components, including locksets, hinges, and pulls, were observed to be inoperable, damaged, loose, or absent. It is advised that a qualified contractor perform necessary repairs or replacements.

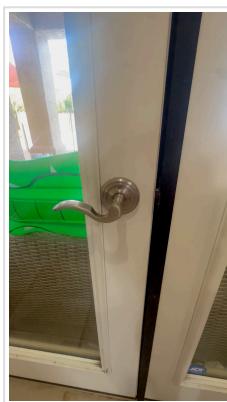
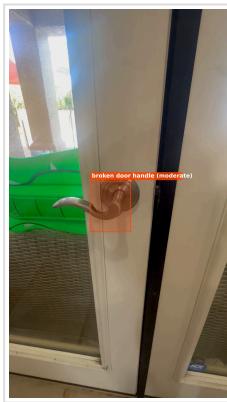
*Original image: broken door handle at Living Room*

The door handle is either damaged or missing. It is recommended that a qualified professional evaluate and repair or replace it as necessary.

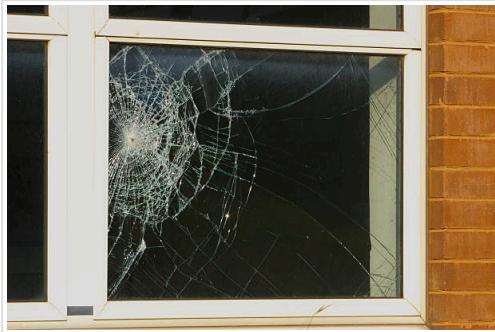
**Location:** Back Yard

The damaged glass pane may expose sharp edges and reduce the thermal barrier against the elements. Further evaluation by a qualified contractor is recommended to repair or replace the damaged window as needed.

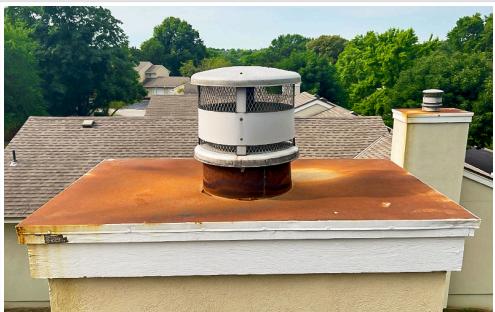
The chimney cap displayed signs of corrosion. Regular maintenance, such as sealing, is recommended to prevent further damage and extend its longevity.

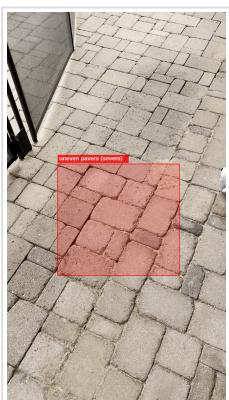
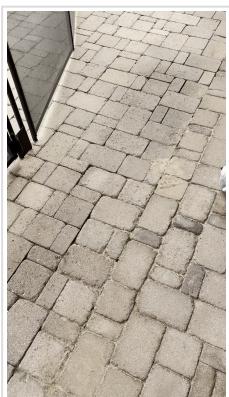
*Annotated image: uneven pavers at Back Yard*

Uneven paver stones were observed in the backyard, creating a potential trip hazard to occupants and visitors. This condition presents an immediate safety concern and should be corrected. Recommend evaluation and repair by a qualified hardscape contractor or landscaper to re-level, reset, or replace affected pavers to eliminate the trip hazard.

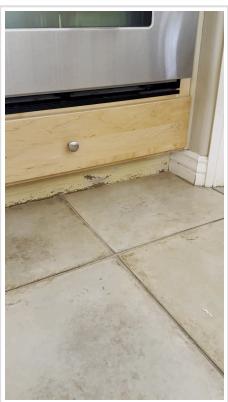
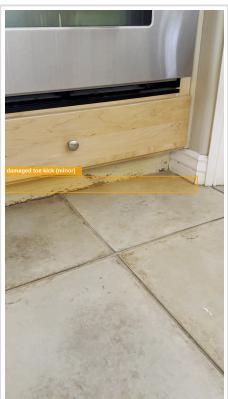
*Original image: damaged toe kick at Kitchen*

The paint finish exhibited signs of failure or peeling in one or more locations. It is recommended that a qualified contractor perform the necessary repairs.

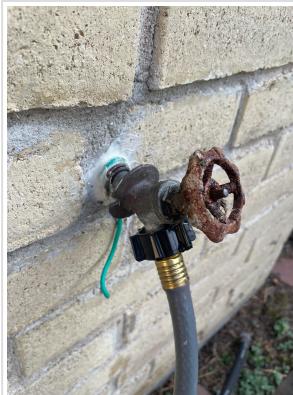
### **Location:** Exterior

Inspector recommends repairing or replacing the exterior hose bib to make it fully operational. Confirm functionality after repair and check for leaks. Obtain quotes from a licensed plumber or qualified contractor as needed.

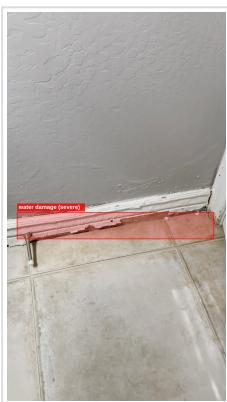
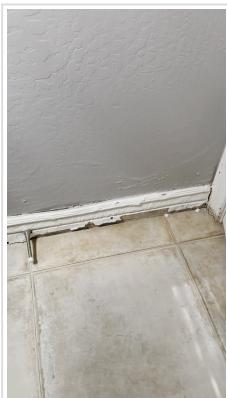
*Annotated image: water damage at Master Bathroom*

The observed leakage could cause additional damage to the framing member and floor decking. Water staining and dampness were noted in one or more areas, as confirmed by a moisture meter. This condition increases the risk of insect infestation, mildew, and decay. It is recommended to consult a licensed contractor to identify and rectify the source of the dampness, which may involve improving exterior drainage, installing a waterproofing system, or sealing foundation cracks.

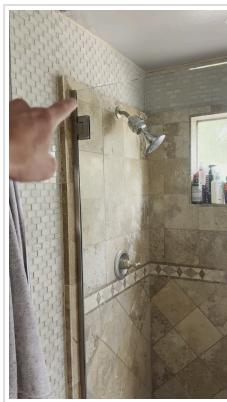
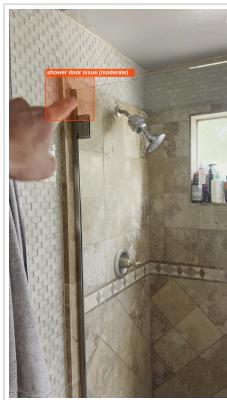
*Original image: shower door issue at Master Bathroom*

The shower door was observed to be striking the adjoining glass and is misaligned. This condition can cause damage to the glass or hardware and may lead to failure if not corrected. It is recommended that a qualified glass/frameless-shower contractor or handyman evaluate the door alignment, adjust hinges or track, and install additional support or reinforcement as necessary to prevent further damage.

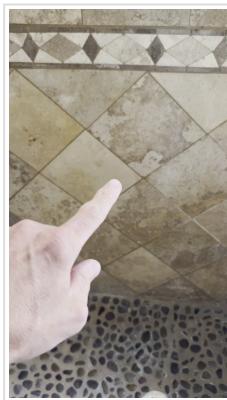
*Original image: loose tiles at Master Bathroom Shower*

Loose tiles were observed in the master bathroom shower and were reported as a potential safety hazard. Loose or detached tiles can fall or create sharp edges and often indicate compromised substrate or prior water intrusion. It is recommended to discontinue use of the shower until a qualified tile contractor or licensed plumber assesses the condition, secures or replaces loose tiles, and evaluates the underlying substrate for moisture damage or continued leaks. Prompt repair is advised to prevent injury and further deterioration.

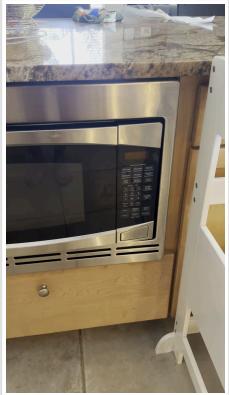
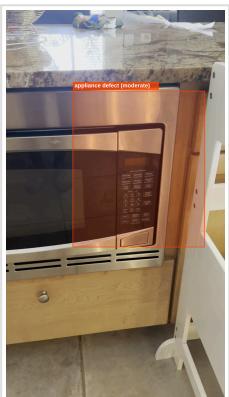
*Original image: appliance defect at Kitchen*

The microwave oven appeared to be non-operational or was malfunctioning. It is advised that a qualified appliance technician evaluate and perform necessary repairs or replacement.
