Project Snagging Report

Produced By: Accelerate
For: BNPPRE Belgrave House
Date:19th January 2018

Project: Ground Stone Floor Restoration Project

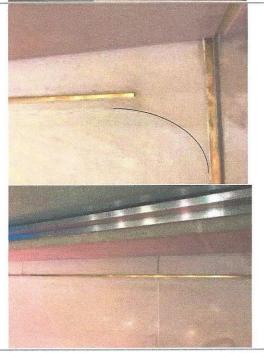
Stone restoration process appears different around the metal strip at the rear of the BGH front reception desk.

Edges appear to have been missed leaving an arch with a clearly visible dirt line.

From a more distant view on photo 2, the same appears all along this metal detailing strip.

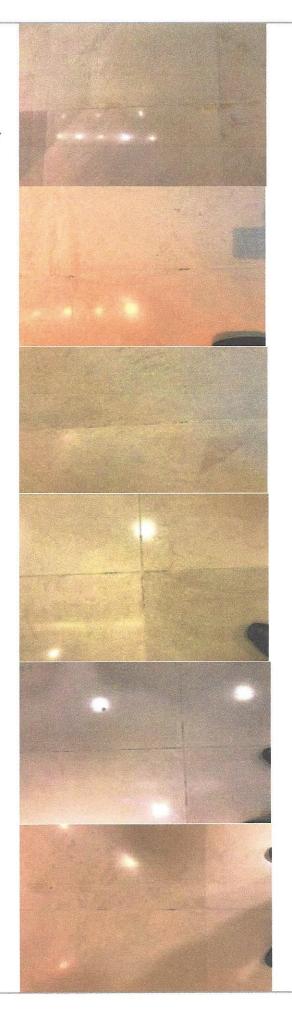
Various Grouting Issues, Front and rear reception Belgrave House.

Images of various black areas of grouting that still need to be replaced and blended to the appearance of the floor.

In terms of the finish to the floor, this element has a particularly negative effect on the final finish.
