Baseline Assessment of Kushtia Municipality Bangladesh

Project: Integrated Water Management in Urban Areas

Baseline Survey Conducted on: March, 2021

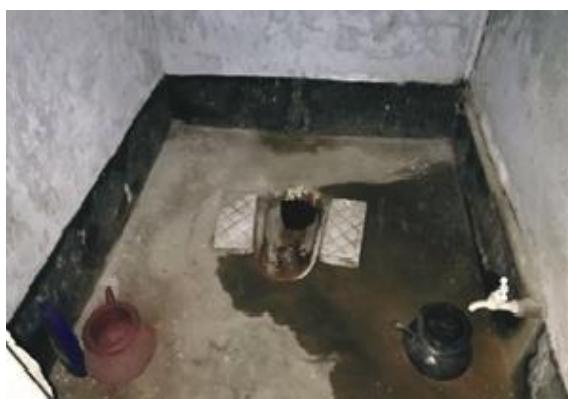
Figure 1: Inside of Public Toilet in Kushtia

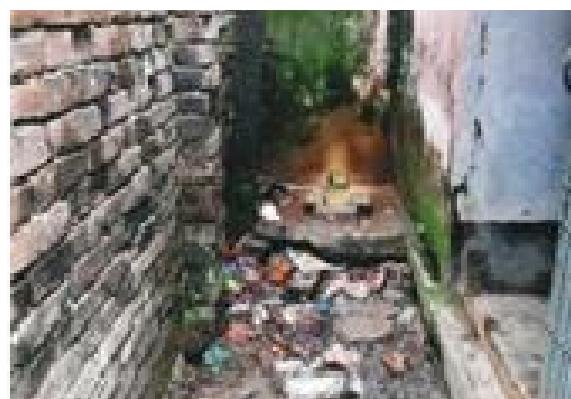
Figure 2: Discharge of Waste from Public Toilet in Kushtia

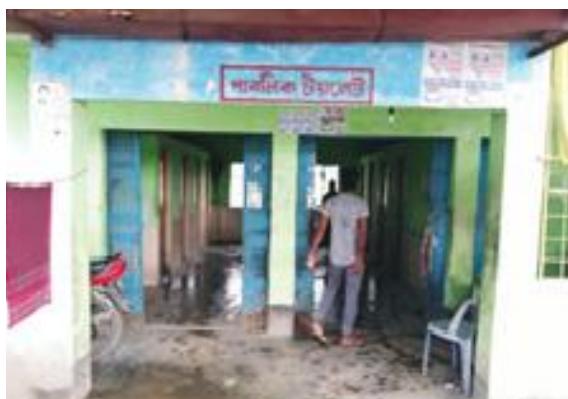
Figure 3: Outside View of Public Toilet

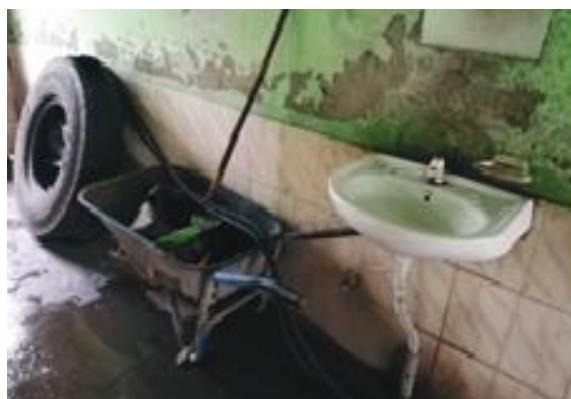
Figure 4: Condition of Toilet Facilities

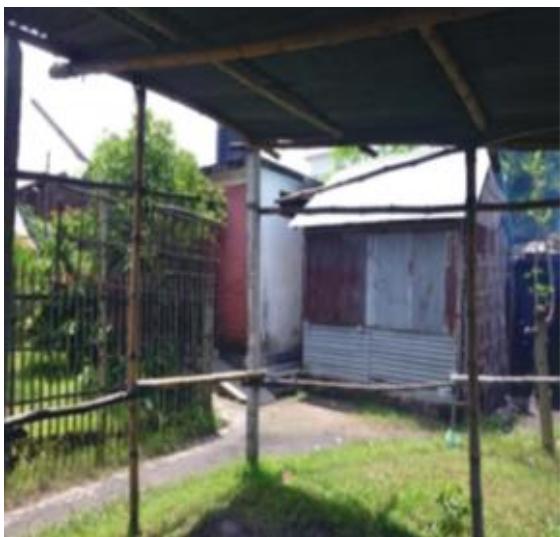
Figure 5: Public Toilet of Rajarhat Bazar

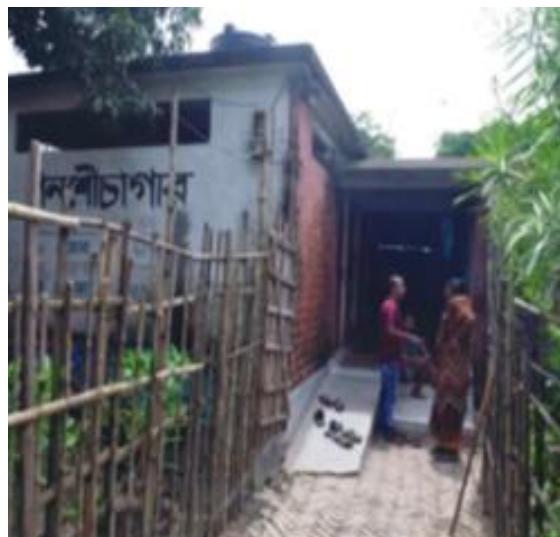
Figure 6: Public Toilet of Sweeper Colony

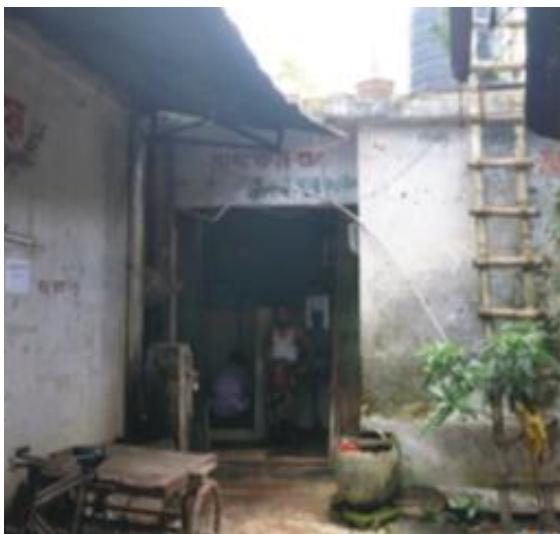
Figure 7: Public Toilet of Municipality Bazar

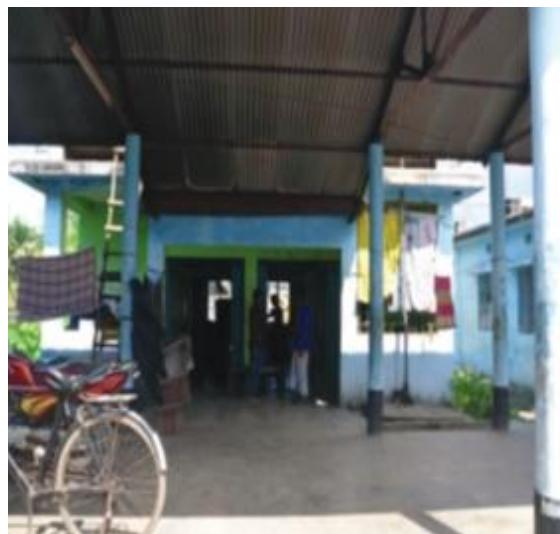
Figure 8: Public Toilet of Bus Terminal

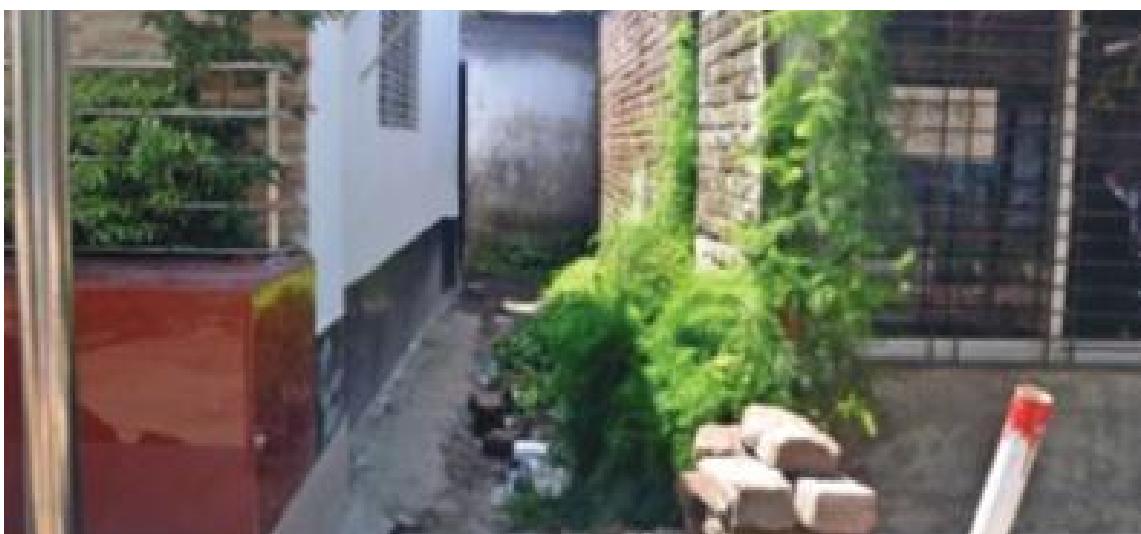
Figure 9: Public Toilet of DC Office

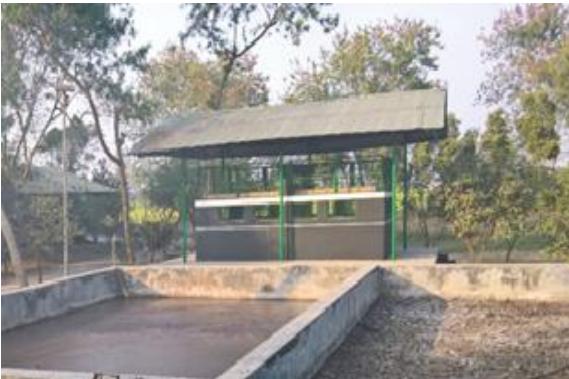
Figure 10: Front Side OG Drying Bed

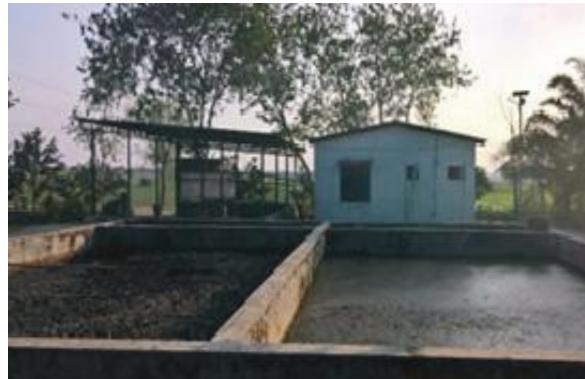
Figure 11: Drying Beds for Dewatering of the Faecal Sludge

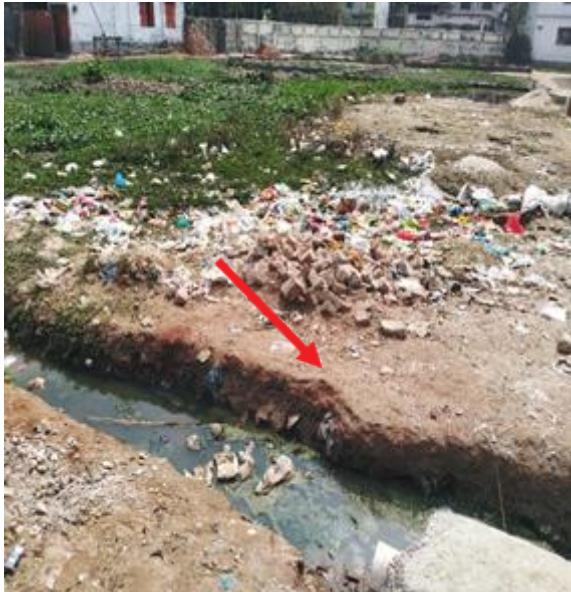
Figure 13: Septic Tank Connected to Nearby Water Body

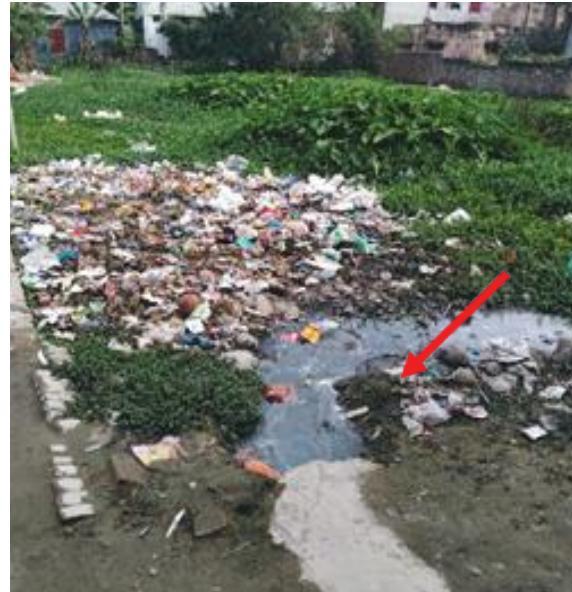
Figure 14: Toilet Pipe Connected to Storm Water Drain

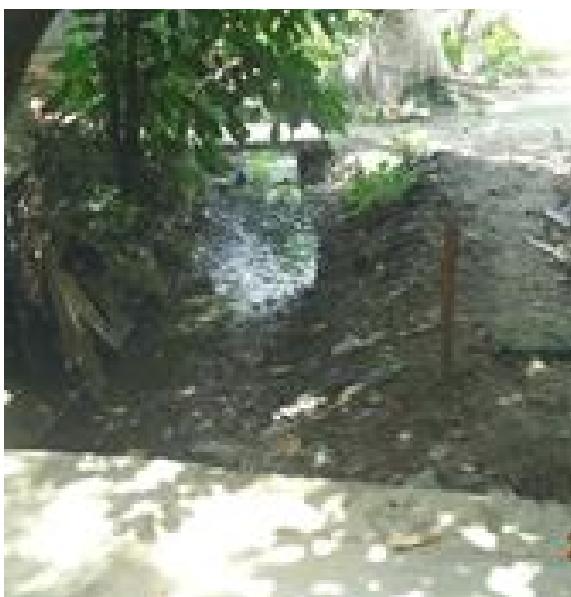
Figure 15: Grey Water Discharge on Ground

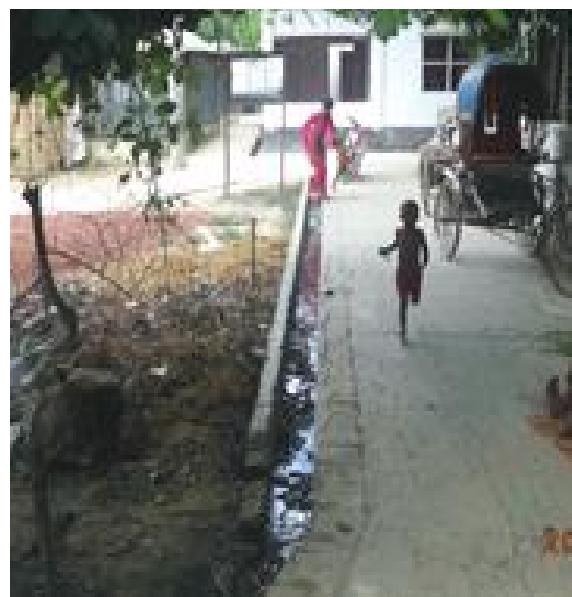
Figure 16: Slum Drains

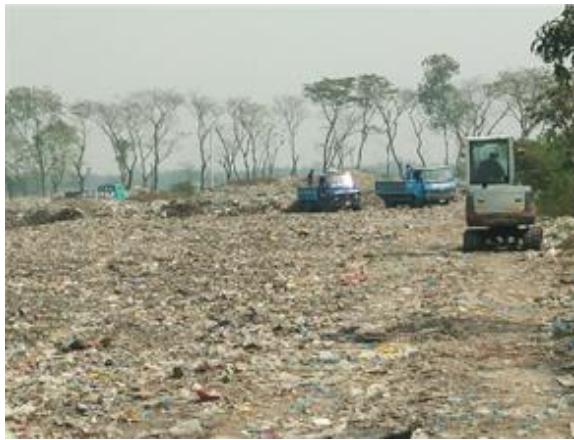
Figure 17: Present dumping ground of Kushtia Pourashava

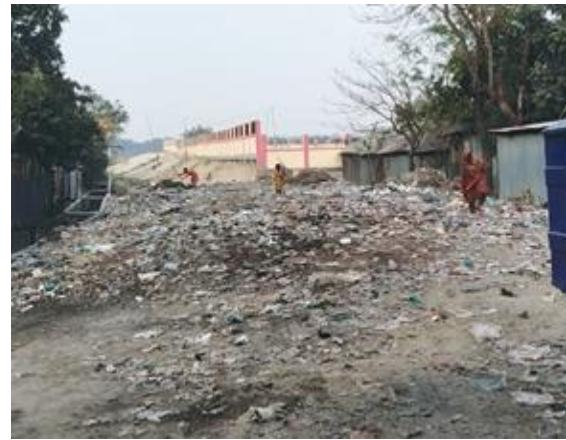
Figure 18: Waste disposed of in open ground

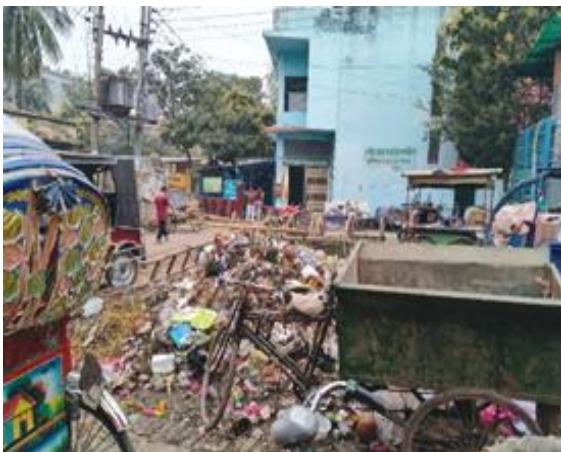
Figure 19: Present dumping ground of Kushtia Pourashava

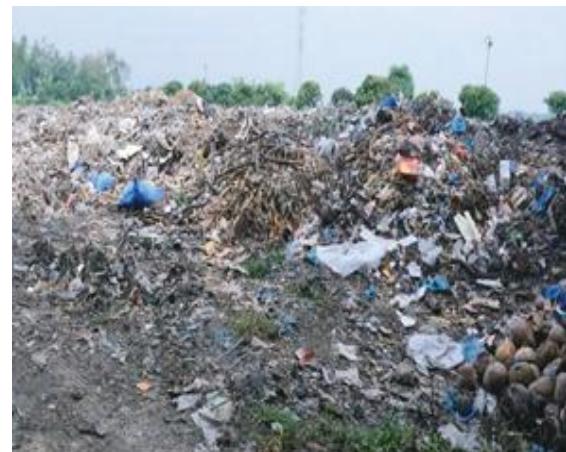
Figure 20: Landfill ground of Kushtia Pourashava

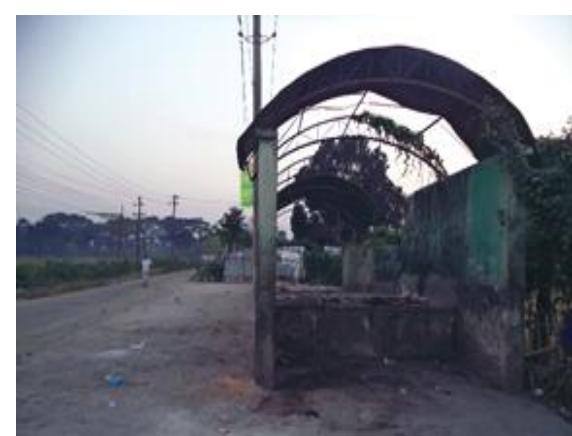
Figure 22: Empty transfer station

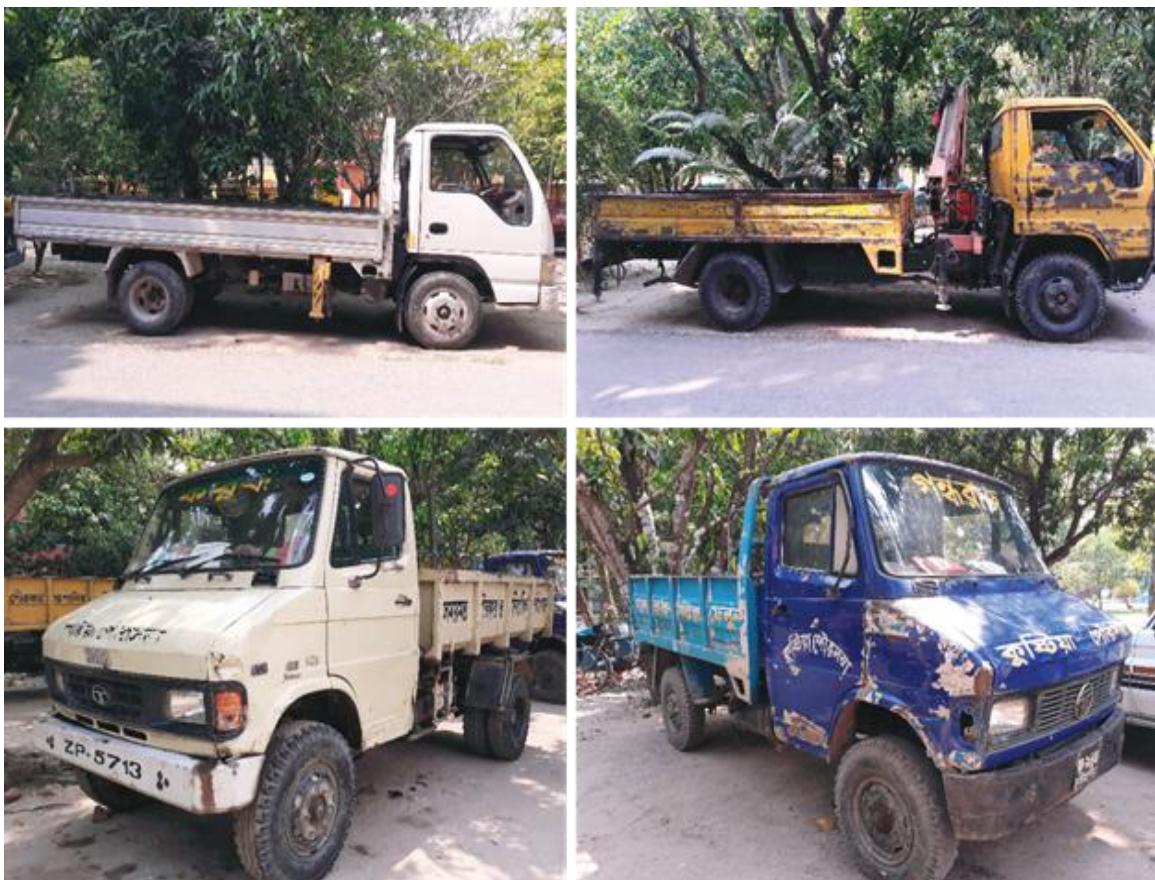
- Inadequate number of trucks
- Inadequate capacity of vehicles
- Inefficient routing plan
- No monitoring of waste transportation system
- Open trucks are used
- Most truck do not have hydraulic tipping system

Figure 23: Garbage Trucks of Kushtia Pourashava
