A REPORT ON PROJECT ACTIVITIES IMPLEMENTED BY WASTE CONCERN UNDER

INTEGRATED WATER MANAGEMENT IN URBAN AREAS AS A CORE TASK OF MUNICIPAL SERVICES OF GENERAL INTEREST PROJECT (PN-161)

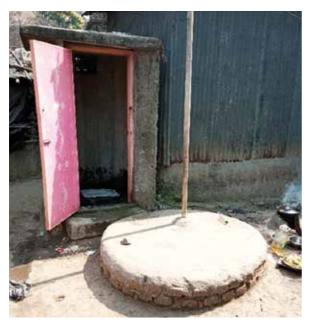
- Most of the toilets were found to be directly connected with drains.
- There is a huge scarcity of public toilets due to unavailability of land.
- Toilets in the slums were mostly found unhygienic.

Figure 2.1: A typical pit latrine in Savar municipality

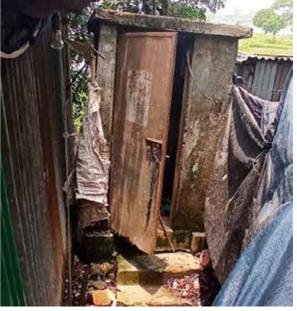
Figure 2.2: A shared toilet in a slum in Savar municipality

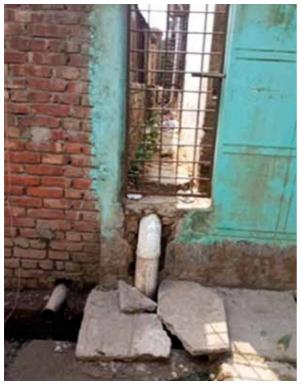
There is no proper greywater management system in the municipality too. Most households discharge greywater directly into open municipal drains, some of which are already blocked because of indiscriminate disposal of solid waste. In some areas of the municipality, greywater is discharged in nearby waterbodies and open fields. Neither the households nor municipal officials have any concern for systematic management of this greywater.

Figure 2.3: Discharging grey water in open area

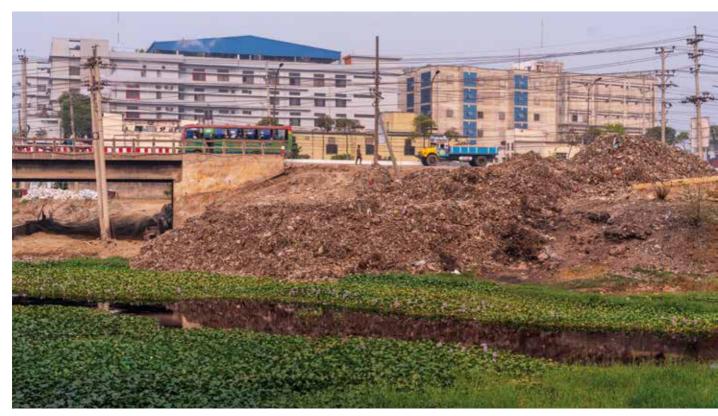
The indiscriminate open dumping of the waste leads to pollution and induces ill effects on public health.

Figure 2.5: Pile of waste alongside a stream near Bank Town in Savar Municipality

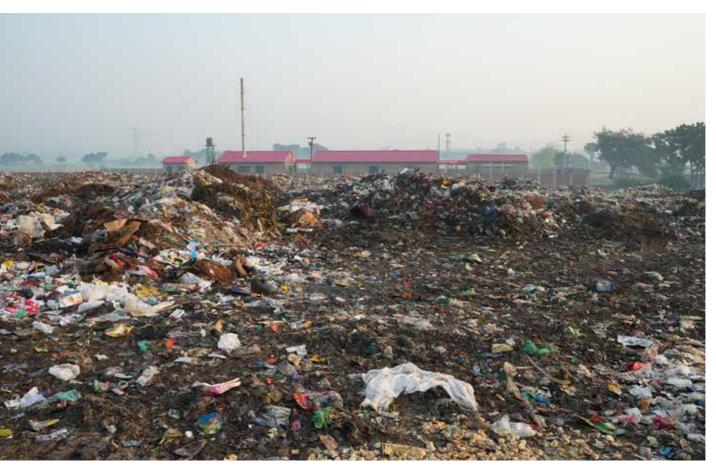
The solid waste collection and management system in Kushtia municipality is quite inadequate and inefficient. Almost 65% of the total waste generated remains uncollected by the municipality. This waste is being thrown into open drains, vacant lands, and roadside spaces, causing clogging of drains and environmental degradation. Clogging of drains due to indiscriminate dumping of waste therein results in water logging. Besides, open dumping of waste causes air, water, and land contamination. According to the Department of Environment (DoE), 67% of air pollution in the municipality happens due to inefficient management of solid waste.

Figure 2.9: A view of the existing landfill site of Kushtia Municipality

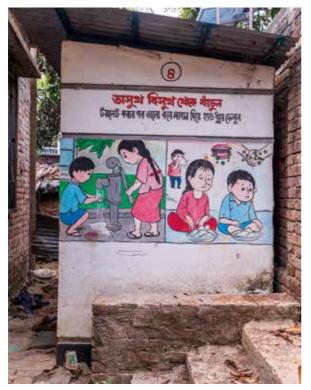
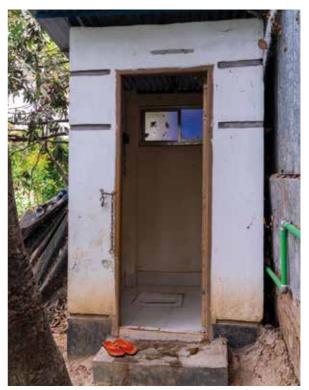
Figure 3.7: Improved Shared Toilets constructed at Bede Para

Under this intervention, all the existing unimproved toilets were replaced with improved ones. A total of 14 improved toilets were constructed that would serve 70 families consisting of 360 users. Each facility would be used and maintained by 4-6 families on a shared basis. The super-structure of these shared toilets consisted of brick walls, CGI sheet roofs, and permanent plastic doors. The plinths were raised 0.3 m (1 ft) above ground level in order to keep the facilities functional even during high flooding events. Good quality squatting pans were installed and the floors were covered with tiles for ease of cleaning. Vent pipe was provided for reducing odour and nuisance. There was also provision for adequate ventilation.

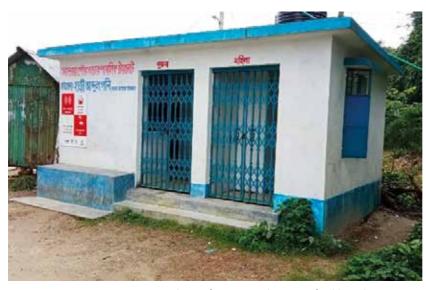
It was observed during initial inspection that the structure of the public toilet was sound and stable. However, due to lack of reliable electricity connection to the public toilet, the submersible pump that had been installed to supply water to the toilet could not be operated. Because the toilet was lying non-operational for a long time, the fixtures were mostly degraded and the existing pump was no longer functional. As a result, the public toilet turned into a dysfunctional facility despite being situated in a strategic location.

Figure 3.13: Condition of exterior and interior of Public Toilet at Karnapara before renovation

In order to operationalize this public toilet, it was planned to renovate this facility along with provision for consistent electricity supply. There was also a plan for landscaping the immediately surrounding area. This would be done by providing seats, pergola, surface pavement, planters, etc. and incorporating a tea stall in this place. These arrangements would be targeted at attracting and retaining more people in this place, therefore enhancing the number of users of this facility. This was also expected to change the perception of general people about public toilets – these can be sociable places with necessary amenities, as opposed to the popular image of public toilets as dirty, unhygienic places.

- Renovation of the public toilet by repairing and replacing the internal and external features.
- Installation of solar panels for ensuring a regular supply of electricity and water.
- Improvement of the surrounding area of public toilet with better landscaping.

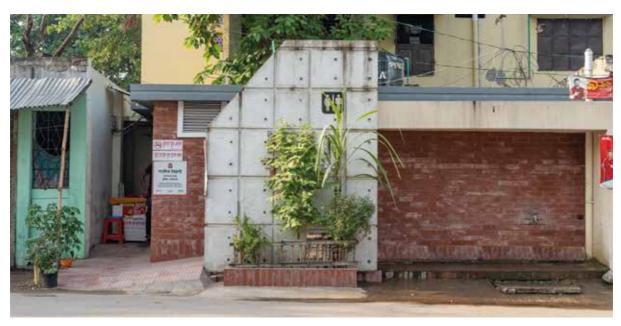
Figure 3.20: Exterior of the Public Toilet at Hospital Road after Renovation

Through this intervention, the toilet was transformed into a usable facility that can address the needs of both male and female users. After renovation, there are 3 units and 3 urinals for male users and 1 unit for female users now. Also, 3 basins for male users and 2 basins for female users were provided. A shower unit was also provided in this public toilet, thus making it a full-fledged facility serving multiple purposes. One unit in the Male section was furnished with commode considering the need of physically challenged people. From the same consideration, the entry to the toilet was facilitated with a ramp instead of steps. The interior walls were covered with tiles in order to prevent dampness and damage to plasters.

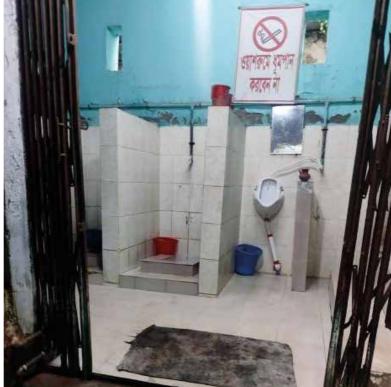
Figure 3.22: Internal Condition of Public Toilet at M. A. Rahim Market before Renovation

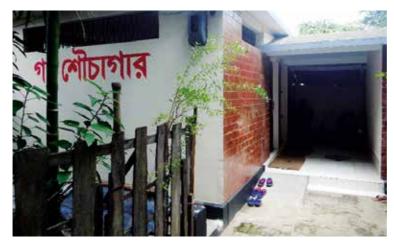
During the assessment of the condition of this toilet, it was found that the flush of a unit had been broken. Some basin pipes and tap fittings were missing. Some light bulbs and shower fittings were missing too. During renovation, all the shower and tap fittings were replaced. Lighting fixtures were replaced and light bulbs were added. Colouring and finishing works were done on both the interior and exterior surfaces.

Figure 3.26: Public Toilet at Kobi Azizur Rahman Road after Renovation

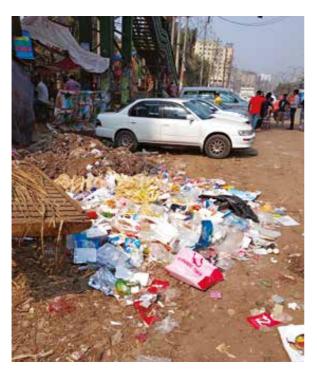
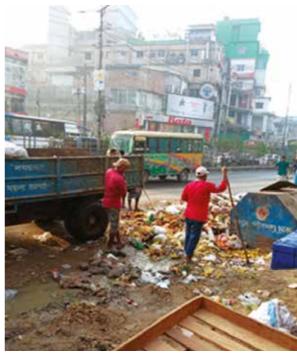
Figure 4.9: Temporary dumping of solid waste on roadside (left) and collection by garbage trucks from roadside (right) in Savar municipality
