# SERVICE BULLETIN

**SUBJECT:** MP3000 Controller Replacements

**BULLETIN NO:** C 048

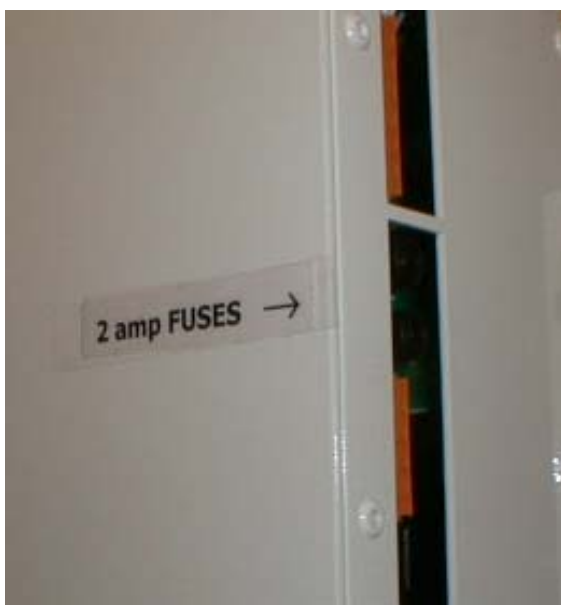
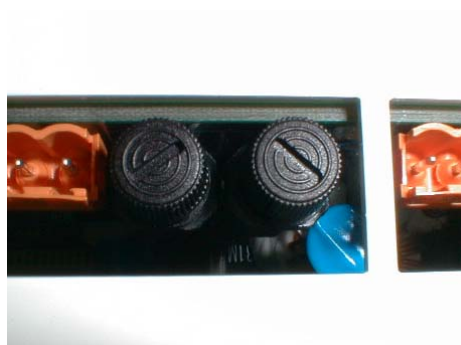
This bulletin recommends some checks to be performed before replacing a MP3000 controller, Main Relay Board (MRB) or keypad. There have been many controllers and MRB's replaced and returned to Thermo King with no trouble found when tested by the vendor. Under the new warranty procedures, claims for non-defective parts will not be paid and the parts returned to the submitting dealer.

- **Check both 2 amp fuses**
  - o Ensure the two fuses are in good condition and not open circuit
  - o Fuses part number: 44-6777
