# UAUC Capture Report

Audit ID: MABP-1 | Project: MABP | 8/7/2026, 4:27:33 pm

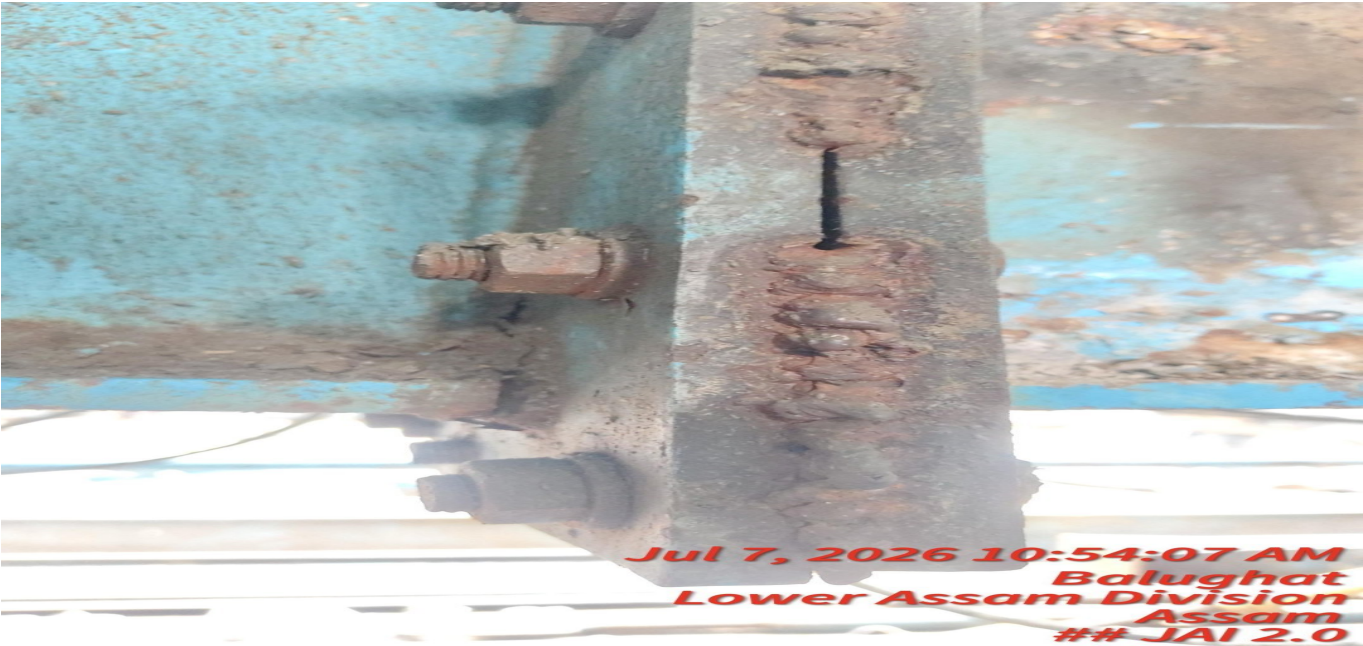
| Safety Issue | Potential Risk |
|---|---|
| • Severe rust and corrosion on structural components | Structural failure leading to collapse |
| • Visible crack in the metal structure | Falling debris causing injury |
| • Loose or damaged bolts | Equipment malfunction due to compromised integrity |

| • Replace corroded and cracked structural components immediately |
| • Inspect and tighten or replace loose or damaged bolts |
| • Conduct a thorough structural integrity assessment |
| • Implement regular maintenance and corrosion prevention measures |
