# UAUC Capture Report

Audit ID: MABP-3 | Project: MABP | 8/7/2026, 4:33:34 pm

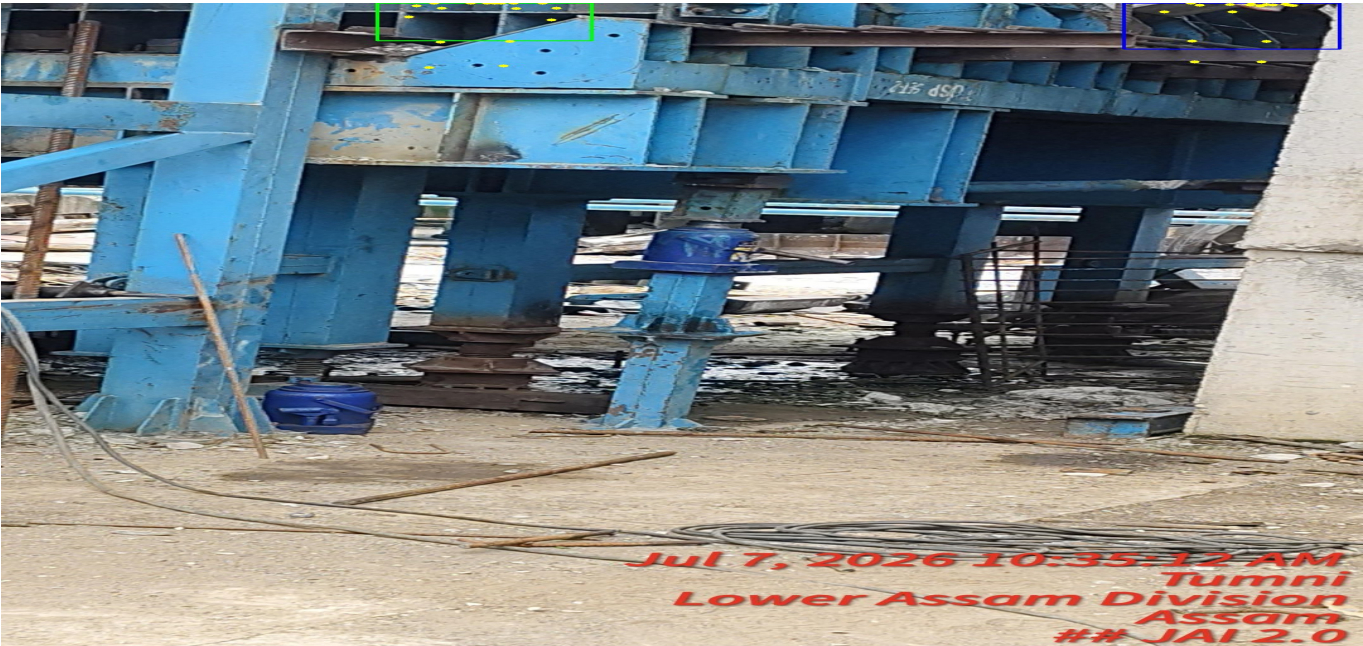
## Analyzed Image

| Safety Issue | Potential Risk |
|---|---|
| <ul style="list-style-type: none"><li>• Trip hazards due to scattered cables and rods on the ground</li></ul> | Trip and fall incidents |
| <ul style="list-style-type: none"><li>• Poor housekeeping with debris and materials obstructing the area</li></ul> | Injury from falling objects |
| <ul style="list-style-type: none"><li>• Potential falling object hazard from unsecured materials above</li></ul> | Slips due to debris accumulation |

| <ul style="list-style-type: none"><li>• Remove scattered cables and rods from the ground to eliminate trip hazards</li></ul> |
| <ul style="list-style-type: none"><li>• Improve housekeeping by clearing debris and organizing materials</li></ul> |
| <ul style="list-style-type: none"><li>• Secure materials stored above to prevent falling object incidents</li></ul> |
