# UAUC Capture Report

Audit ID: MABP-5 | Project: MABP | 7/9/2026, 9:53:25 AM

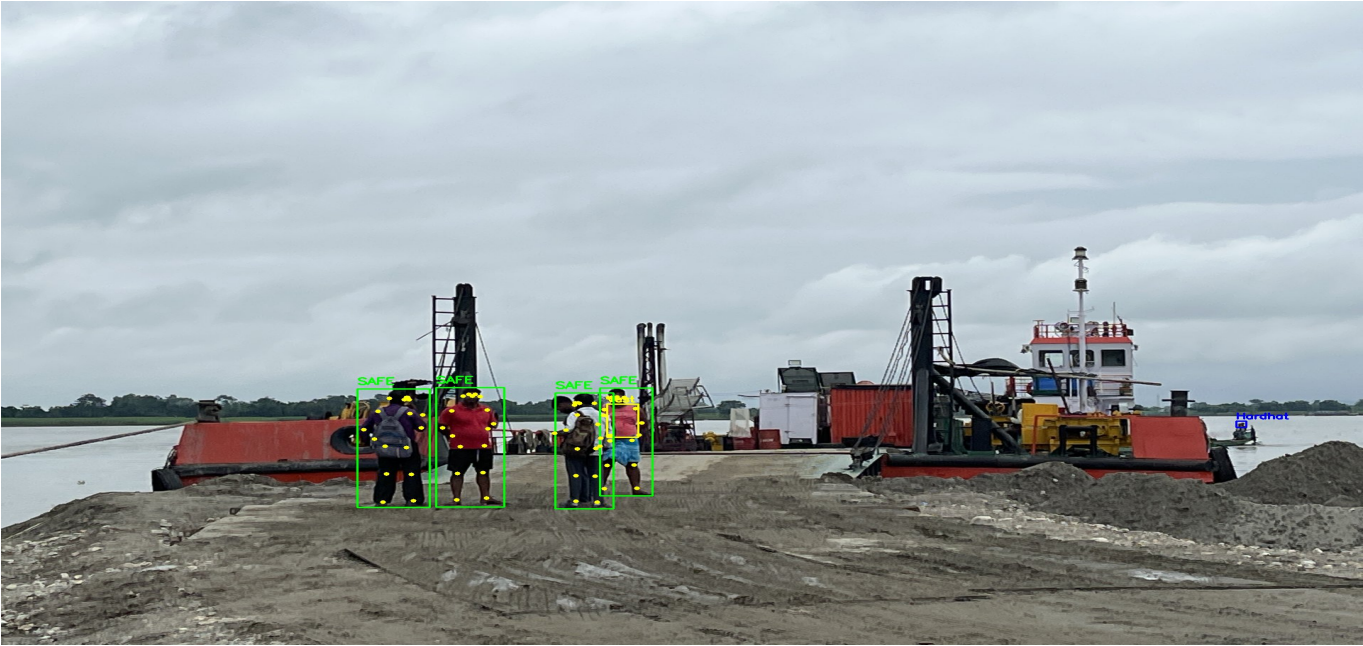
| Safety Issue | Potential Risk |
|---|---|
| <ul style="list-style-type: none"><li>Workers are not wearing visible safety vests.</li></ul> | Trip and fall due to uneven and loose soil. |
| <ul style="list-style-type: none"><li>Workers are not wearing helmets.</li></ul> | Head injury due to lack of helmets. |
| <ul style="list-style-type: none"><li>Uneven and loose soil on the ground creates a trip hazard.</li></ul> | Drowning or falling into water due to lack of barricades or warning signs. |
| <ul style="list-style-type: none"><li>No visible barricades or warning signs near the edge of the water.</li></ul> | high |

| <ul style="list-style-type: none"><li>Ensure all workers wear safety vests and helmets.</li></ul> |
| <ul style="list-style-type: none"><li>Level and compact the soil to reduce trip hazards.</li></ul> |
| <ul style="list-style-type: none"><li>Install barricades or warning signs near the edge of the water to prevent falls.</li></ul> |
| <ul style="list-style-type: none"><li>Conduct regular safety inspections to ensure compliance with PPE and site safety standards.</li></ul> |
