# UAUC Capture Report

Audit ID: MPSB-13 | Project: MPSB | 18/6/2026, 2:51:30 pm

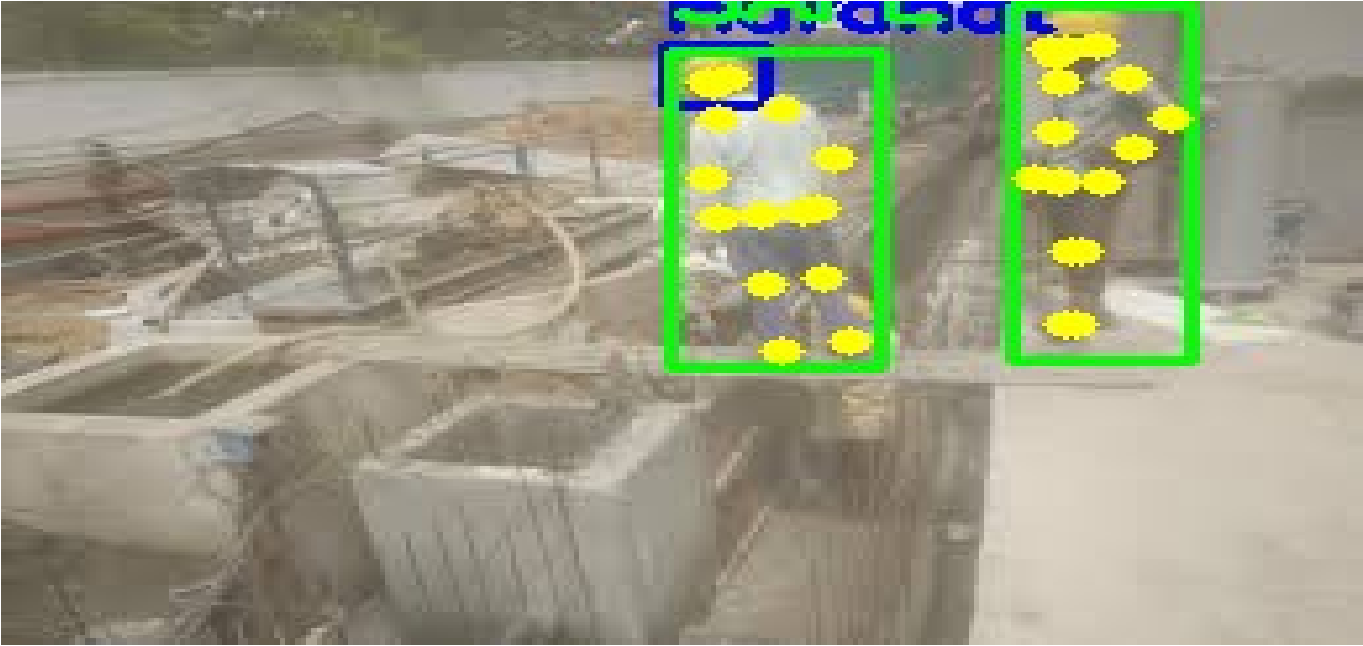
| Safety Issue | Potential Risk |
|---|---|
| <ul style="list-style-type: none"><li>Worker not wearing a safety vest.</li></ul> | Worker may fall into the open gap due to unstable footing. |
| <ul style="list-style-type: none"><li>Worker standing on an unstable wooden plank over an open gap.</li></ul> | Injury due to lack of visibility without a safety vest. |

| <ul style="list-style-type: none"><li>Ensure all workers wear safety vests for visibility.</li><li>Replace the wooden plank with a stable and secure platform or install proper scaffolding.</li><li>Install guardrails or barriers around open gaps to prevent falls.</li></ul> |
