# UAUC Capture Report

Audit ID: MPSB-14 | Project: MPSB | 19/6/2026, 9:19:58 am

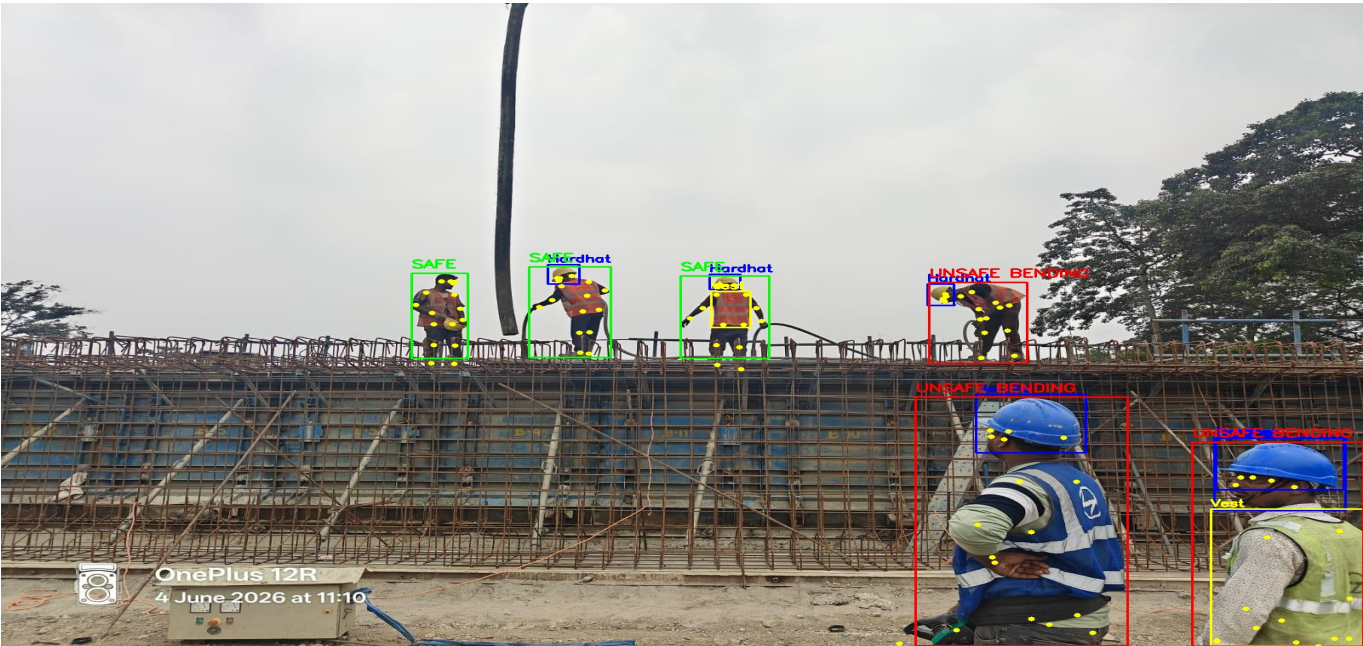
## Analyzed Image

| Safety Issue | Potential Risk |
|---|---|
| • Unsafe bending posture detected. | Risk of musculoskeletal injuries due to unsafe bending posture. |
| • Workers on elevated platform without visible fall protection. | Risk of falling from height due to lack of fall protection. |
| • Uneven surface with protruding rebar on the elevated platform. | Risk of tripping or injury from exposed rebar on the platform. |

- Provide proper training on safe lifting and bending techniques.
- Ensure all workers on elevated platforms use fall protection equipment such as harnesses.
- Cover or cap exposed rebar to prevent injuries and ensure the platform surface is even and clear of hazards.
