# UAUC Capture Report

Audit ID: MPSB-15 | Project: MPSB | 6/26/2026, 5:30:48 AM

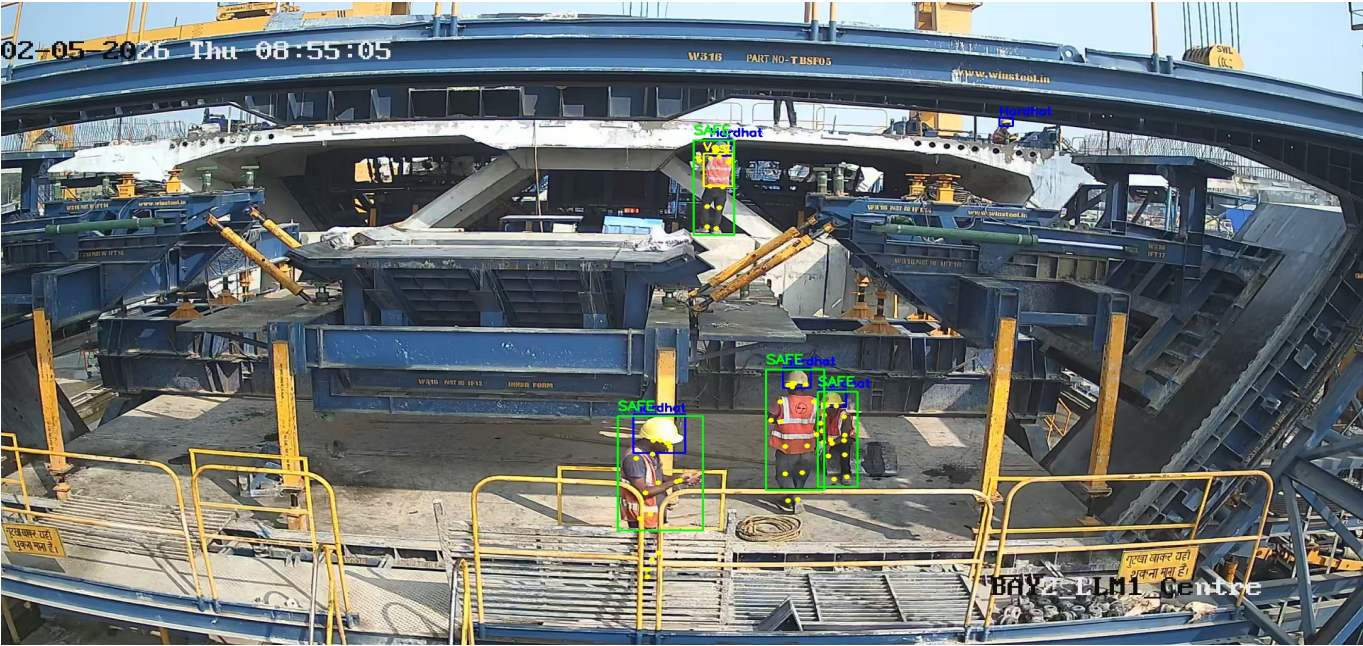
## Analyzed Image

| Safety Issue | Potential Risk |
|---|---|
| <ul style="list-style-type: none"><li>Worker standing on an elevated platform without visible fall protection.</li></ul> | Fall from height due to lack of fall protection. |
| <ul style="list-style-type: none"><li>Loose cables and hoses on the floor creating potential trip hazards.</li></ul> | Tripping over loose cables and hoses leading to injury. |

| <ul style="list-style-type: none"><li>Ensure all workers on elevated platforms use appropriate fall protection equipment such as harnesses.</li><li>Organize and secure loose cables and hoses to eliminate trip hazards.</li></ul> |
