# UAUC Capture Report

Audit ID: MPSB-23 | Project: MPSB | 7/2/2026, 6:47:28 AM

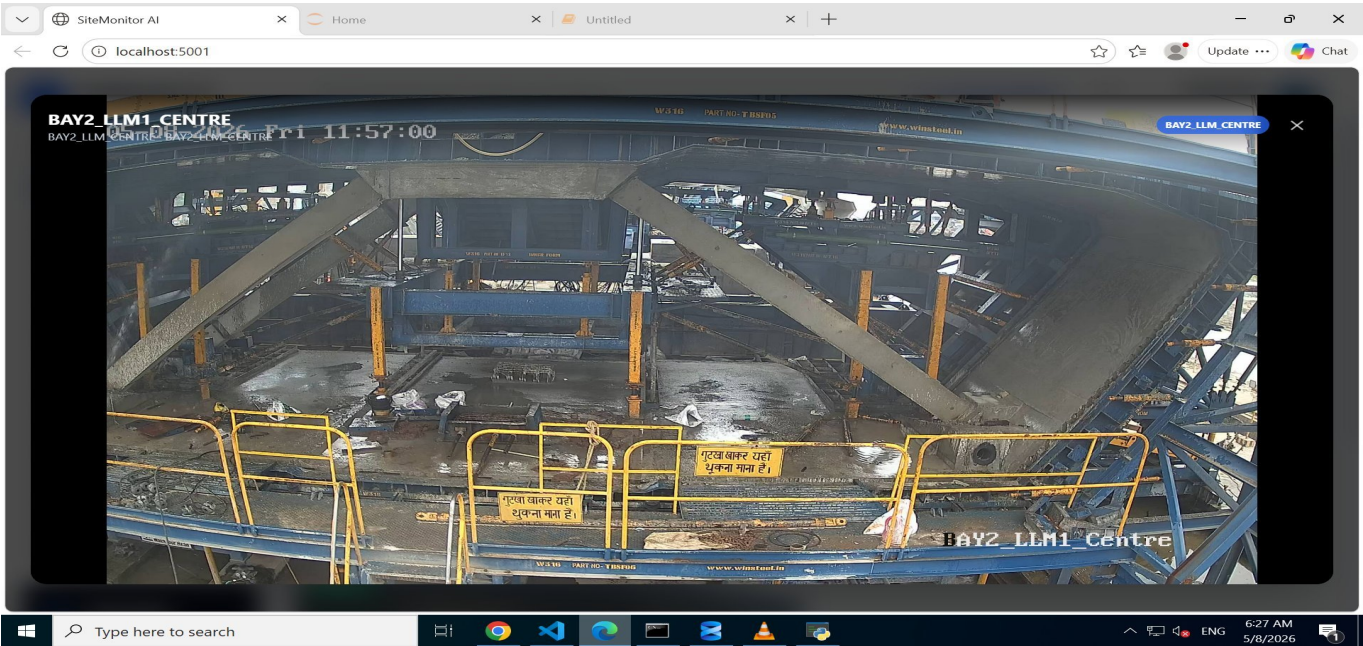
| Safety Issue | Potential Risk |
|---|---|
| <ul style="list-style-type: none"><li>Water accumulation on the floor creating a slip hazard.</li></ul> | Slip and fall due to water accumulation. |
| <ul style="list-style-type: none"><li>Poor housekeeping with scattered materials and debris on the floor.</li></ul> | Trip and fall due to scattered materials and debris. |
| <ul style="list-style-type: none"><li>Open edges without proper barricades in some areas.</li></ul> | Fall from height due to open edges without proper barricades. |

- Remove water accumulation and ensure the floor is dry.
- Improve housekeeping by clearing scattered materials and debris.
- Install proper barricades or guardrails at open edges to prevent falls.
