# UAUC Capture Report

Audit ID: MPSB-29 | Project: MPSB | 7/9/2026, 11:19:57 AM

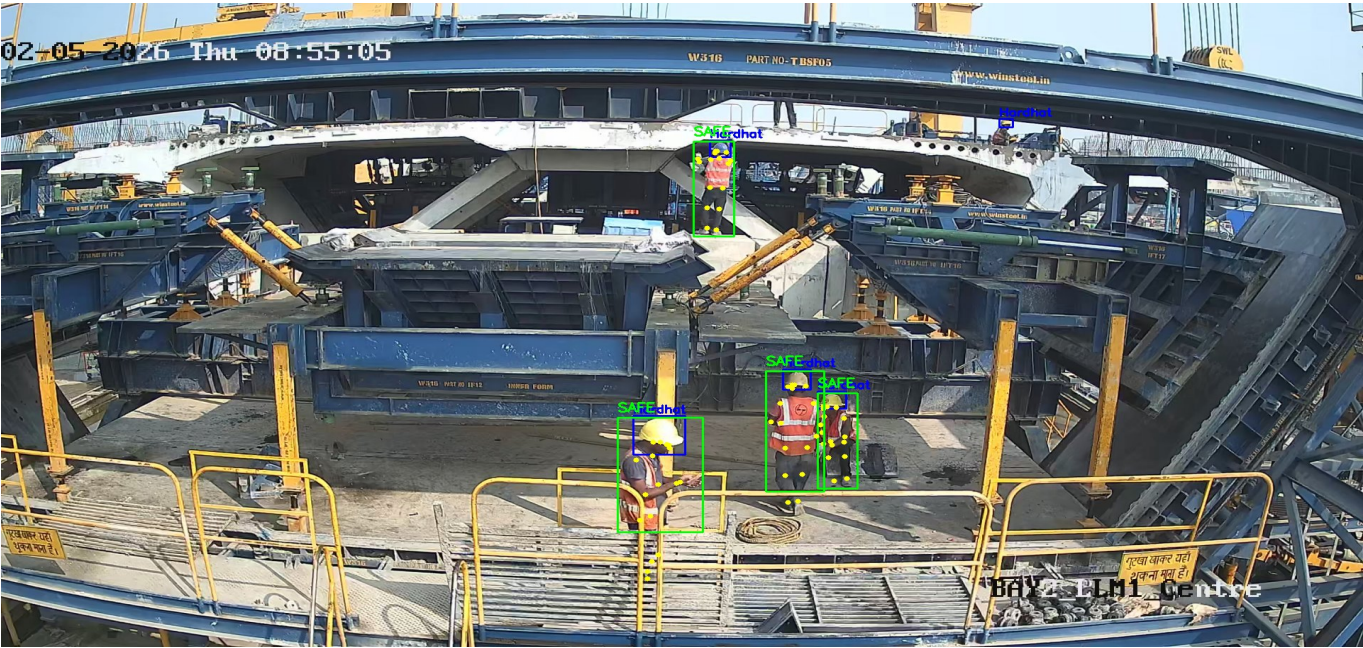
## Analyzed Image

| Safety Issue | Potential Risk |
|---|---|
| <ul style="list-style-type: none"><li>Worker at height without visible fall protection</li></ul> | Fall from height |
| <ul style="list-style-type: none"><li>Loose materials on the platform</li></ul> | Trip and fall due to loose materials |
| <ul style="list-style-type: none"><li>Worker using mobile phone in a construction zone</li></ul> | Distraction leading to accidents |

- Ensure workers at height use proper fall protection equipment.
- Remove loose materials from the platform to prevent tripping hazards.
- Prohibit mobile phone usage in active construction zones.
