# UAUC Capture Report

Audit ID: MPSB-2 | Project: MPSB | 6/24/2026, 5:45:35 AM

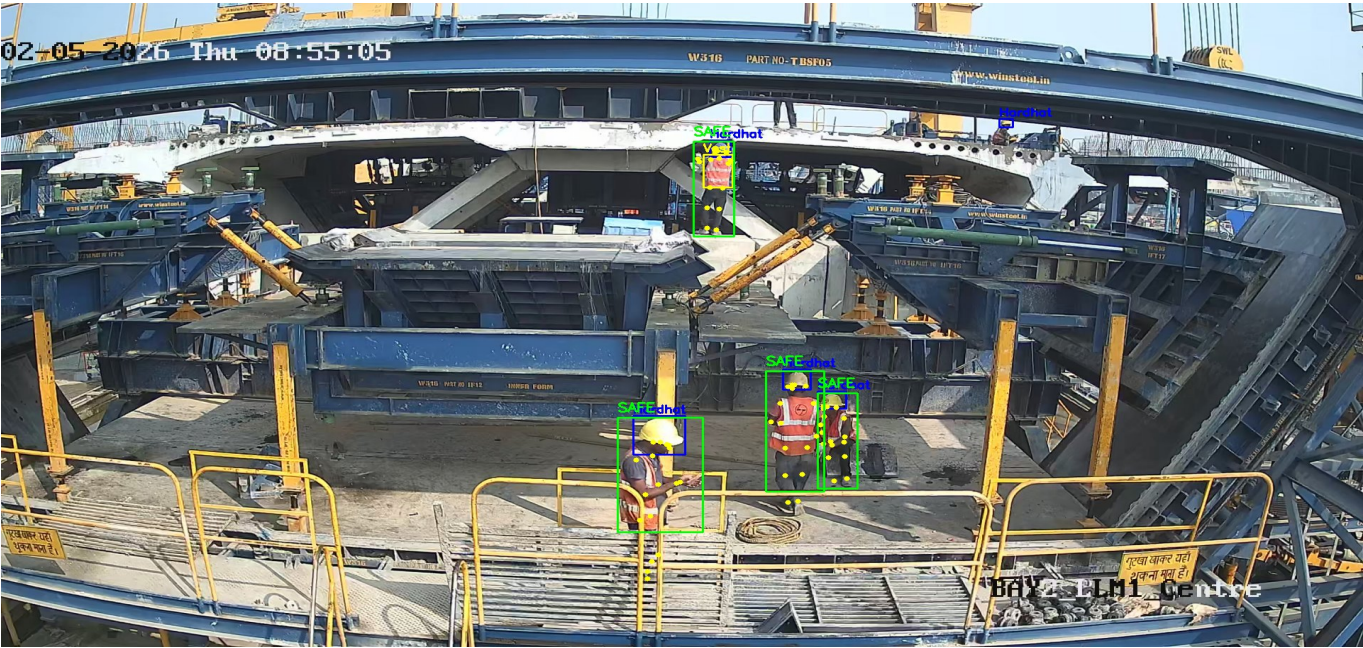
## Analyzed Image

| Safety Issue | Potential Risk |
|---|---|
| <ul style="list-style-type: none"><li>Worker standing on an elevated platform without visible fall protection.</li></ul> | Fall from height due to lack of fall protection. |
| <ul style="list-style-type: none"><li>Loose cables and hoses on the ground creating potential trip hazards.</li></ul> | Tripping over loose cables and hoses leading to injury. |

| <ul style="list-style-type: none"><li>Ensure all workers on elevated platforms use proper fall protection equipment such as harnesses.</li><li>Organize and secure loose cables and hoses to eliminate trip hazards.</li></ul> |
