# UAUC Capture Report

Audit ID: MPSB-32 | Project: MPSB | 9/7/2026, 7:04:34 pm

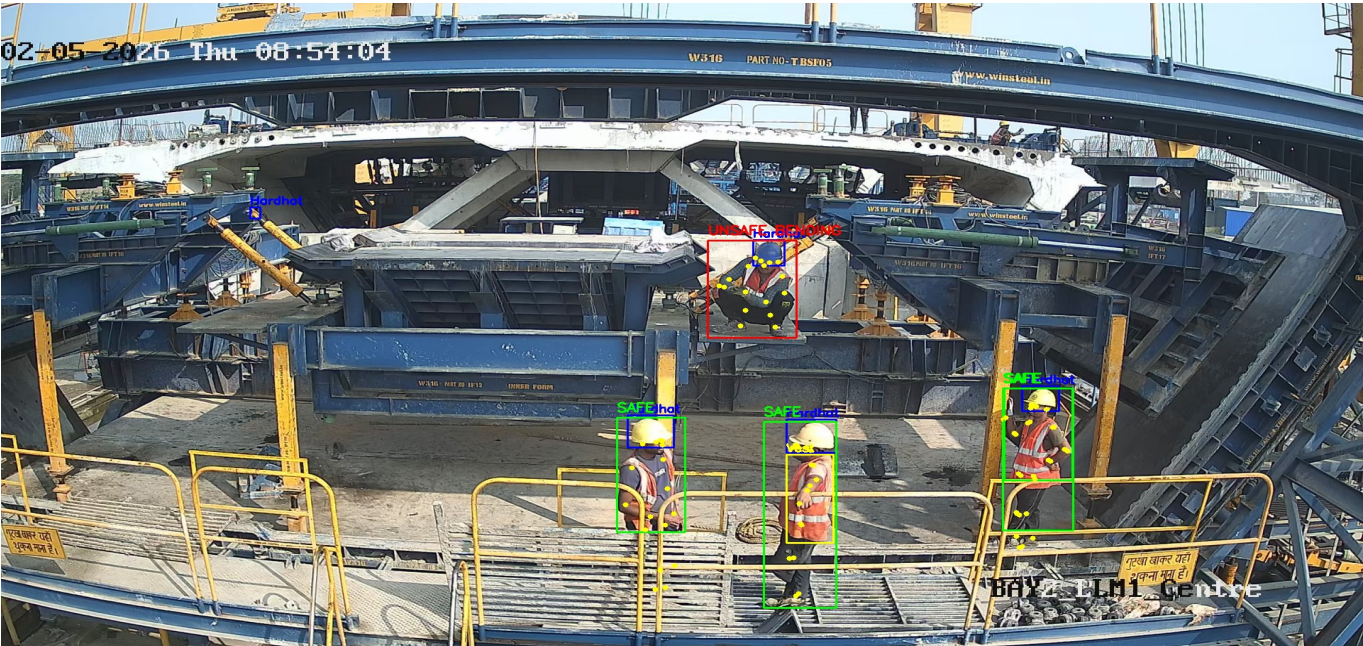
| Safety Issue | Potential Risk |
|---|---|
| • Unsafe bending posture by worker squatting on elevated structure | Fall from height |
| • Worker squatting on elevated structure without fall protection | Musculoskeletal injury due to unsafe posture |
| • Potential trip hazard due to loose materials on the walkway | Trip and fall leading to injury |

- Ensure workers use fall protection equipment when working at height
- Train workers on safe postures and ergonomics
- Remove loose materials from walkways to prevent trip hazards
