# UAUC Capture Report

Audit ID: MPSB-35 | Project: MPSB | 10/7/2026, 11:51:35 am

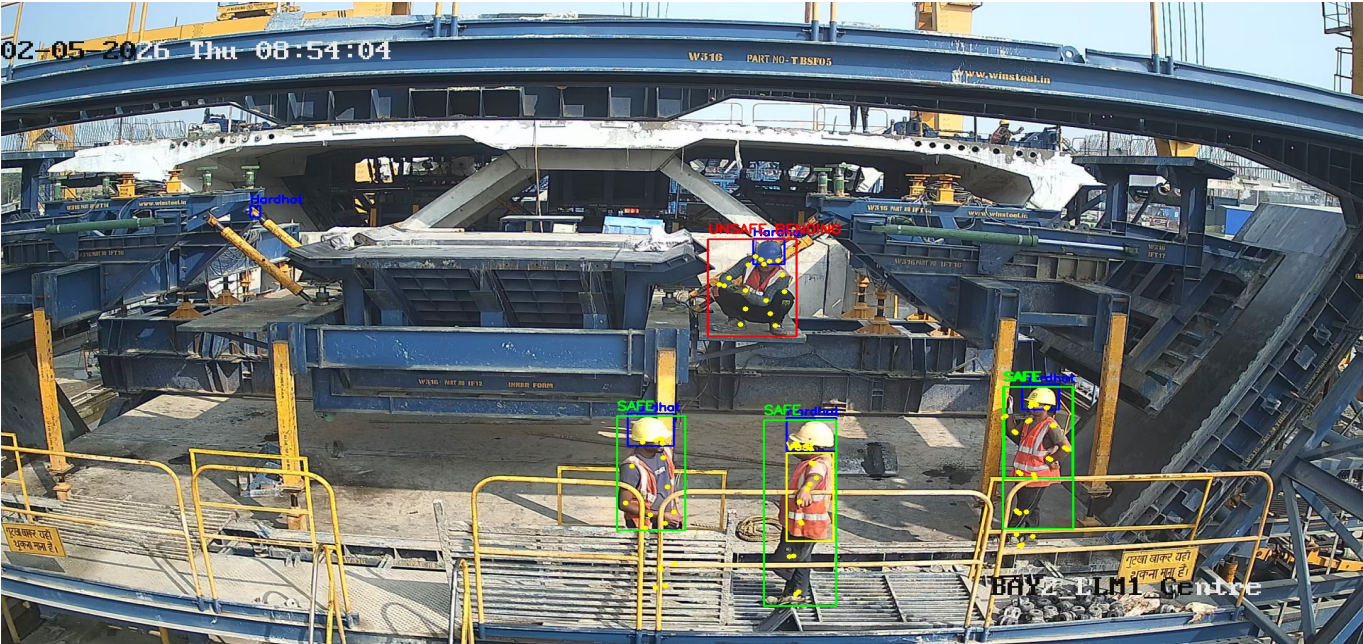
## Analyzed Image

| Safety Issue | Potential Risk |
|---|---|
| • Unsafe bending posture by worker on elevated structure | Fall from height |
| • Worker on elevated structure without visible fall protection | Head injury due to falling objects |
| • Open edges without proper barricades or toe boards | Trip and fall on obstructed walkway |
| • Material obstruction on walkway | critical |

- Ensure workers on elevated structures use fall protection equipment such as harnesses.
- Install proper barricades and toe boards on open edges to prevent falls.
- Remove obstructions from walkways to ensure safe access.
- Train workers on safe posture and ergonomics to prevent strain or injury.
