# UAUC Capture Report

Audit ID: MPSB-36 | Project: MPSB | 7/10/2026, 12:23:10 PM

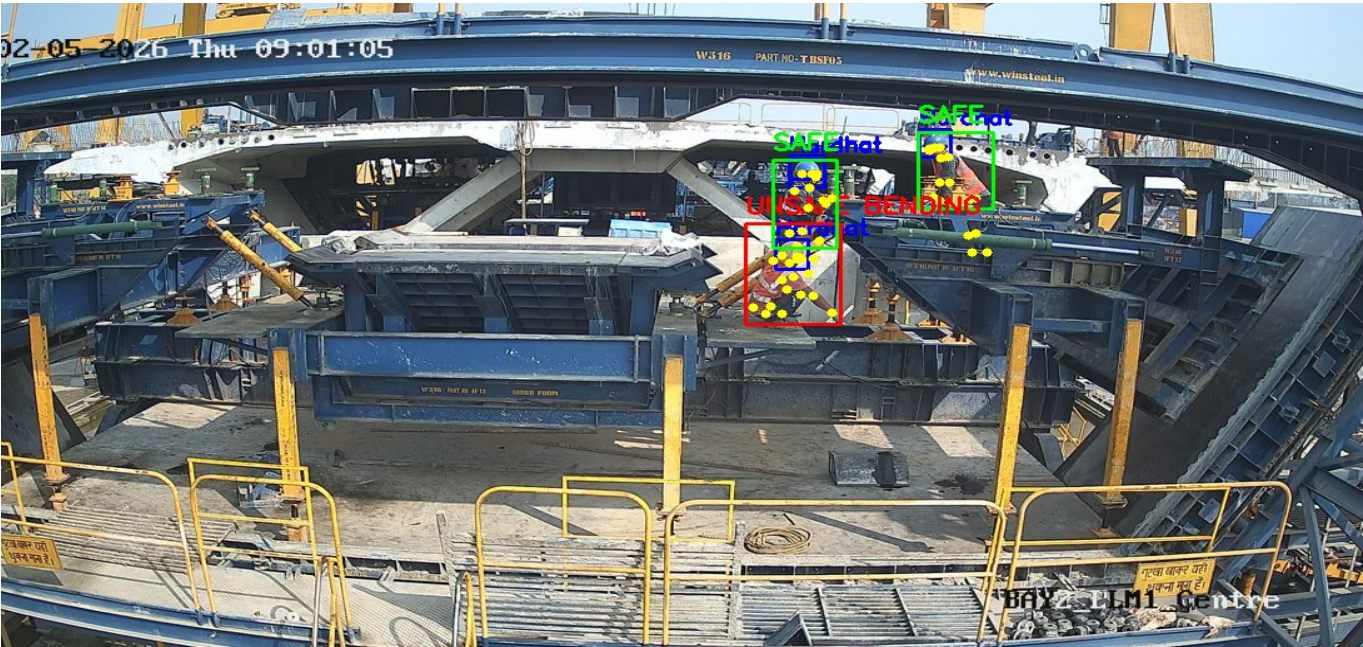
| Safety Issue | Potential Risk |
|---|---|
| <ul style="list-style-type: none"><li>Unsafe bending posture observed for one worker.</li></ul> | Musculoskeletal injury due to unsafe bending posture. |
| <ul style="list-style-type: none"><li>Safety vest not detected on one worker.</li></ul> | Reduced visibility and protection due to absence of safety vest. |
| <ul style="list-style-type: none"><li>Worker positioned on an elevated structure without visible fall protection.</li></ul> | Fall from height leading to serious injury. |

| <ul style="list-style-type: none"><li>Train workers on safe lifting and bending techniques to prevent musculoskeletal injuries.</li><li>Ensure all workers wear safety vests for visibility and protection.</li><li>Provide and enforce the use of fall protection equipment for workers on elevated structures.</li></ul> |
