# UAUC Capture Report

Audit ID: MPSB-42 | Project: MPSB | 7/10/2026, 1:32:46 PM

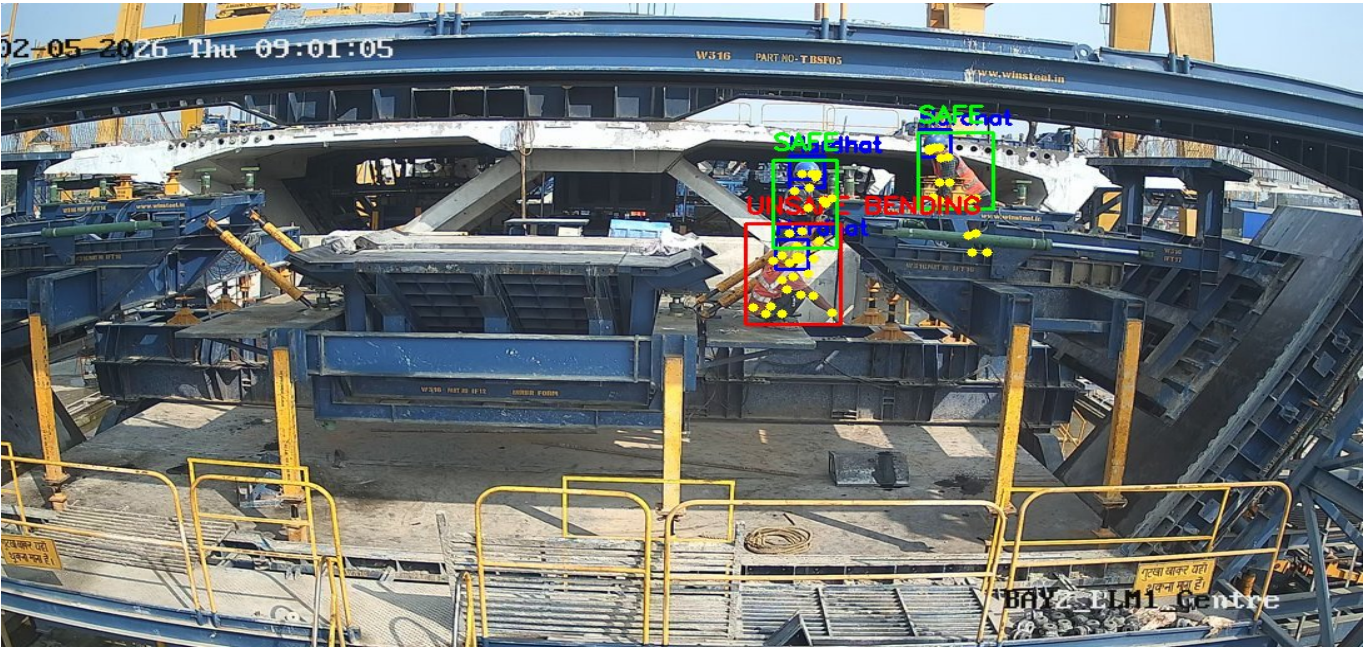
| Safety Issue | Potential Risk |
|---|---|
| <ul style="list-style-type: none"><li>Unsafe bending posture observed for one worker.</li></ul> | Musculoskeletal injury due to unsafe bending posture. |
| <ul style="list-style-type: none"><li>Safety vest not detected on one worker.</li></ul> | Increased risk of injury due to lack of visibility without a safety vest. |
| <ul style="list-style-type: none"><li>Worker positioned on an elevated structure without visible fall protection.</li></ul> | Fall from height due to lack of fall protection. |
| <ul style="list-style-type: none"><li>Loose materials and tools scattered on the platform, creating trip hazards.</li></ul> | Trip and fall incidents due to scattered materials and tools. |

- Train workers on safe lifting and bending techniques to prevent musculoskeletal injuries.
- Ensure all workers wear safety vests for visibility and compliance.
- Provide and enforce the use of fall protection equipment for workers on elevated structures.
- Improve housekeeping by organizing and securing loose materials and tools on the platform.
