# UAUC Capture Report

Audit ID: MPSB-43 | Project: MPSB | 10/7/2026, 2:21:07 pm

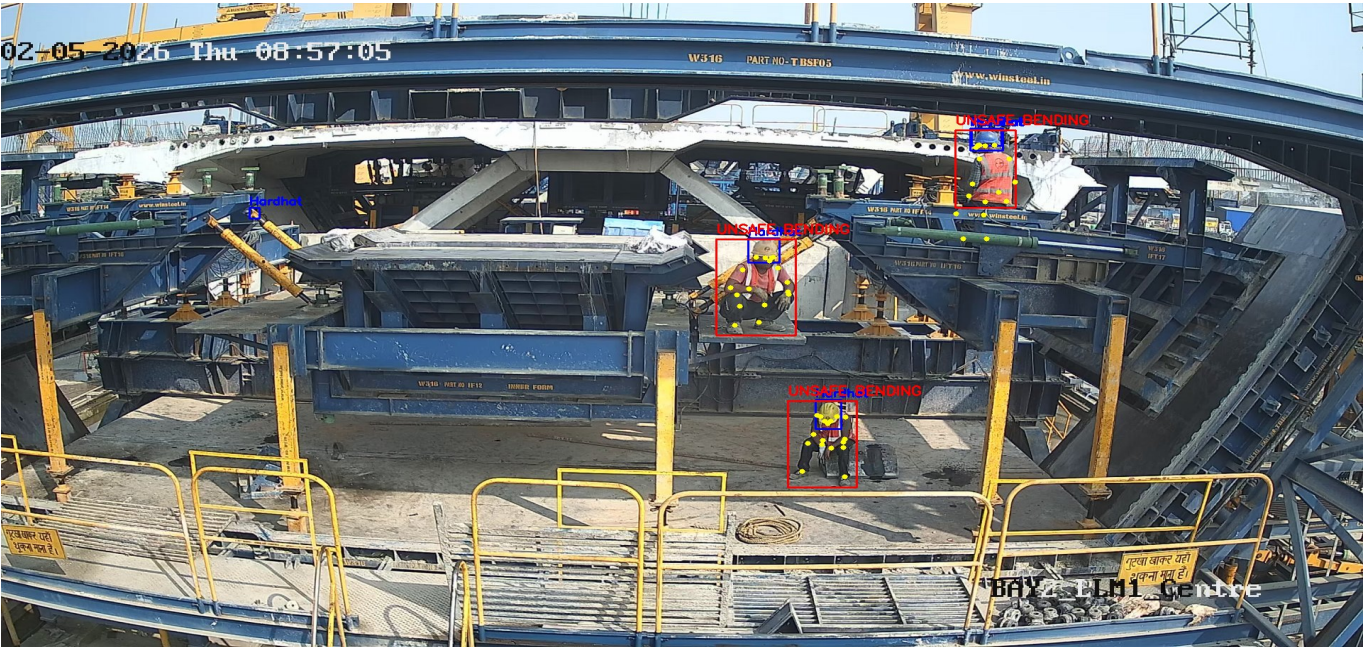
| Safety Issue | Potential Risk |
|---|---|
| Unsafe bending posture observed for worker on the platform. | Musculoskeletal injury due to unsafe bending posture. |
| Coiled rope left on the walkway creating a trip hazard. | Trip and fall due to coiled rope on the walkway. |
| Worker sitting on an elevated platform without fall protection. | Fall from height due to lack of fall protection. |

- Train workers on safe lifting and bending techniques.
- Remove coiled rope from the walkway to prevent trip hazards.
- Ensure workers on elevated platforms use fall protection equipment.
