# UAUC Capture Report

Audit ID: MPSB-6 | Project: MPSB | 6/24/2026, 6:31:36 AM

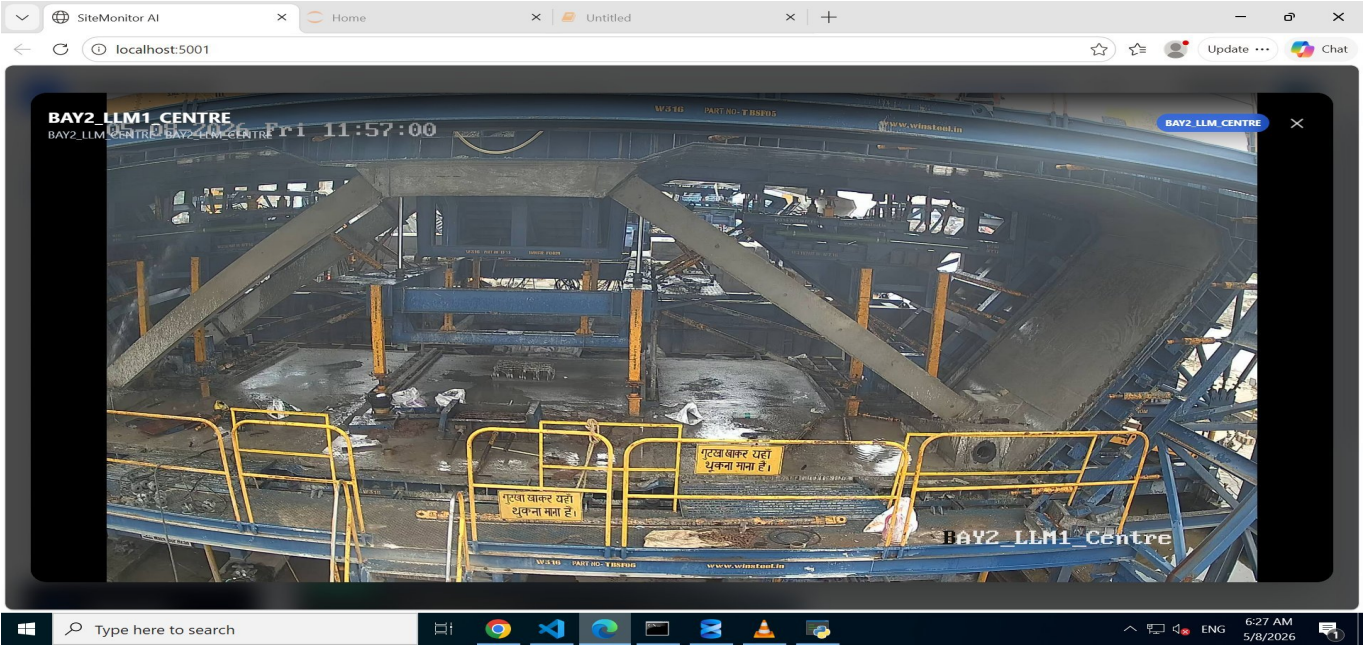
## Analyzed Image

| Safety Issue | Potential Risk |
|---|---|
| <ul style="list-style-type: none"><li>Wet and slippery floor visible in multiple areas.</li></ul> | Workers may slip and fall due to the wet and slippery floor. |
| <ul style="list-style-type: none"><li>Loose debris and materials scattered on the floor.</li></ul> | Loose debris may cause trip hazards. |

- Clean and dry the floor to eliminate slippery surfaces.
- Remove loose debris and materials from the floor to prevent trip hazards.
- Ensure proper drainage to avoid water accumulation in the work area.
