# UAUC Capture Report

Audit ID: MSBP\_Sarai Ghat-20 | Project: MSBP\_Sarai Ghat | 6/15/2026, 4:23:54 AM

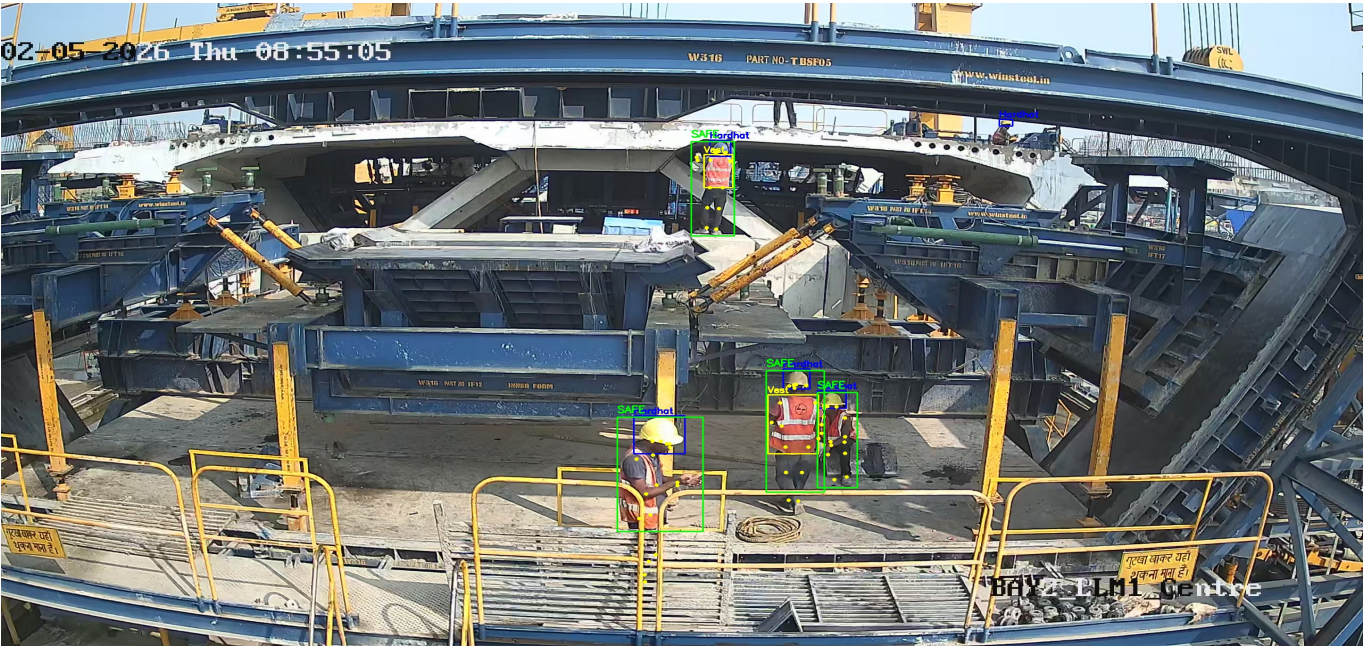
## Analyzed Image

| Safety Issue | Potential Risk |
|---|---|
| <ul style="list-style-type: none"><li>Worker on elevated platform without visible fall protection.</li></ul> | Fall from height due to lack of fall protection. |
| <ul style="list-style-type: none"><li>Loose cable on the ground creating a trip hazard.</li></ul> | Tripping over loose cable leading to injury. |
| <ul style="list-style-type: none"><li>Worker using a mobile phone in a construction zone.</li></ul> | Distraction from mobile phone use causing accidents. |

| <ul style="list-style-type: none"><li>Ensure all workers on elevated platforms use proper fall protection equipment such as harnesses.</li><li>Secure or remove loose cables from the ground to eliminate trip hazards.</li><li>Prohibit mobile phone use in active construction zones unless for work-related purposes.</li></ul> |
