## Cement Bond Log Report for 33847-CBL.las

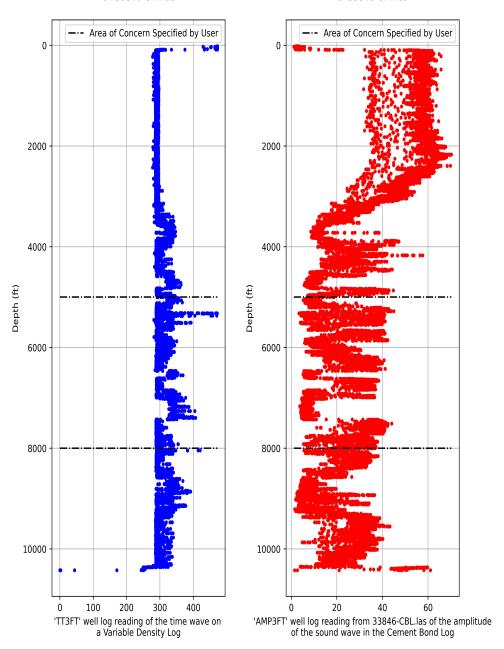
This is the time of return for the transmission on 33846-CBL.las

This is the sound wave amplitude of 33846-CBL.las

This appears to have an unusually low amplitude.

The area of concern for casing inspection ranges from 5000 - 8000 feet.

For the area of concern specified, the average time in usec is 340.0 with a standard deviation of 33.0.

In contrast, the average time of return for the entire length of the well log is 331.0.

For the area of concern specified, the average amplitude in mV is 15.0 with a standard deviation of 9.0.

In contrast, the average amplitude for the entire well log is 22.0.
