Crabtree Endurance Panel System Familiarisation

Order No 4700071621

Work Report

08/06/2023

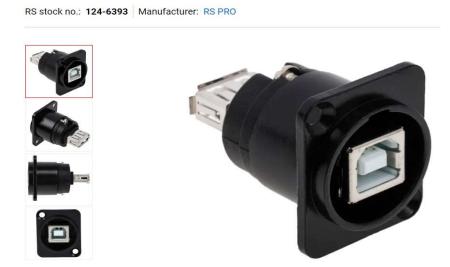
We suggest mounting panel mount socket to socket connectors such as those shown below on the LAB06 panel to allow for USB connection to the new PC. The are available from RS Online (https://za.rs-online.com/web/)
