# Interim Progress & Drawdown Report — No. 5

Halyard Quarter · 8-storey mixed-use · prepared for the Lender · site inspection 14 Aug 2026 (Month 13 of 22)

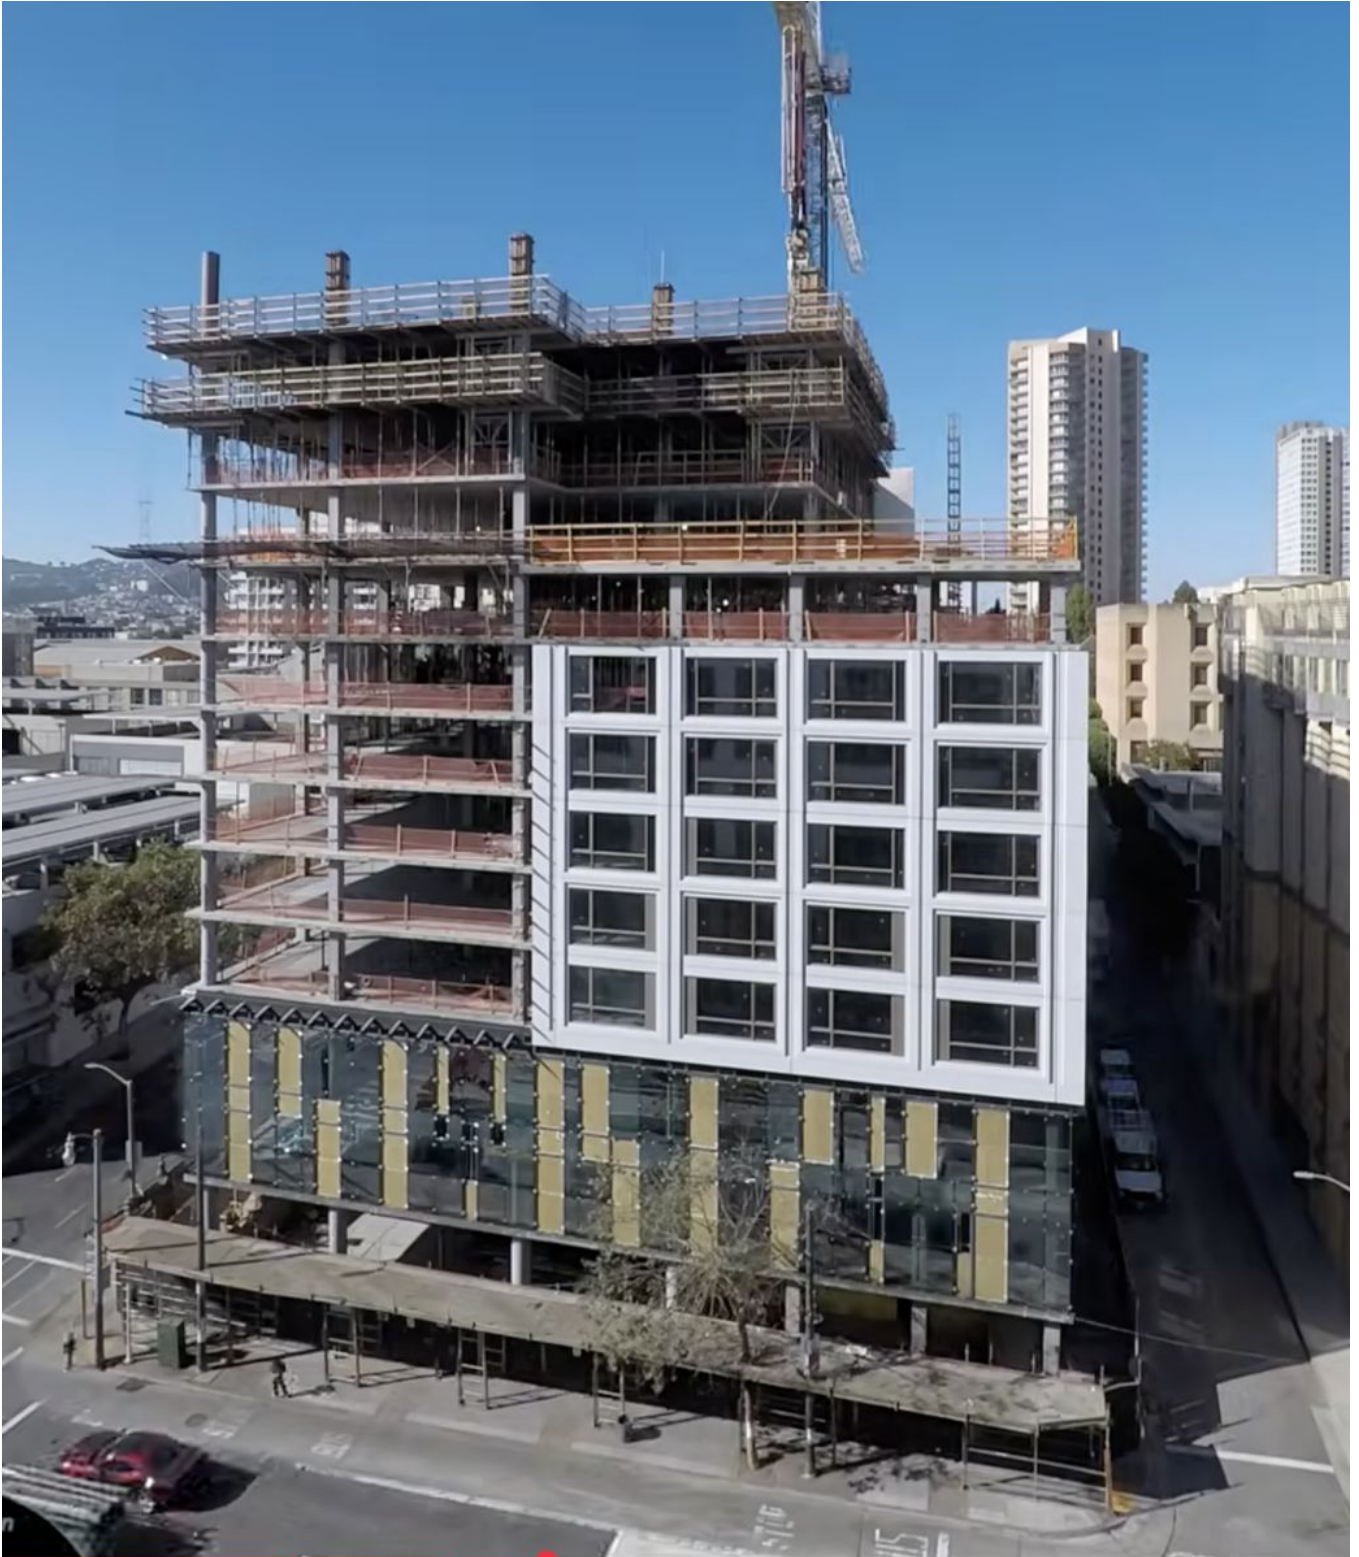
Aerial capture, 14 Aug 2026: frame topped out; façade and glazing installed to the lower floors only; upper floors remain open structure.

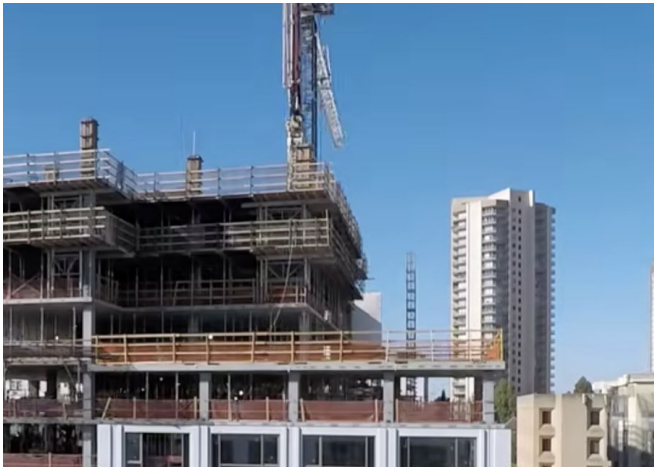
**Deviation:** upper ~4 floors — curtain wall & glazing not installed; open frame. Drives the façade shortfall (verified 38% vs 55% claimed).

| <b>Envelope / façade &amp; glazing</b> | Claimed 55%, verified 38%. | EXCEPTION |
| Curtain wall installed to lower floors only; upper ~4 storeys open. ~3 weeks behind the weathertightness milestone; delays internal trades that follow. | | |

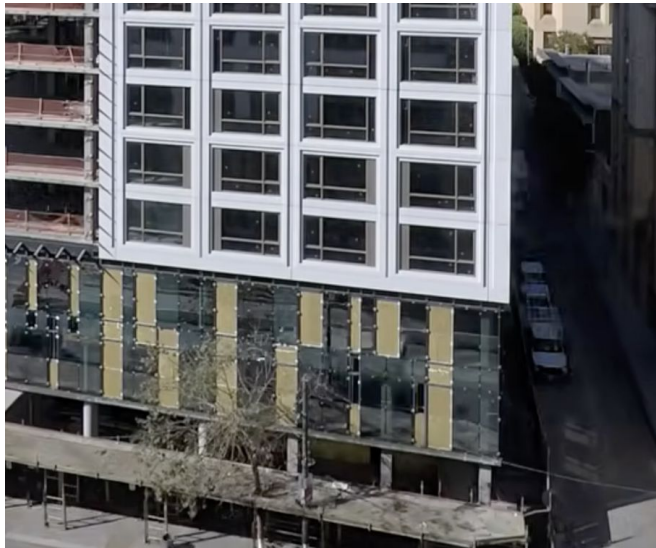
**Verified:** lower floors — cladding & glazing installed and weathertight; consistent with the approved design.

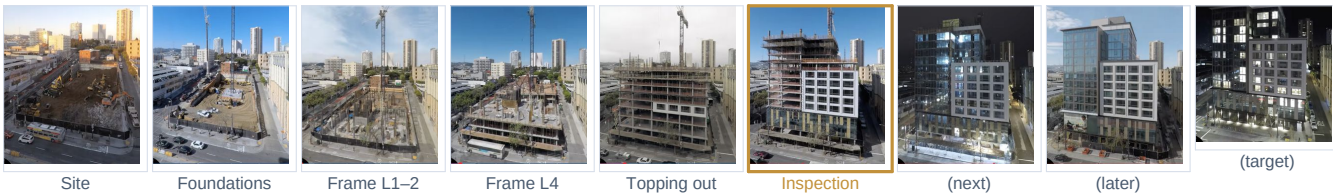
The same site, flight by flight, from enabling works to the inspection point (highlighted). Each frame is a dated, sealed capture; the trend is what catches slippage early.
