PHOTOGRAPHIC CONDITION INSPECTION

# Sample Property B — Two-bedroom house, City Bowl

Two-bedroom house, City Bowl, Cape Town

20 July 2026

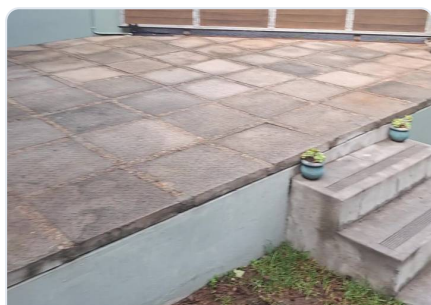
**Plate 001** Driveway paving - large square exposed-aggregate/textured concrete pavers laid in a grid

| REF | FINDING AS OBSERVED | SEVERITY | PLATE |
|---|---|---|---|
| F177 | Paving stones heavily stained with dark patches/discolouration throughout | MEDIUM | Plate 001 |
| F178 | Retaining wall shows surface staining | LOW | Plate 001 |

| ITEM AS RECORDED | QTY | CONDITION AS OBSERVED | PLATES |
|---|---|---|---|
| Driveway paving - large square exposed-aggregate/textured concrete pavers laid in a grid | 1 | Poor - paving stones heavily stained with dark patches and algae-type staining throughout, with marked colour variation and uneven weathering between squares | Plate 001 |

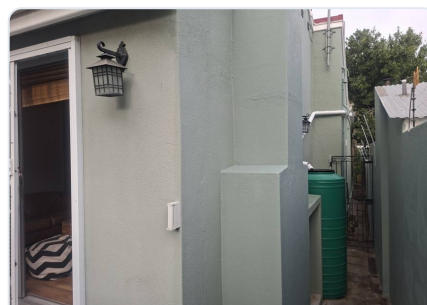
**Plate 003** Side passage exterior wall, sage/pale-green painted plaster

| ITEM AS RECORDED | QTY | CONDITION AS OBSERVED | PLATES |
|---|---|---|---|
| Green plastic cylindrical rainwater/water storage tank standing in the side passage against the wall | 1 | Good - tank body intact, no splits or leaks visible | Plate 003 |
| Black wrought-iron side gate in the side passage | 1 | Good - gate in place, no rust or damage noted | Plate 003 |
| Corrugated metal roof over the lean-to/shed structure at the far end of the side passage | 1 | Fair - sheeting in place; surface condition not assessable at the distance and angle available | Plate 003 |

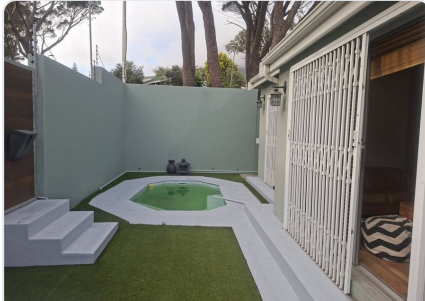
**Plate 005** Small octagonal plunge pool - shell, submerged steps and water

At inspection the plunge pool water was **severely green and murky with an active algae bloom**, and dark sediment had settled on the submerged steps and floor. The white pool surround carried water staining and hairline cracking. The pool is **not swimmable and must not be presented as ready for use** until it has been treated, cleared and re-inspected. The pump, filtration and backwash equipment do not appear anywhere in the record and remain to be documented separately.

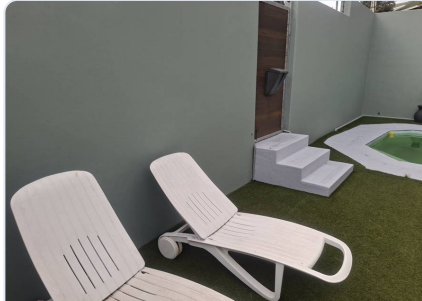
| ITEM AS RECORDED | QTY | CONDITION AS OBSERVED | PLATES |
|---|---|---|---|
| Small octagonal plunge pool - shell, submerged steps and water | 1 | Poor - pool water severely green, murky and opaque, an algae bloom; dark sediment/algae buildup visible on the submerged steps and pool floor; dark algae staining on the pool walls. Water was not clear at any point in the record | Plate 005, Plate 006, Plate 007, Plate 008, Plate 009, Plate 010, Plate 011 |
| White-painted concrete steps leading up from the courtyard to the side door | 1 | Good - three to four risers, edges intact, no cracking noted | Plate 005, Plate 006, Plate 008, Plate 013, Plate 014 |
| Courtyard side door/gate - dark wood-toned vertical planks in a galvanized metal surround, set into the boundary wall | 1 | Good - planks and surround intact, no rot or rust noted | Plate 005, Plate 006, Plate 013, Plate 014 |
| Courtyard boundary walls - sage-green painted render enclosing two sides, with small drain/weep holes near the base | 1 | Good - render intact and evenly painted, no cracks or staining recorded on these wall faces | Plate 005, Plate 006, Plate 008, Plate 012 |
| Electric fence strand wires running along the top of the courtyard boundary wall | 1 | Good - wires in place along the full run, no broken strands or leaning brackets visible | Plate 005, Plate 006, Plate 008, Plate 012 |

| ITEM AS RECORDED | QTY | CONDITION AS OBSERVED | PLATES |
|---|---|---|---|
| Black wrought-iron lantern wall lights on the courtyard-facing house wall - square frosted-glass shades divided into a 3x3 grid by black metal muntins, on curled scroll brackets, one larger and one smaller | 2 | Fair - a small brown debris clump (possibly an insect nest) is adhered to the inside of one frosted glass pane, and there is general grime and weathering on the metal surround | Plate 005, Plate 008, Plate 009, Plate 015, Plate 016 |

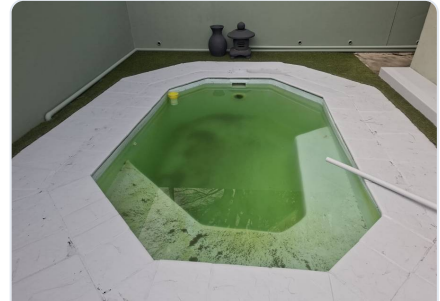
**Plate 006** Small octagonal plunge pool - shell, submerged steps and water

| ITEM AS RECORDED | QTY | CONDITION AS OBSERVED | PLATES |
|---|---|---|---|
| Artificial turf (astro turf) ground covering to the pool courtyard | 1 | Fair - turf laid flat and complete; dry pine needles and loose debris scattered across the surface at inspection | Plate 005, Plate 006, Plate 008, Plate 012, Plate 009, Plate 013, Plate 014 |
| White plastic sun-lounger chairs with adjustable slatted backrests, one fitted with caster wheels on its front legs | 2 | Fair - scuff marks and light dirt visible on the white plastic surfaces of both loungers | Plate 006, Plate 008, Plate 012, Plate 013, Plate 014 |

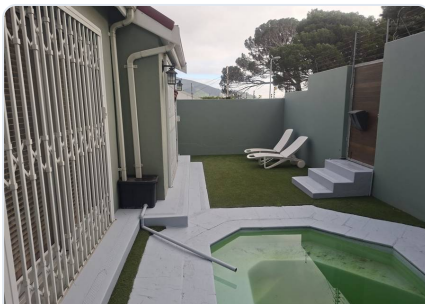
**Plate 007** Small octagonal plunge pool - shell, submerged steps and water

| REF | FINDING AS OBSERVED | SEVERITY | PLATE |
|---|---|---|---|
| F016 | Pool water severely green and murky, algae bloom | HIGH | Plate 007 |

| REF | FINDING AS OBSERVED | SEVERITY | PLATE |
|---|---|---|---|
| F017 | Dark sediment/algae buildup visible on submerged pool steps and floor | HIGH | Plate 007 |
| F018 | Hairline cracks in the white pool-surround paving | MEDIUM | Plate 007 |
| F019 | Grime/staining on paving surface | MEDIUM | Plate 007 |

| ITEM AS RECORDED | QTY | CONDITION AS OBSERVED | PLATES |
|---|---|---|---|
| Pool coping and paved surround - white-painted concrete coping with white stone/tile paving | 1 | Poor - hairline cracks visible in the white pool-surround paving, grime and dark staining on several paving stones, and water-staining discolouration on the white coping | Plate 007, Plate 009, Plate 010, Plate 011 |

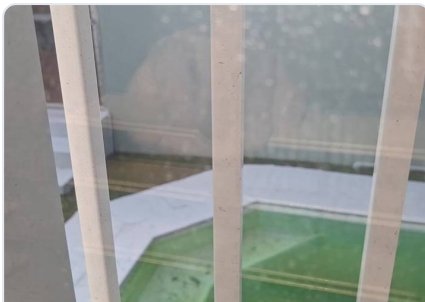
**Plate 010** Small octagonal plunge pool - shell, submerged steps and water

| REF | FINDING AS OBSERVED | SEVERITY | PLATE |
|---|---|---|---|
| F228 | Pool water is green and murky, indicating algae growth or neglected water treatment | HIGH | Plate 010 |

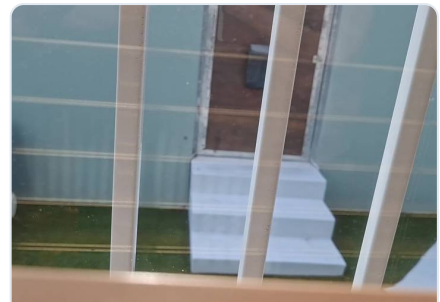
**Plate 012** Artificial turf (astroturf) ground covering to the pool courtyard

| REF | FINDING AS OBSERVED | SEVERITY | PLATE |
|---|---|---|---|
| F009 | Dust/grime buildup on the white security gate bars | MEDIUM | Plate 012 |
| F010 | Dry needles/debris scattered on the artificial turf | LOW | Plate 012 |

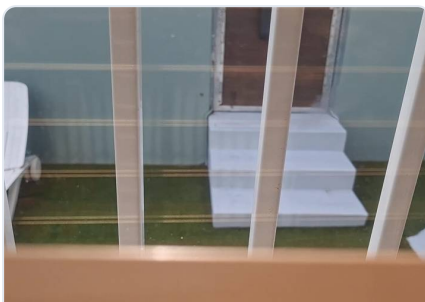
**Plate 013** Artificial turf (astroturf) ground covering to the pool courtyard

| REF | FINDING AS OBSERVED | SEVERITY | PLATE |
|---|---|---|---|
| F218 | Exterior wall and step surfaces beyond the window not established through the glazing and blind; listed for closer inspection | RE-CHECK | Plate 013 |

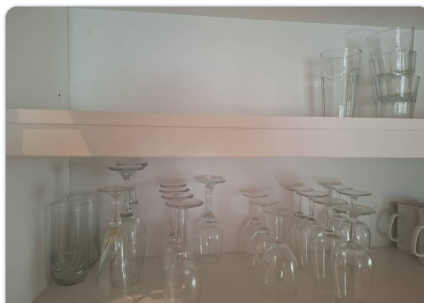
Plate 052 Fitted overhead wall cabinets

| REF | FINDING AS OBSERVED | SEVERITY | PLATE |
|---|---|---|---|
| F050 | Small dark mark/dot on interior cabinet side wall, possibly a screw hole or blemish | LOW | Plate 052 |

| ITEM AS RECORDED | QTY | CONDITION AS OBSERVED | PLATES |
|---|---|---|---|
| Fitted overhead wall cabinets, white gloss, including two hydraulic lift-up (flip-up) units, one glass-fronted, with white internal shelving | 1 | Good - interiors clean and undamaged; small dark mark/dot on one cabinet interior side wall (possibly a screw hole or blemish) | Plate 051,<br>Plate 052,<br>Plate 053,<br>Plate 054,<br>Plate 055 |

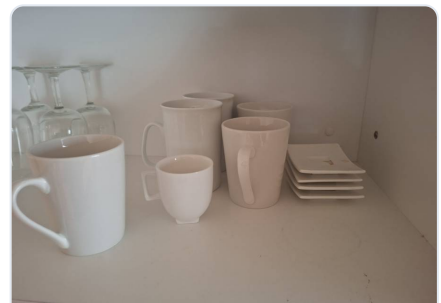
Plate 053 Fitted overhead wall cabinets

| REF | FINDING AS OBSERVED | SEVERITY | PLATE |
|---|---|---|---|
| F051 | Small brown/orange stain on the top square saucer in the stacked pile | LOW | Plate 053 |

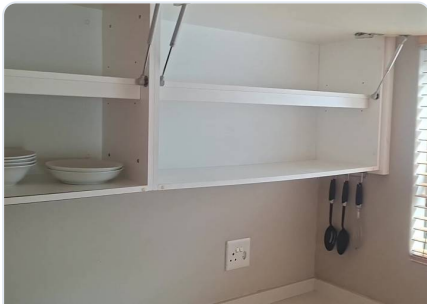
**Plate 054** Fitted overhead wall cabinets

| REF | FINDING AS OBSERVED | SEVERITY | PLATE |
|---|---|---|---|
| F208 | No visible defects; cabinet interiors and walls appear clean and undamaged | SOUND | Plate 054 |

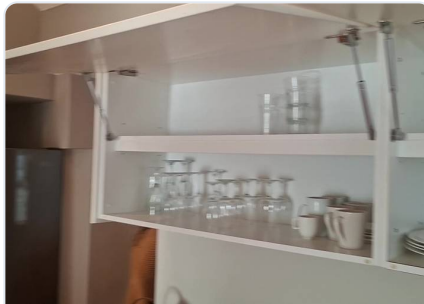
**Plate 055** Fitted overhead wall cabinets

| REF | FINDING AS OBSERVED | SEVERITY | PLATE |
|---|---|---|---|
| F209 | Glassware not inspected individually for chips; listed for closer inspection | RE-CHECK | Plate 055 |

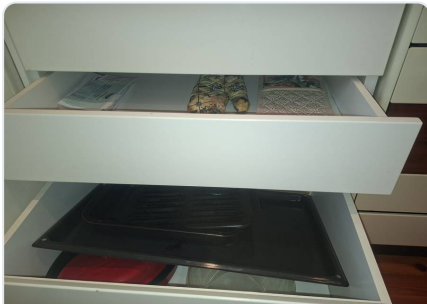
**Plate 057** Fitted base cabinets and drawer units

| REF | FINDING AS OBSERVED | SEVERITY | PLATE |
|---|---|---|---|
| F058 | Staining/residue marks on black oven grill tray surface (ridged section) | LOW | Plate 057 |

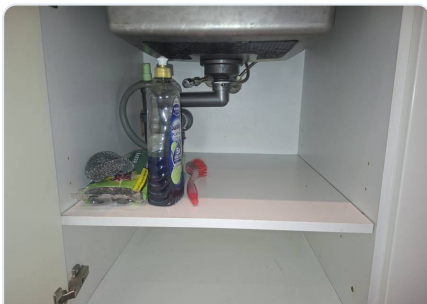
**Plate 060** Under-sink base cabinet, white melamine interior with chrome hinges, two shelf levels

| REF | FINDING AS OBSERVED | SEVERITY | PLATE |
|---|---|---|---|
| F056 | Dark mark/smudge on white laminate shelf surface | LOW | Plate 060 |
| F057 | Cabinet interior shows general wear consistent with under-sink storage | LOW | Plate 060 |

| ITEM AS RECORDED | QTY | CONDITION AS OBSERVED | PLATES |
|---|---|---|---|
| Under-sink base cabinet, white melamine interior with chrome hinges, two shelf levels | 1 | Fair - dark smudge/mark on the white laminate shelf surface; general wear consistent with under-sink storage | Plate 060 |

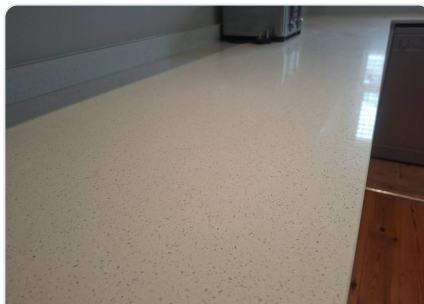
**Plate 061** Perimeter worktop

| ITEM AS RECORDED | QTY | CONDITION AS OBSERVED | PLATES |
|---|---|---|---|
| Perimeter worktop, cream/white speckled quartz-look engineered stone, glossy finish, with matching light-grey upstand to wall join | 1 | Good - smooth and largely unmarked; small dark mark on the countertop near the wall junction (chip, stain or shadow - cause unclear) | Plate 051, Plate 061, Plate 059 |

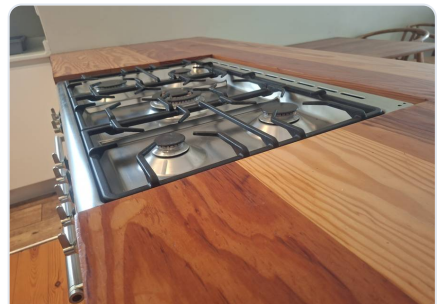
**Plate 062** Kitchen island / breakfast-bar worktop

| REF | FINDING AS OBSERVED | SEVERITY | PLATE |
|---|---|---|---|
| F153 | Visible colour/tone mismatch seam between two different wood sections of the countertop | LOW | Plate 062 |

| REF | FINDING AS OBSERVED | SEVERITY | PLATE |
|---|---|---|---|
| F154 | Light general wear/patina on hob's stainless surface | LOW | Plate 062 |

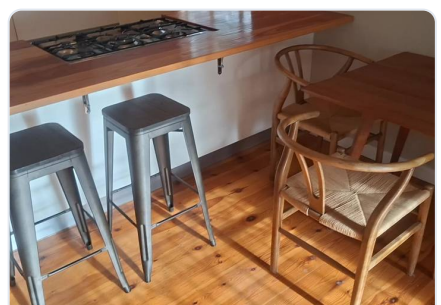
**Plate 065** Kitchen island / breakfast-bar worktop

| REF | FINDING AS OBSERVED | SEVERITY | PLATE |
|---|---|---|---|
| F214 | No visible defects on stools, table, or counter surfaces; floor and walls appear in good condition | SOUND | Plate 065 |

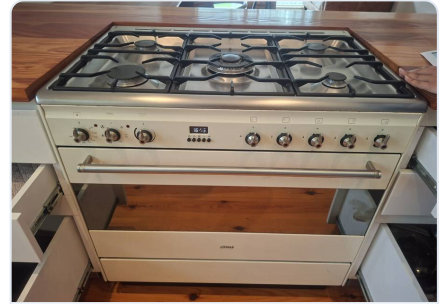
**Plate 068** SMEG freestanding range cooker

| REF | FINDING AS OBSERVED | SEVERITY | PLATE |
|---|---|---|---|
| F054 | Green/dark tarnish or residue build-up around bases of several control knobs on the right side | MEDIUM | Plate 068 |

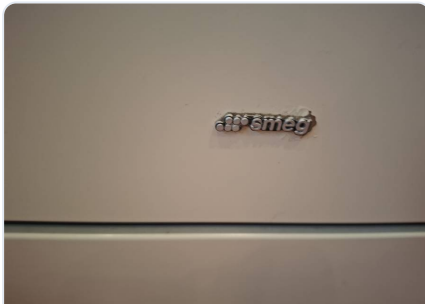
**Plate 069** SMEG freestanding range cooker

| REF | FINDING AS OBSERVED | SEVERITY | PLATE |
|---|---|---|---|
| F055 | Light dust/residue build-up around the brand badge | LOW | Plate 069 |

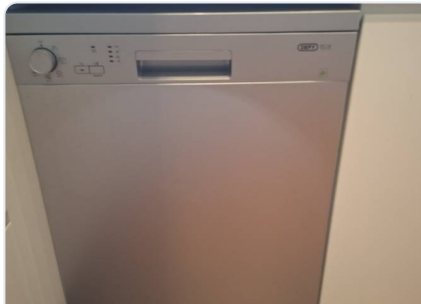
**Plate 070** DEFY dishwasher

| REF | FINDING AS OBSERVED | SEVERITY | PLATE |
|---|---|---|---|
| F062 | Surface detail of the appliance door panel not established with confidence; listed for closer inspection | RE-CHECK | Plate 070 |

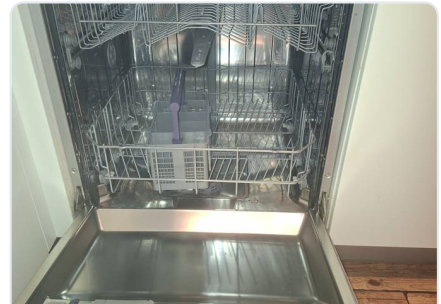
**Plate 071** DEFY dishwasher

| REF | FINDING AS OBSERVED | SEVERITY | PLATE |
|---|---|---|---|
| F063 | Wire rack tines appear bent/splayed out of alignment in places | MEDIUM | Plate 071 |

| REF | FINDING AS OBSERVED | SEVERITY | PLATE |
|---|---|---|---|
| F064 | Torn or lifting rubber door seal/gasket visible at top of door opening | MEDIUM | Plate 071 |
| F065 | Water spot residue and minor food debris specks on interior walls | LOW | Plate 071 |

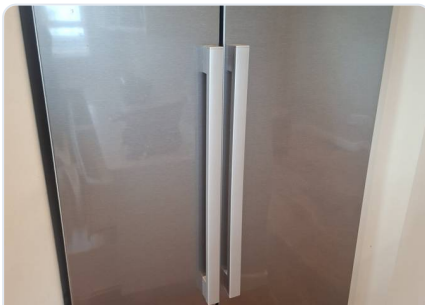
**Plate 072** DEFY side-by-side double-door stainless steel fridge/freezer with paired brushed-steel

| REF | FINDING AS OBSERVED | SEVERITY | PLATE |
|---|---|---|---|
| F061 | Light fingerprint/smudge marks on stainless steel door surface (minor, cosmetic) | LOW | Plate 072 |

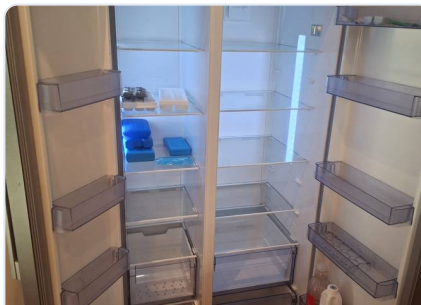
**Plate 073** DEFY side-by-side double-door stainless steel fridge/freezer with paired brushed-steel

| ITEM AS RECORDED | QTY | CONDITION AS OBSERVED | PLATES |
|---|---|---|---|
| Refrigerator accessories - ice-cube tray, two blue plastic ice/freezer blocks and white egg-crate style trays | 4 | Good - clean, no damage observed | Plate 073 |

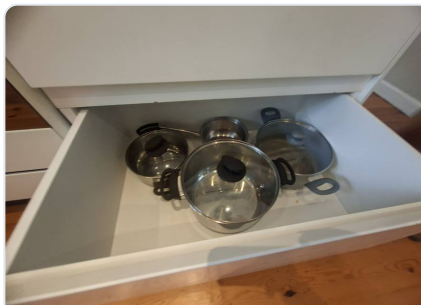
**Plate 076** Stainless steel pots/saucepans of varying sizes with glass lids and black/grey silicone

| REF | FINDING AS OBSERVED | SEVERITY | PLATE |
|---|---|---|---|
| F076 | Light water spot/residue marks on the glass lid of the front pot | LOW | Plate 076 |

| REF | FINDING AS OBSERVED | SEVERITY | PLATE |
|---|---|---|---|
| F075 | No visible dents, rust or damage on pots - appear in used but good condition | SOUND | Plate 076 |

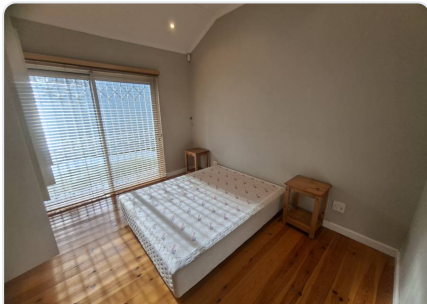
**Plate 102** Double/queen bed

| REF | FINDING AS OBSERVED | SEVERITY | PLATE |
|---|---|---|---|
| F048 | Mattress is bare with no bedding/linen fitted | LOW | Plate 102 |

| ITEM AS RECORDED | QTY | CONDITION AS OBSERVED | PLATES |
|---|---|---|---|
| Double/queen bed — white upholstered divan base with a bare mattress; the mattress ticking is a quilted cream/pink-and-white fabric printed with the repeating brand text "Rest Assured" in red lettering with a blue logo mark. No headboard, no bedding, linen or pillows fitted | 1 | Fair — mattress is entirely bare with no bedding or linen fitted (property is part-furnished); no tears, sagging or staining visible on the ticking | Plate 102, Plate 103, Plate 104, Plate 105 |

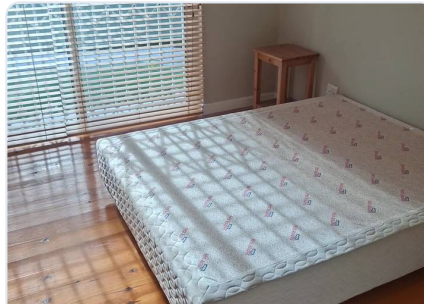
**Plate 103** Double/queen bed

| REF | FINDING AS OBSERVED | SEVERITY | PLATE |
|---|---|---|---|
| F223 | No defects visible to the bedroom floor, walls or furniture at this position | SOUND | Plate 103 |

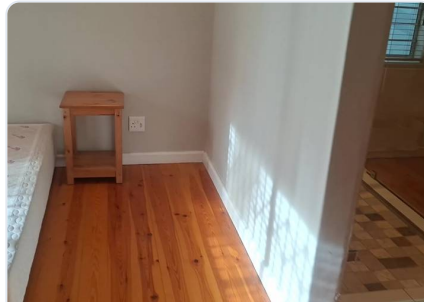
**Plate 106** Pine bedside tables flanking the bed

| REF | FINDING AS OBSERVED | SEVERITY | PLATE |
|---|---|---|---|
| F222 | No defects visible to the bedroom wall or floor surfaces at this position | SOUND | Plate 106 |

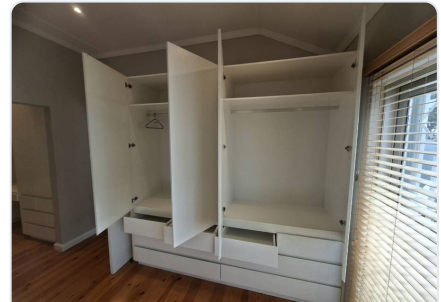
**Plate 107** Large white built-in wardrobe spanning the wall

| REF | FINDING AS OBSERVED | SEVERITY | PLATE |
|---|---|---|---|
| F049 | No visible damage; wardrobe and drawers are simply empty | SOUND | Plate 107 |

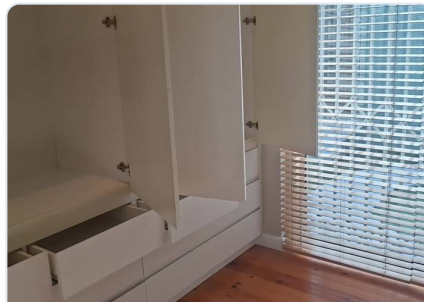
**Plate 109** Large white built-in wardrobe spanning the wall

| REF | FINDING AS OBSERVED | SEVERITY | PLATE |
|---|---|---|---|
| F226 | Venetian blind slats hang unevenly/crookedly on the lower section of the window | MEDIUM | Plate 109 |

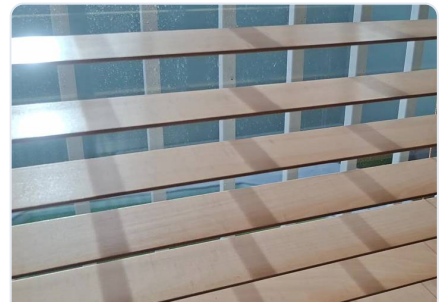
**Plate 110** Wooden-slat / faux-wood venetian blinds to the sliding door and the bedroom windows

| REF | FINDING AS OBSERVED | SEVERITY | PLATE |
|---|---|---|---|
| F227 | Numerous water spots/droplets on the window glass behind the blinds | LOW | Plate 110 |

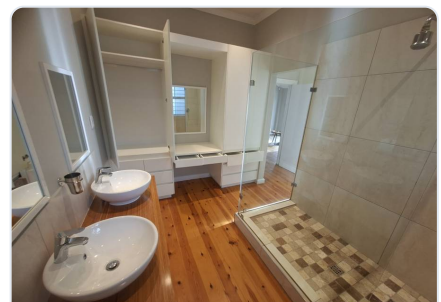
**Plate 113** Paired white ceramic vessel/bowl basins set on the timber vanity countertop

| REF | FINDING AS OBSERVED | SEVERITY | PLATE |
|---|---|---|---|
| F043 | Visible seam/joint gap in wooden flooring near shower threshold | LOW | Plate 113 |

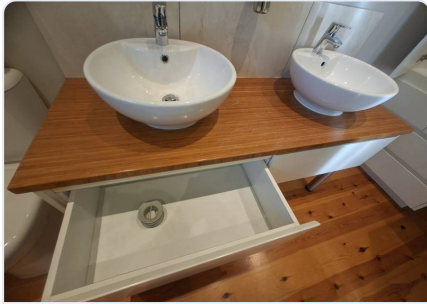
**Plate 114** Paired white ceramic vessel/bowl basins set on the timber vanity countertop

| SURFACE / ELEMENT | CONDITION | CLEANLINESS | OBSERVED |
|---|---|---|---|
| Walls | FAIR | Clean | Visible pale mineral/water staining on the tiled wall behind the basins. (F047) |

| REF | FINDING AS OBSERVED | SEVERITY | PLATE |
|---|---|---|---|
| F047 | Visible pale mineral/water staining on the tiled wall behind the basins | MEDIUM | Plate 114 |

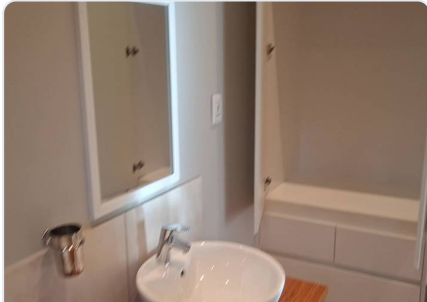
**Plate 117** Rectangular/square white-framed wall mirrors, one above each basin

| ITEM AS RECORDED | QTY | CONDITION AS OBSERVED | PLATES |
|---|---|---|---|
| White electrical light-switch plate on the wall beside the mirror | 1 | Good — plate intact and unmarked | Plate 117 |

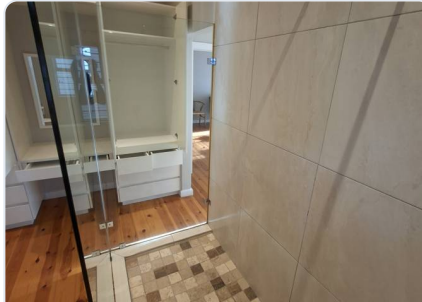
**Plate 118** Large walk-in shower enclosure with frameless glass screen/door separating the shower

| REF | FINDING AS OBSERVED | SEVERITY | PLATE |
|---|---|---|---|
| F046 | No visible cracks or damage; grout lines appear intact | SOUND | Plate 118 |

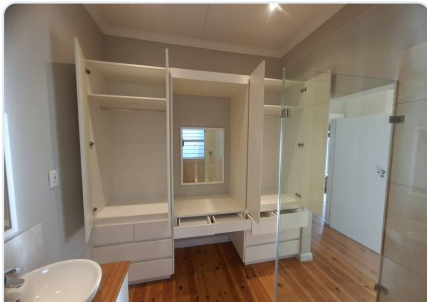
**Plate 120** Built-in white gloss wardrobe/cabinet units flanking the dressing-table nook

| REF | FINDING AS OBSERVED | SEVERITY | PLATE |
|---|---|---|---|
| F045 | Vanity doors and drawers standing open; no other surface defect to the joinery | SOUND | Plate 120 |

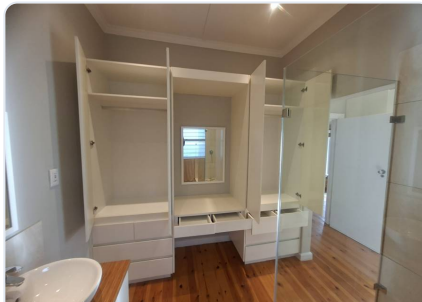
**Plate 121** Built-in white gloss wardrobe/cabinet units flanking the dressing-table nook

| REF | FINDING AS OBSERVED | SEVERITY | PLATE |
|---|---|---|---|
| F044 | Vanity doors and drawers standing open; no surface defect to the joinery itself | SOUND | Plate 121 |

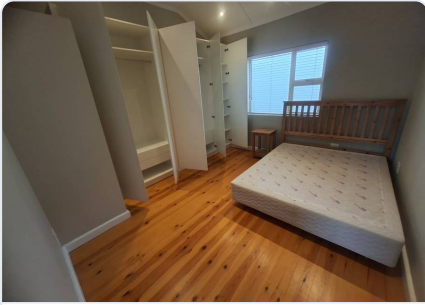
**Plate 123** Double bed with a natural wood slatted headboard

| REF | FINDING AS OBSERVED | SEVERITY | PLATE |
|---|---|---|---|
| F079 | Mattress has no bedding - fully bare, exposing printed ticking pattern | LOW | Plate 123 |

| REF | FINDING AS OBSERVED | SEVERITY | PLATE |
|---|---|---|---|
| F080 | Wardrobe doors standing open; interior empty and unused | SOUND | Plate 123 |

| ITEM AS RECORDED | QTY | CONDITION AS OBSERVED | PLATES |
|---|---|---|---|
| Double bed with a natural wood slatted headboard, carrying a bare mattress whose ticking fabric is printed repeatedly with the brand text "REST ASSURED" | 1 | Fair — mattress fully bare with no bedding or linen fitted, exposing the printed ticking; no tears or staining visible | Plate 123, Plate 124, Plate 125 |

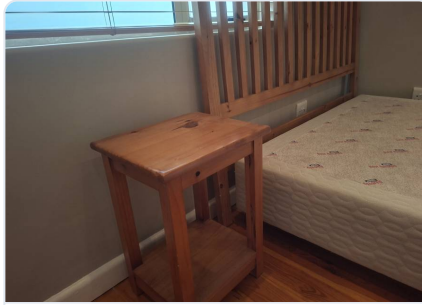
**Plate 124** Double bed with a natural wood slatted headboard

| REF | FINDING AS OBSERVED | SEVERITY | PLATE |
|---|---|---|---|
| F086 | Dark stain/knot mark near the front-left corner of the table top | MEDIUM | Plate 124 |
| F085 | Visible wood knots and small round blemish/knot marks on the table top surface | LOW | Plate 124 |
| F087 | Varnish shows minor wear/scuff sheen variation on the table top | LOW | Plate 124 |

| ITEM AS RECORDED | QTY | CONDITION AS OBSERVED | PLATES |
|---|---|---|---|
| Small pine bedside tables/stools with an open lower shelf, in unfinished/natural varnished pine — a matching pair, one at the bed head and one across the room | 2 | Fair — visible wood knots and small round blemish/knot marks across the table top, a dark stain/knot mark near the front-left corner, and minor varnish wear with sheen variation on the top surface | Plate 124, Plate 126, Plate 127, Plate 129, Plate 130 |

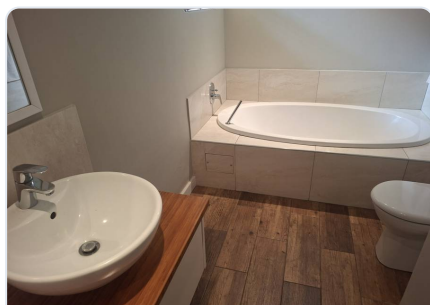
**Plate 133** White oval built-in bathtub set into a cream/beige large-format tiled surround with

| REF | FINDING AS OBSERVED | SEVERITY | PLATE |
|---|---|---|---|
| F093 | No visible cracks or chips on sink, tub, or tiles | SOUND | Plate 133 |
| F094 | Tile grout appears intact, no visible staining or mould in view | SOUND | Plate 133 |

| ITEM AS RECORDED | QTY | CONDITION AS OBSERVED | PLATES |
|---|---|---|---|
| Small square access/inspection panel cut into the tiled skirt at the base of the bath (plumbing access) | 1 | Fair — noted because the square cut-out in the tiled skirt reads as a defect if not an intentional access hatch; edges otherwise clean | Plate 133, Plate 136 |

| ITEM AS RECORDED | QTY | CONDITION AS OBSERVED | PLATES |
|---|---|---|---|
| White round countertop-mounted (vessel) basin with chrome single-lever mixer tap and chrome pop-up waste | 1 | Fair — small dark mark/residue spot near the drain area inside the basin; no chips or cracks otherwise | Plate 133, Plate 137, Plate 138 |
| Mirror mounted on the wall above the basin | 1 | Good — no cracking or de-silvering observed (partial view only) | Plate 133 |

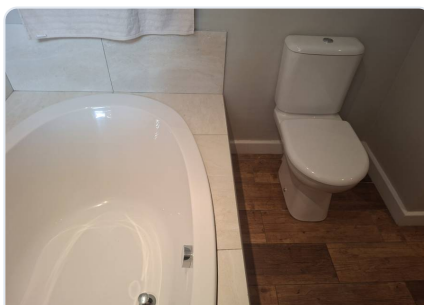
**Plate 134** White oval built-in bathtub set into a cream/beige large-format tiled surround with

| ITEM AS RECORDED | QTY | CONDITION AS OBSERVED | PLATES |
|---|---|---|---|
| White oval built-in bathtub set into a cream/beige large-format tiled surround with tiled deck and front skirt panel | 1 | Good — tub surface glossy and clean, no cracks or chips visible on the tub or the tiled surround; grout lines intact | Plate 133, Plate 134, Plate 135, Plate 136 |
| Wall-mounted chrome bath mixer tap with a separate hand-held shower attachment on a bracket, plus chrome overflow drain | 1 | Good — no corrosion or limescale build-up observed | Plate 133, Plate 134 |
| Chrome circular flush-mounted jet/inlet fitting on the inner wall of the bathtub near the overflow drain (spa/jacuzzi-style bath) | 1 | Good — fitting seated flush, no staining around the collar | Plate 134 |

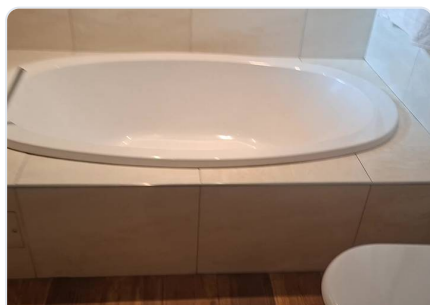
**Plate 136** White oval built-in bathtub set into a cream/beige large-format tiled surround with

| REF | FINDING AS OBSERVED | SEVERITY | PLATE |
|---|---|---|---|
| F187 | Small square cut/access panel in the tiled tub skirt, lower left, could be read as a defect if not an intentional access hatch | LOW | Plate 136 |

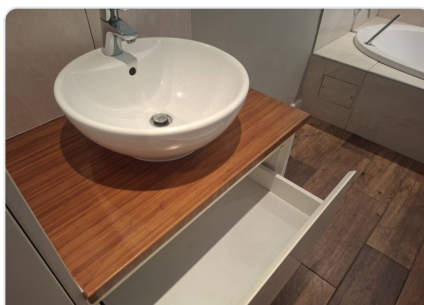
**Plate 137** White round countertop-mounted

| REF | FINDING AS OBSERVED | SEVERITY | PLATE |
|---|---|---|---|
| F097 | Small dark mark/residue spot near the drain area inside the basin | LOW | Plate 137 |

| REF | FINDING AS OBSERVED | SEVERITY | PLATE |
|---|---|---|---|
| F098 | Otherwise no visible chips or cracks on the basin | SOUND | Plate 137 |
| F099 | Empty drawer shows no items and no visible damage inside | SOUND | Plate 137 |

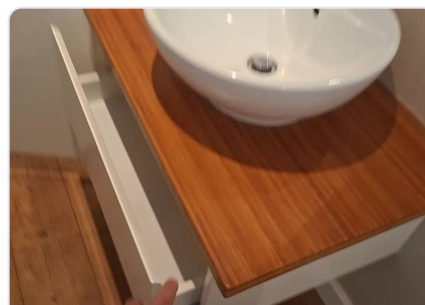
**Plate 138** White round countertop-mounted

| ITEM AS RECORDED | QTY | CONDITION AS OBSERVED | PLATES |
|---|---|---|---|
| Vanity unit beneath the basin — white cabinet surround with a wood-toned, ridged teak-look slatted countertop and a drawer | 1 | Good — drawer pulled fully open and completely empty with a grey-lined interior; no damage inside or to the carcass | Plate 137, Plate 138 |

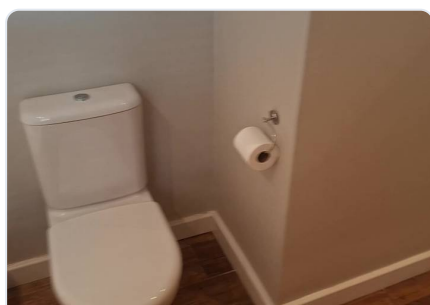
**Plate 139** White close-coupled toilet with cistern

| SURFACE / ELEMENT | CONDITION | CLEANLINESS | OBSERVED |
|---|---|---|---|
| Skirtings, cornices & trim | GOOD | Clean | Visible floor trim/transition strip forming an odd raised outline near the corner, could indicate a floor level change or repair. (F188) |

| REF | FINDING AS OBSERVED | SEVERITY | PLATE |
|---|---|---|---|
| F188 | Visible floor trim/transition strip forming an odd raised outline near the corner, could indicate a floor level change or repair | LOW | Plate 139 |

| ITEM AS RECORDED | QTY | CONDITION AS OBSERVED | PLATES |
|---|---|---|---|
| White close-coupled toilet with cistern, seat and lid, chrome dual-flush button on the cistern lid | 1 | Good — clean, no visible cracks, chips or staining to pan, cistern or seat | Plate 134, Plate 135, Plate 139 |
| Chrome wall-mounted toilet-roll holder carrying a single partially-used white paper roll | 1 | Good — holder secure and unmarked | Plate 139 |

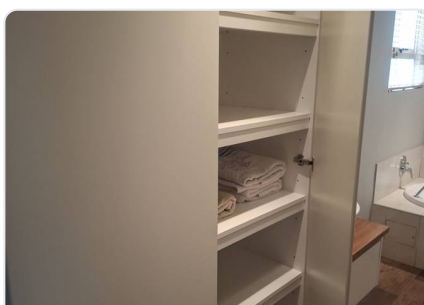
**Plate 140** Built-in white melamine linen cupboard with six vertical compartments and hinged doors

| REF | FINDING AS OBSERVED | SEVERITY | PLATE |
|---|---|---|---|
| F091 | Cupboard interior appears empty apart from two towels - no visible damage to shelving | LOW | Plate 140 |

| REF | FINDING AS OBSERVED | SEVERITY | PLATE |
|---|---|---|---|
| F092 | Hinges show no visible wear issues | SOUND | Plate 140 |

| ITEM AS RECORDED | QTY | CONDITION AS OBSERVED | PLATES |
|---|---|---|---|
| Built-in white melamine linen cupboard with six vertical compartments and hinged doors | 1 | Good — shelving clean and undamaged, hinges show no wear issues; five of the six compartments are EMPTY | Plate 140, Plate 141 |
| Towel stock held in one compartment of the linen cupboard — two rolled cream/beige towels with a subtle patterned stripe seen in one view; a stack of approximately four to five rolled tan/beige towels with one patterned beige towel folded on top seen in the other | 1 | Good — no staining, fraying or tearing observed; counts differ between the two views and are recorded exactly as seen | Plate 140, Plate 141 |

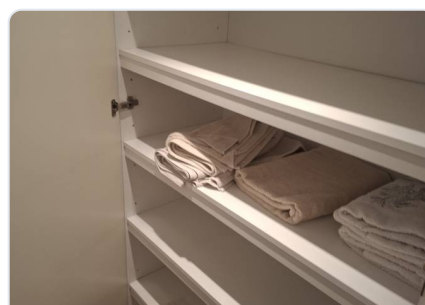
**Plate 141** Built-in white melamine linen cupboard with six vertical compartments and hinged doors

| REF | FINDING AS OBSERVED | SEVERITY | PLATE |
|---|---|---|---|
| F095 | Cupboard shelving shows no visible damage | SOUND | Plate 141 |
| F096 | Interior surfaces clean, no stains or marks | SOUND | Plate 141 |

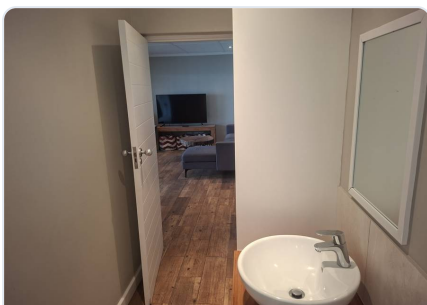
**Plate 142** Round white ceramic vessel/bowl-style basin mounted on a wood-toned vanity top

| ITEM AS RECORDED | QTY | CONDITION AS OBSERVED | PLATES |
|---|---|---|---|
| White-framed mirror / frosted-opaque glass panel mounted on the wall above and beside the basin | 1 | Good — glass intact, surround unmarked | Plate 142 |
| Warm taupe/greige painted wall finish — recorded for condition only | 1 | Good — no visible defects in the wall paint from the angle available | Plate 142 |

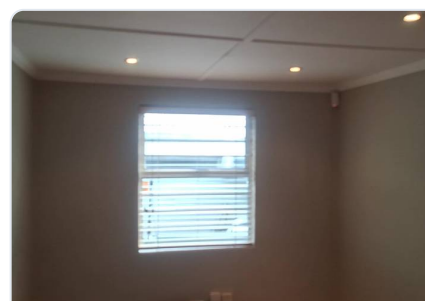
**Plate 148** UNATTRIBUTED ROOM C (taupe/grey walls with cornice, indistinctly recorded)

| ITEM AS RECORDED | QTY | CONDITION AS OBSERVED | PLATES |
|---|---|---|---|
| UNATTRIBUTED ROOM C (taupe/grey walls with cornice, indistinctly recorded) – window fitted with white-slat venetian blinds, a wall-mounted security/PIR sensor showing a live red LED, a white double wall socket, and three recessed ceiling downlights; the edge of a wooden furniture item is visible at the the bottom of the view | 1 | Fair – sensor LED illuminated, indicating the unit is powered; a diagonal seam/line runs across the ceiling, possibly a board joint. Detail at this position is not established | Plate 148 |
