# Insurance Evidence Pack

What is here, what it is worth, what condition it was in — and what this pack does not prove

Two-bedroom house, City Bowl, Cape Town

SAMPLE-B

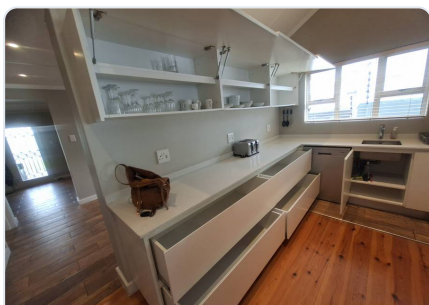
**Plate 001** Fitted overhead wall cabinets

| ITEM | AREA | PROOF HELD | CONDITION | EXPECTED (R) | PLATES |
|---|---|---|---|---|---|
| Fitted overhead wall cabinets, white gloss, including two hydraulic lift-up (flip-up) units, one glass-fronted, with white internal shelving | Kitchen | Photographic | GOOD | 40,000 | Plate 001, Plate 014, Plate 015, Plate 016, Plate 017 |
