# Investment Prospectus

Two-bedroom house, City Bowl, Cape Town

SAMPLE-B

20 July 2026

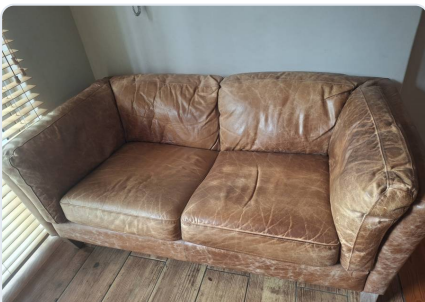
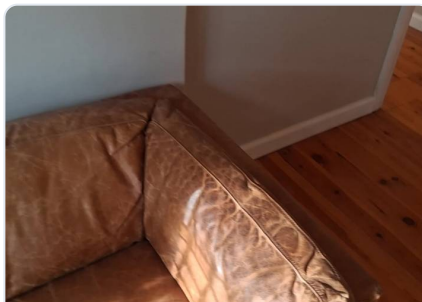
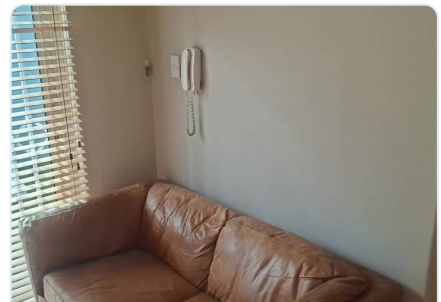
**Plate 013** Tan/caramel-brown leather sofa

**Plate 014** Tan/caramel-brown leather sofa

**Plate 015** Tan/caramel-brown leather sofa

| WORK | PRIORITY | INDICATIVE COST |
|---|---|---|
| Soft furnishings: professionally clean the sectional chaise and the outdoor cushions; the leather two-seater is heavily worn and should be recovered or replaced | PRESENTATION | R3,000 – R26,000 (clean vs replace) |
