## LANDLORD REPORT

# Owner & Managing-Agent Report

Two-bedroom house, City Bowl, Cape Town

SAMPLE-B

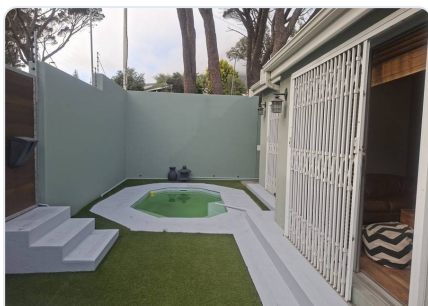
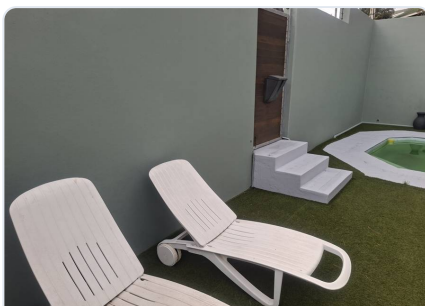
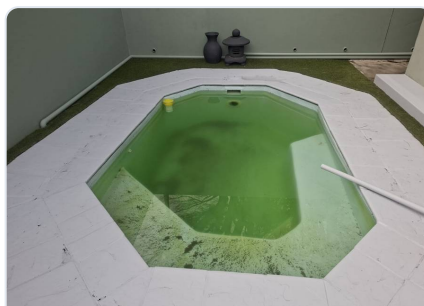
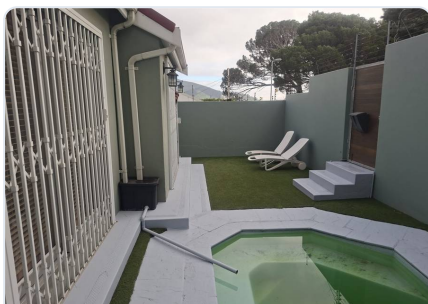
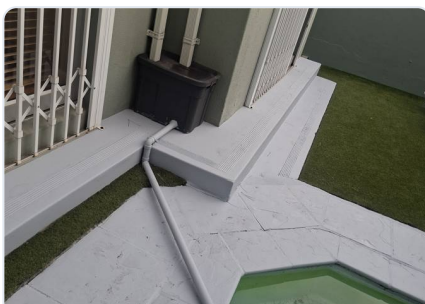
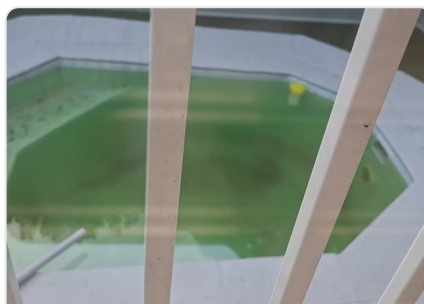
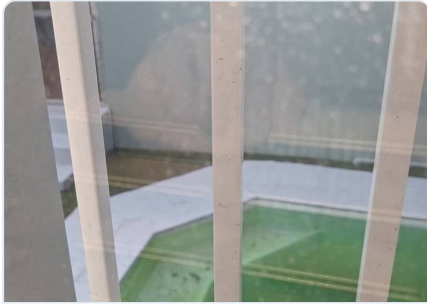
| AREA | STATUS | NOTES |
|---|---|---|
| Pool courtyard | ATTENTION | Pool water appears green/algae-affected, not clear; Pool water green/algae-tinted (visible in background) |

| OPEN MATTER |
|---|
| POOL – water is severely green and algae-affected with sediment on the submerged steps and floor. Treatment is required before any listing photography, viewing or tenancy |

**Plate 019** Small octagonal plunge pool - shell, submerged steps and water

**Plate 020** Small octagonal plunge pool - shell, submerged steps and water

**Plate 021** Small octagonal plunge pool - shell, submerged steps and water

**Plate 022** Small octagonal plunge pool - shell, submerged steps and water

**Plate 023** Small octagonal plunge pool - shell, submerged steps and water

**Plate 024** Small octagonal plunge pool - shell, submerged steps and water

**Plate 025** Small octagonal plunge pool - shell, submerged steps and water

| WORK | PRIORITY | INDICATIVE COST | STATUS |
|---|---|---|---|
| Pool treatment and clearance | HIGH | R4,000 – R9,000 | Not started |

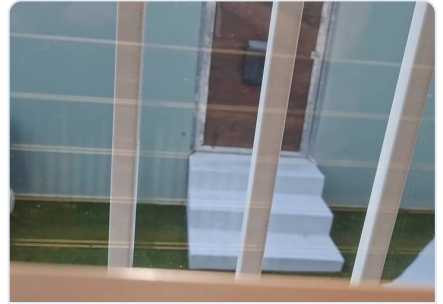
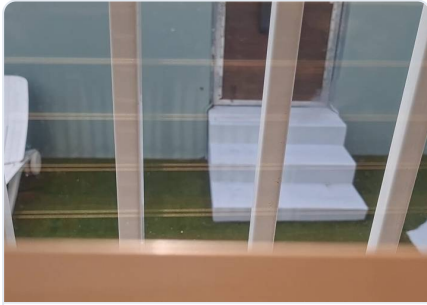
**Plate 026** Artificial turf (astroturf) ground covering to the pool courtyard

**Plate 027** Artificial turf (astroturf) ground covering to the pool courtyard

**Plate 028** Artificial turf (astroturf) ground covering to the pool courtyard

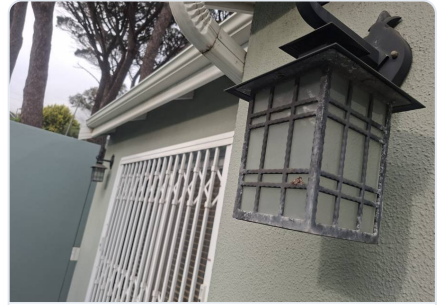
**Plate 029** Black wrought-iron lantern wall lights on the courtyard-facing house wall

**Plate 030** Black wrought-iron lantern wall lights on the courtyard-facing house wall
