MOVE-IN CONDITION REPORT

Two-bedroom house, City Bowl, Cape Town

SAMPLE-B

20 July 2026

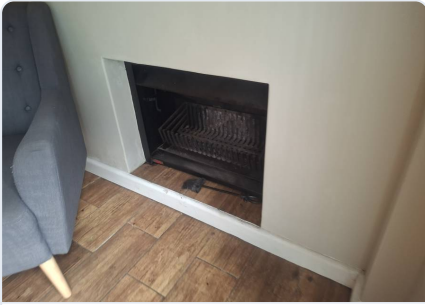
**Plate 046** Built-in fireplace recess with black metal gas/radiant fire insert

| REF | AREA | MARK AS OBSERVED | CLASSIFICATION | PLATE |
|---|---|---|---|---|
| F030 | Lounge | Sooty/blackened staining inside the fireplace insert (expected wear from use) | FAIR WEAR | Plate 046 |
| F031 | Lounge | Small chip/notch in plaster step beside the fireplace opening | FAIR WEAR | Plate 046 |

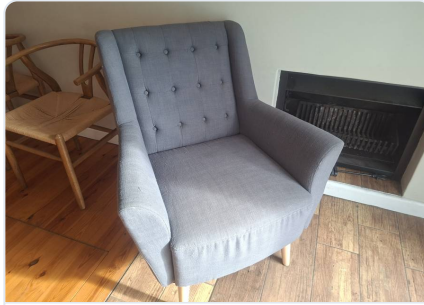
**Plate 047** Built-in fireplace recess with black metal gas/radiant fire insert

| REF | AREA | MARK AS OBSERVED | CLASSIFICATION | PLATE |
|---|---|---|---|---|
| F034 | Lounge | Visible vertical crease/wear marks and light staining on the lower front seat cushion of the grey armchair | FAIR WEAR | Plate 047 |
| F035 | Lounge | Some fine surface fuzz/pilling texture visible on the armchair fabric | FAIR WEAR | Plate 047 |

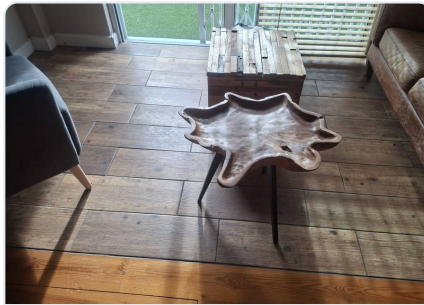
**Plate 015** Grey woven-fabric wingback armchair

| REF | AREA | DEFECT AS OBSERVED | CLASSIFICATION | PLATE |
|---|---|---|---|---|
| F039 | Lounge | Visible splits/cracks in the wood slats of the trunk-table top | PRE-EXISTING | Plate 015 |

| REF | AREA | MARK AS OBSERVED | CLASSIFICATION | PLATE |
|---|---|---|---|---|
| F040 | Lounge | One slat on the trunk appears raised or misaligned relative to others | FAIR WEAR | Plate 015 |

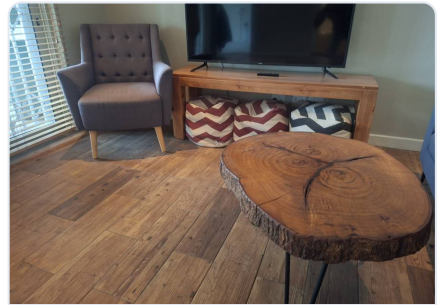
**Plate 022** Grey woven-fabric wingback armchair

| REF | AREA | DEFECT AS OBSERVED | CLASSIFICATION | PLATE |
|---|---|---|---|---|
| F103 | Lounge | Natural crack/split running across the wood-slab coffee table top | PRE-EXISTING | Plate 022 |

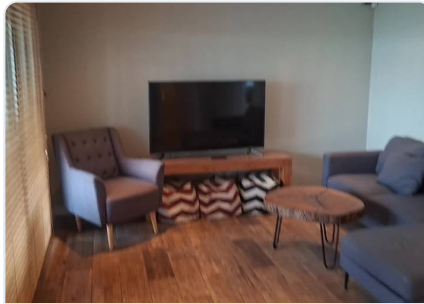
**Plate 081** Grey woven-fabric wingback armchair

| REF | AREA | MARK AS OBSERVED | CLASSIFICATION | PLATE |
|---|---|---|---|---|
| F184 | Lounge | Noticeable lighter discoloured patch on the wood floor near the armchair, possible sun-fading or rug mark | FAIR WEAR | Plate 081 |

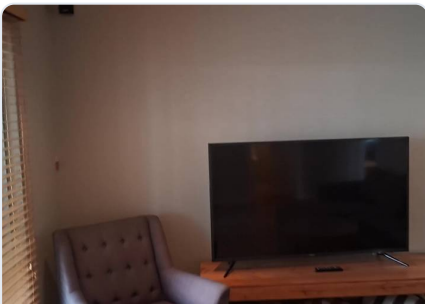
**Plate 082** Grey woven-fabric wingback armchair

| REF | AREA | MARK AS OBSERVED | CLASSIFICATION | PLATE |
|---|---|---|---|---|
| F185 | Lounge | Small dark mark/spot on wall to left of TV, could be a scuff or nail hole | FAIR WEAR | Plate 082 |

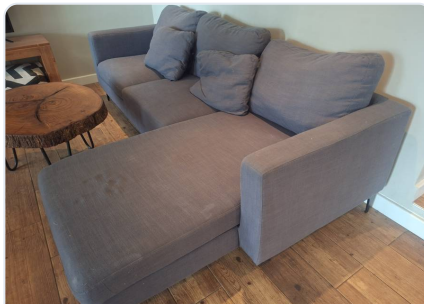
**Plate 021** Grey/charcoal fabric L-shaped sectional sofa with chaise section

| REF | AREA | DEFECT AS OBSERVED | CLASSIFICATION | PLATE |
|---|---|---|---|---|
| F101 | Lounge | Dark stain/blotch marks on the seat cushion of the chaise section | PRE-EXISTING | Plate 021 |

| REF | AREA | MARK AS OBSERVED | CLASSIFICATION | PLATE |
|---|---|---|---|---|
| F102 | Lounge | Fine dust/lint visible on the sofa armrest fabric | FAIR WEAR | Plate 021 |

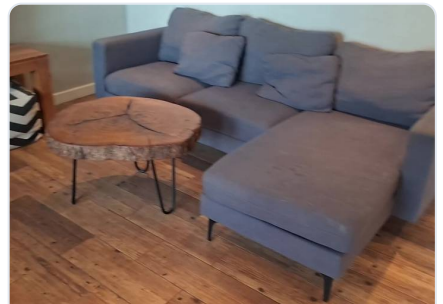
**Plate 083** Grey/charcoal fabric L-shaped sectional sofa with chaise section

| REF | AREA | MARK AS OBSERVED | CLASSIFICATION | PLATE |
|---|---|---|---|---|
| F186 | Lounge | Light discoloration/water-mark-like patch on the fabric of the chaise cushion, centre-right of the ottoman section | FAIR WEAR | Plate 083 |

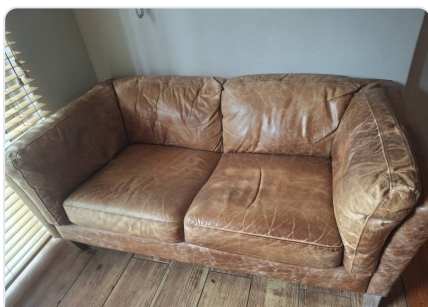
**Plate 014** Tan/caramel-brown leather sofa

| REF | AREA | DEFECT AS OBSERVED | CLASSIFICATION | PLATE |
|---|---|---|---|---|
| F032 | Lounge | Heavy creasing and wrinkling across all leather cushions consistent with distressed-style leather or wear | PRE-EXISTING | Plate 014 |

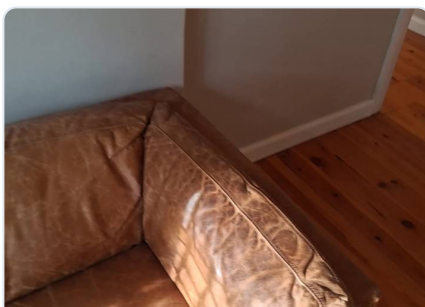
**Plate 039** Tan/caramel-brown leather sofa

| REF | AREA | DEFECT AS OBSERVED | CLASSIFICATION | PLATE |
|---|---|---|---|---|
| F220 | Lounge | Leather shows extensive creasing/wrinkling and a mottled worn appearance across the visible surface - could be a distressed-style finish or actual wear, not clearly distinguishable | PRE-EXISTING | Plate 039 |

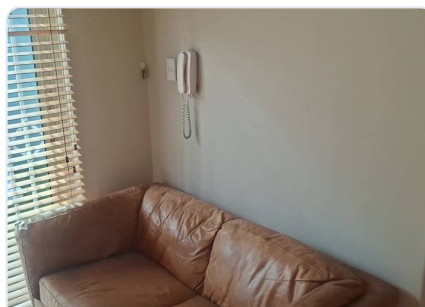
**Plate 040** Tan/caramel-brown leather sofa

| REF | AREA | DEFECT AS OBSERVED | CLASSIFICATION | PLATE |
|---|---|---|---|---|
| F221 | Lounge | Leather sofa shows heavy creasing/wrinkling consistent with wear or distressed-style finish across both visible cushions | PRE-EXISTING | Plate 040 |

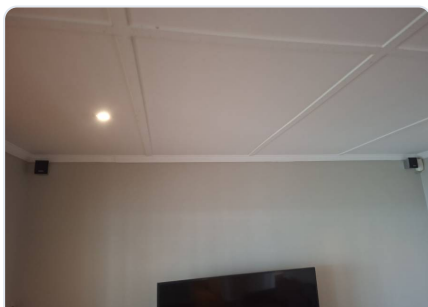
**Plate 071** SAMSUNG flat-screen television

| REF | AREA | MARK AS OBSERVED | CLASSIFICATION | PLATE |
|---|---|---|---|---|
| F108 | Lounge | A few small dark specks/marks on the ceiling near the panel seams | FAIR WEAR | Plate 071 |

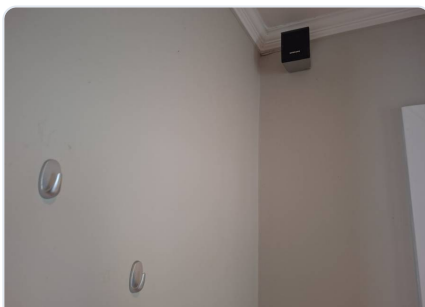
**Plate 070** SAMSUNG wireless satellite speakers

| REF | AREA | MARK AS OBSERVED | CLASSIFICATION | PLATE |
|---|---|---|---|---|
| F105 | Lounge | Small dark smudge to the lounge wall, high on the left-hand return | FAIR WEAR | Plate 070 |

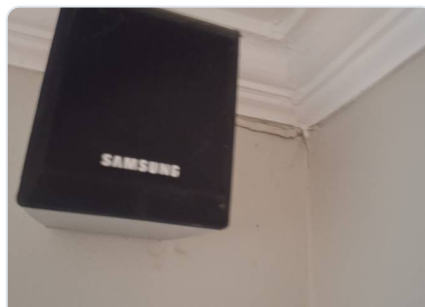
**Plate 023** SAMSUNG wireless satellite speakers

| REF | AREA | DEFECT AS OBSERVED | CLASSIFICATION | PLATE |
|---|---|---|---|---|
| F109 | Lounge | Crack and open gap in the plaster where the door architrave meets the ceiling corner | PRE-EXISTING | Plate 023 |

| REF | AREA | MARK AS OBSERVED | CLASSIFICATION | PLATE |
|---|---|---|---|---|
| F110 | Lounge | Several small dark specks/spots on the wall to the right of the speaker | FAIR WEAR | Plate 023 |
