OWNER REPORT

Two-bedroom home, Atlantic Seaboard,  
Cape Town

SAMPLE-A

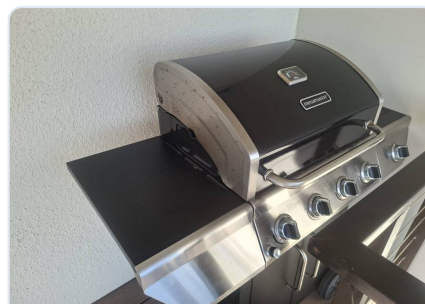
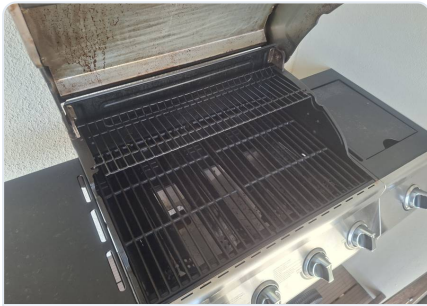
**Plate 003** Gas braai, Megamaster

| ITEM | FINDING | PRIORITY | ACTION |
|---|---|---|---|
| Gas braai, Megamaster — 4-burner with enamel hood, temperature gauge, stainless side shelf and cabinet base | Extensive brown/orange rust staining and streaking to the underside of the hood from the hinge area; grates carry soot and grease build-up; speckled residue on the stainless front edge | HIGH | Clean and assess the rust on the lid trim and hinge before the next listing photography |

The Megamaster gas braai carries extensive rust staining under the hood from the hinge line, with soot and grease build-up on the grates. It is a feature the listing will lead on, so it needs a proper clean and a rust assessment before the next photography — not after.

Gas braai requires cleaning and a rust assessment before the next guest or listing photography

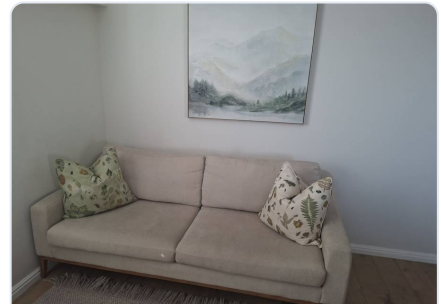
**Plate 009** Sofa, 2-seater beige/oatmeal fabric with wood-toned base

| ITEM | FINDING | PRIORITY | ACTION |
|---|---|---|---|
| Sofa, 2-seater beige/oatmeal fabric with wood-toned base — light mark to front edge of left seat cushion | Small light-coloured mark on left seat cushion | MEDIUM | Clean or treat at the next deep clean and re-photograph |

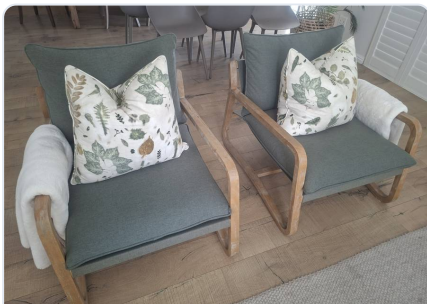
**Plate 010** Armchairs, bentwood surround with sage/grey-green upholstery

| ITEM | FINDING | PRIORITY | ACTION |
|---|---|---|---|
| Armchairs, bentwood surround with sage/grey-green upholstery — whitewashed wear patches to arms and legs | Worn/whitewashed patches on surrounds, consistent with a distressed finish | MEDIUM | Clean or treat at the next deep clean and re-photograph |
