# Snag & Maintenance Report

Two-bedroom house, City Bowl, Cape Town

SAMPLE-B

20 July 2026

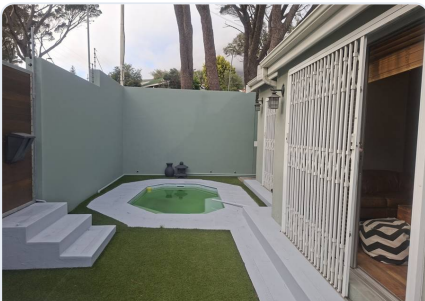
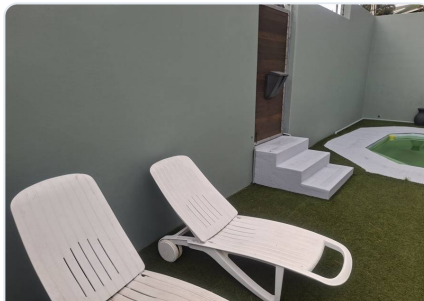
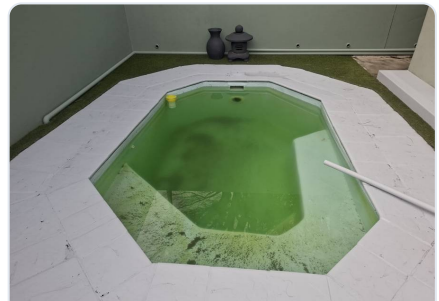
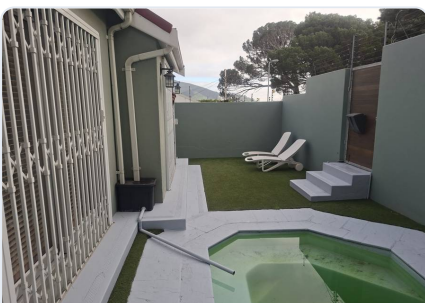
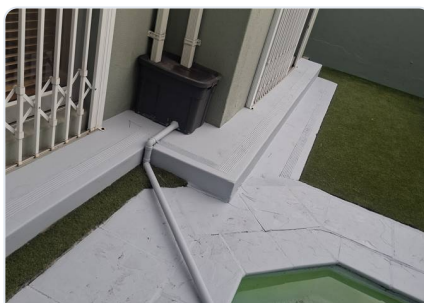
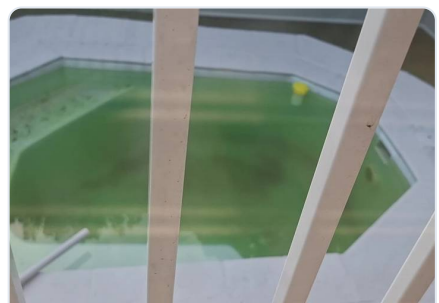
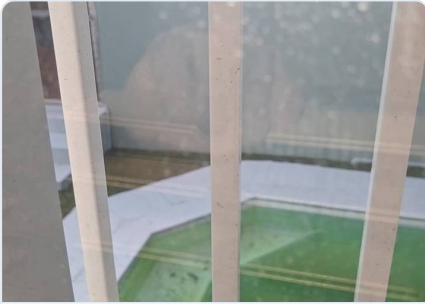
**Plate 001** Small octagonal plunge pool - shell, submerged steps and water

**Plate 002** Small octagonal plunge pool - shell, submerged steps and water

**Plate 003** Small octagonal plunge pool - shell, submerged steps and water

**Plate 005** Small octagonal plunge pool - shell, submerged steps and water

**Plate 006** Small octagonal plunge pool - shell, submerged steps and water

**Plate 010** Small octagonal plunge pool - shell, submerged steps and water

**Plate 011** Small octagonal plunge pool - shell, submerged steps and water

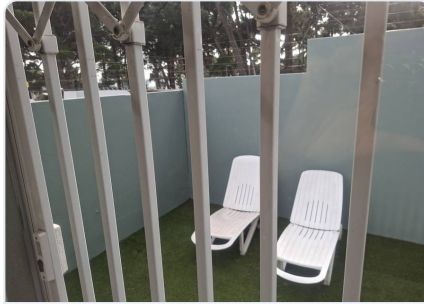
**Plate 013** Artificial turf (astroturf) ground covering to the pool courtyard

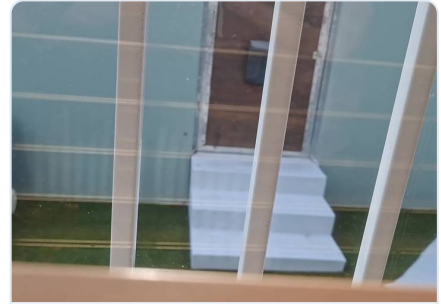
**Plate 097** Artificial turf (astroturf) ground covering to the pool courtyard

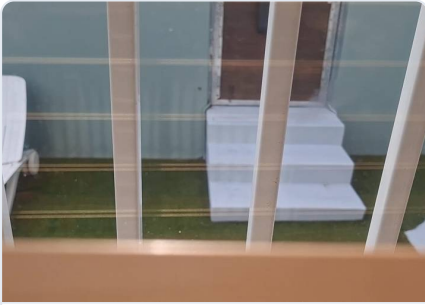
**Plate 098** Artificial turf (astroturf) ground covering to the pool courtyard

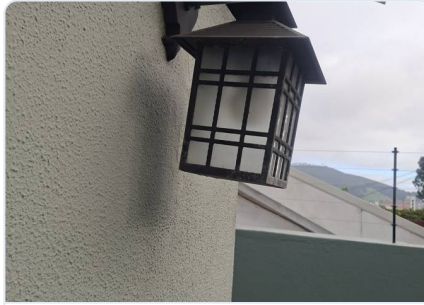
**Plate 099** Black wrought-iron lantern wall lights on the courtyard-facing house wall

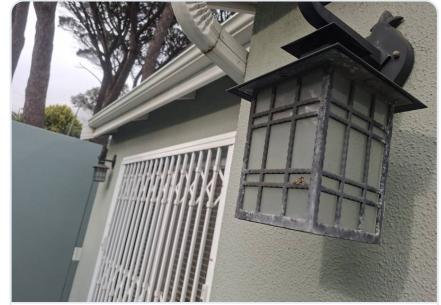
**Plate 045** Black wrought-iron lantern wall lights on the courtyard-facing house wall
