## **LEAD RECYCLING AFRICA PROJECT**

### **USED LEAD ACID BATTERY (ULAB) RECYCLING IN TANZANIA**

#### **SURVEY REPORT**

**JANUARY 2016**

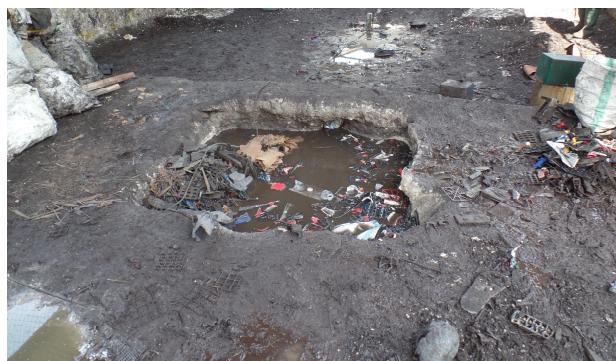
After receiving the batteries, the facility drains off all the acid ready for other recycling processes. The acid is collected in a reservoir. The next process is manual battery breaking which is done by a few workers who use primitive tools such as axes, and others. Workers who were dismantling the batteries complained that sometimes remaining acid in the battery spilled on them while breaking the batteries.

**Photograph 1. Place where dismantling is done at OK Plast**

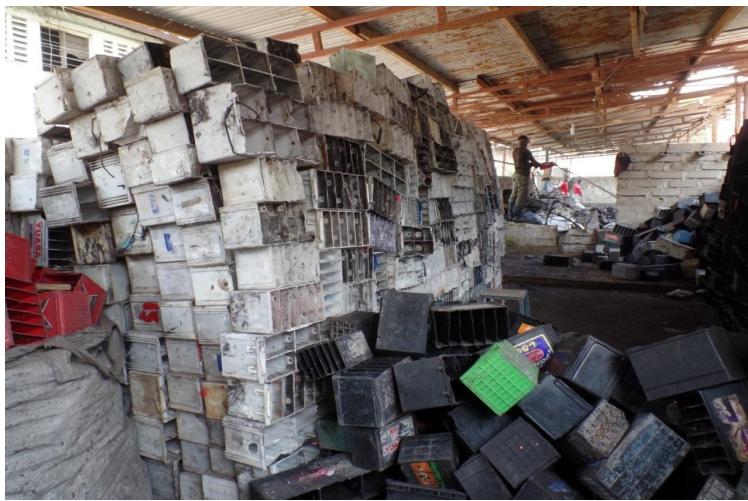
**Photograph 2. Plastic casings washed ready for crushing – OK Plast**

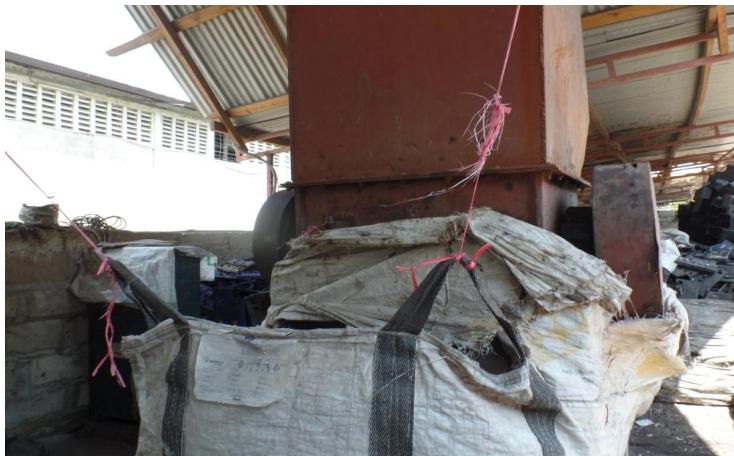
**Photograph 3. Crushing/shredding machine at OK Plast**

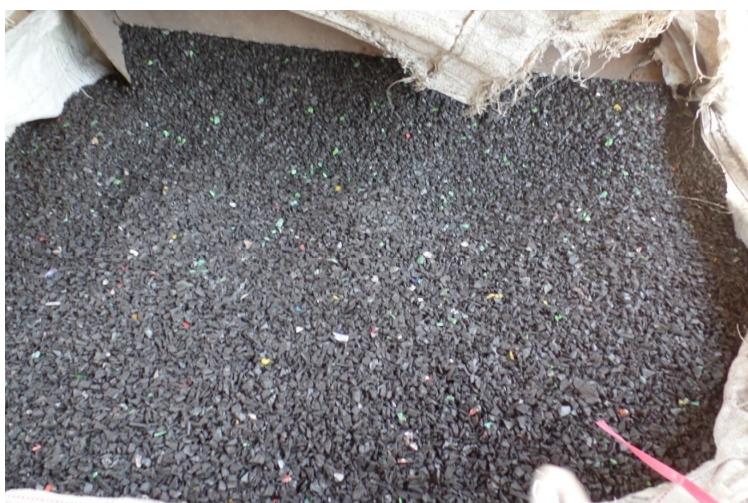
**Photograph 4. Pieces of shredded plastic casings at OK Plast**

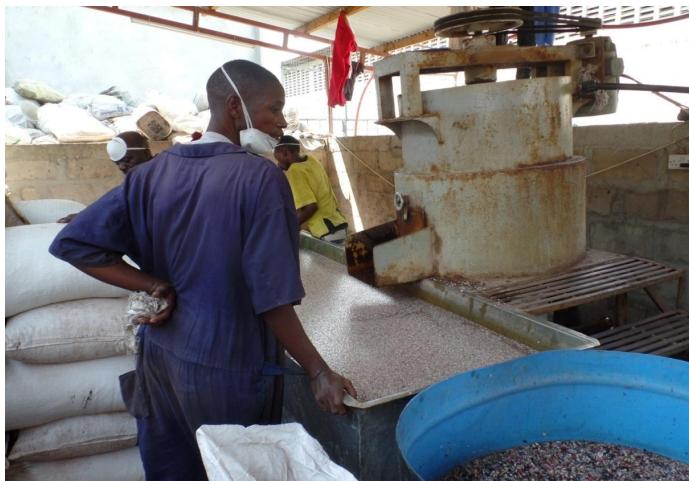
**Photograph 5. Separation of pieces shredded materials**

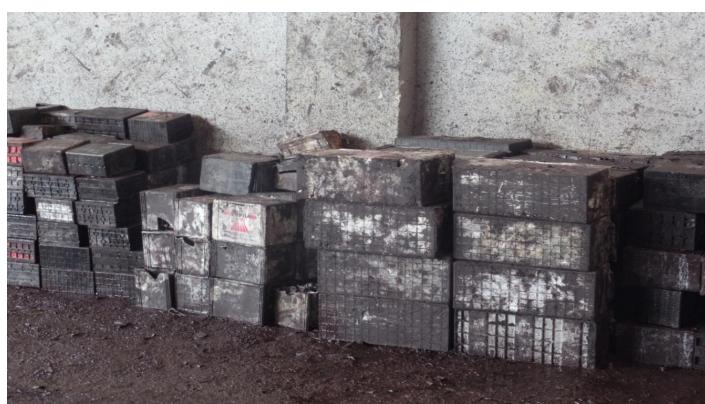
**Photograph 6. Scrap lead batteries ready for cut machine at Gaia**

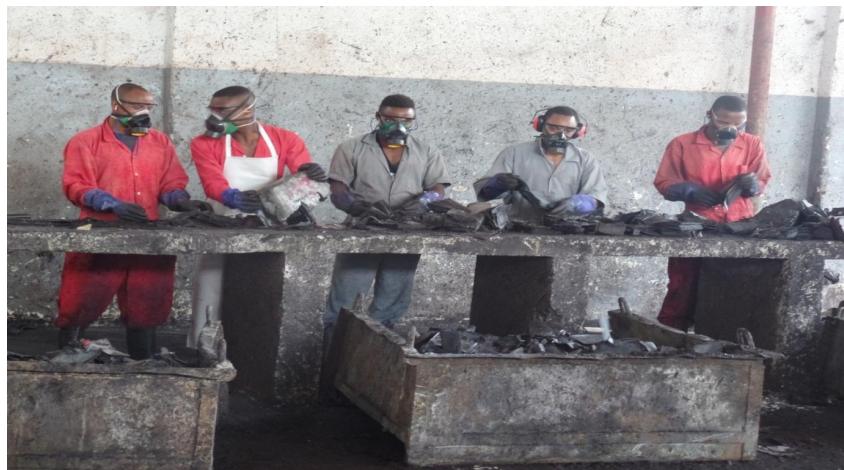
**Photograph 7.** Lead bearing materials after being separated from plastic casings at Gaia

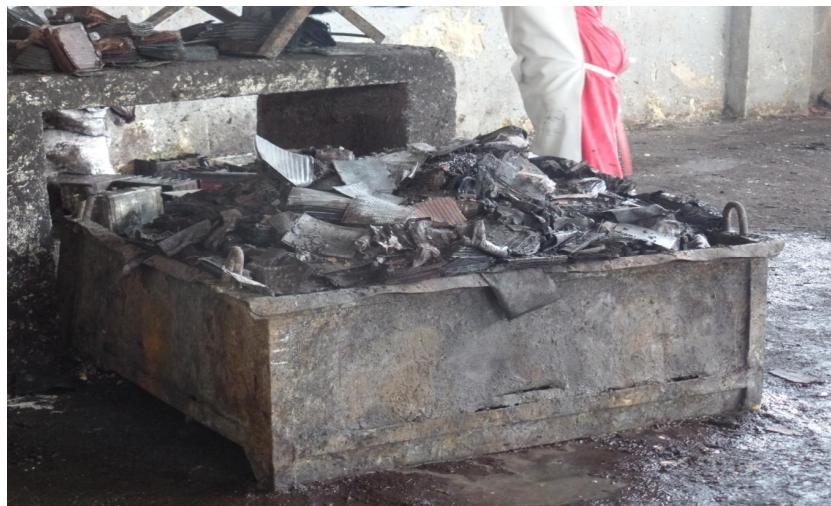
**Photograph 8.** Lead bearing materials ready for burning into the furnace - GAIA

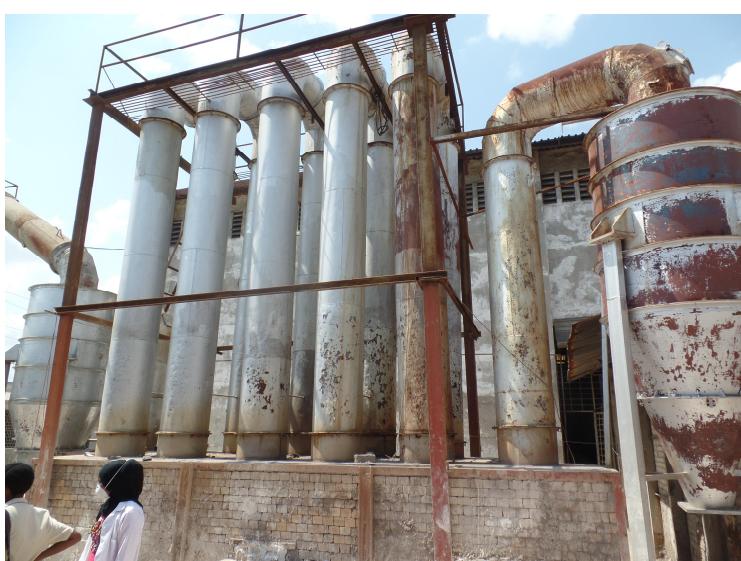
**Photograph 9. Emission control**

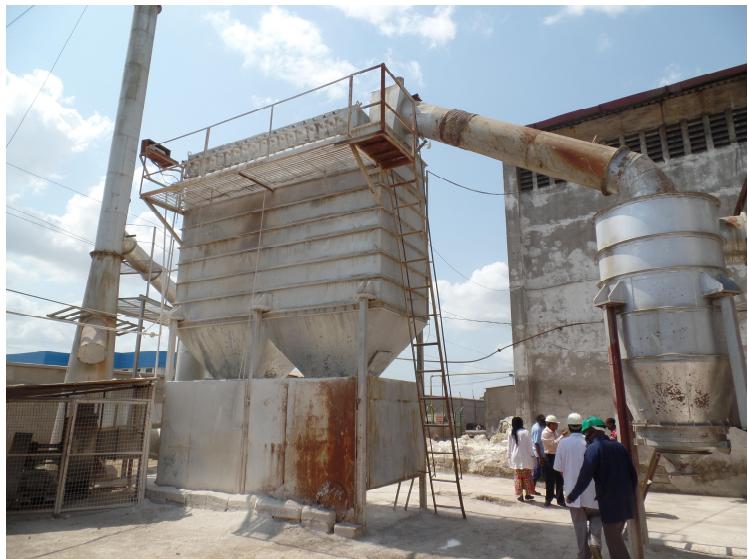
**Photograph 10. Emission control 2**

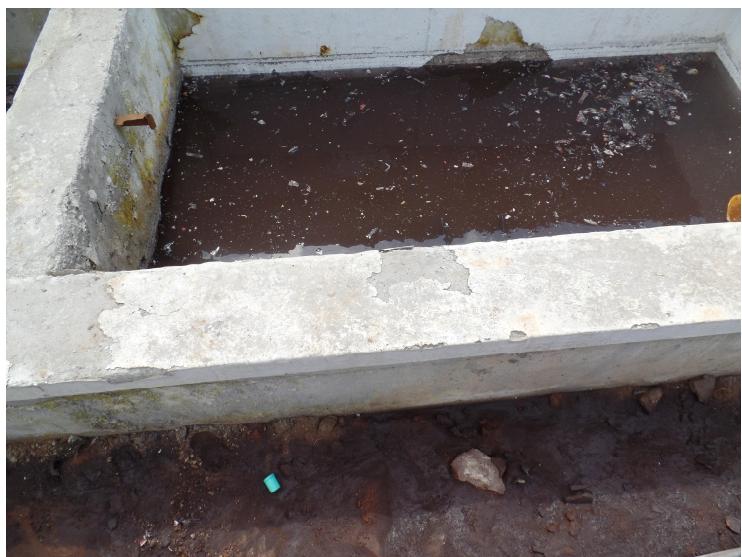
**Photograph 11. Washing water pond**

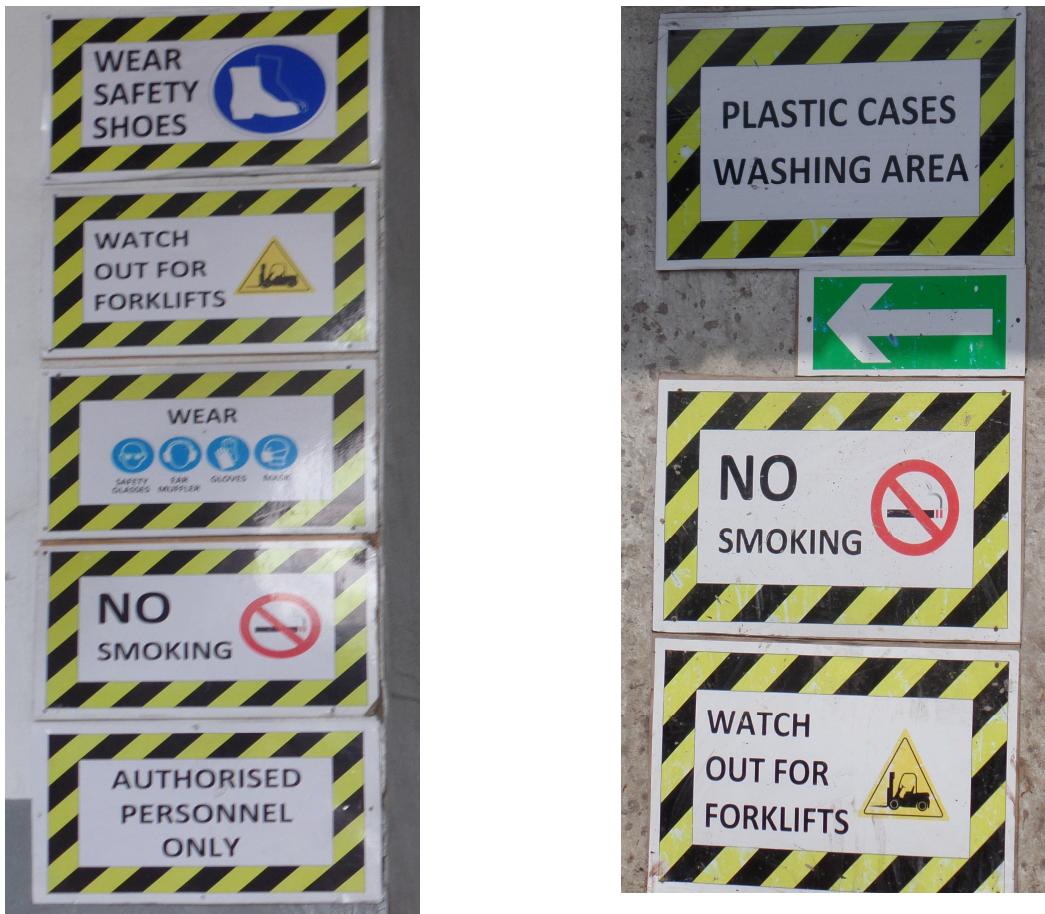
**Photograph 12.** Some warning signs

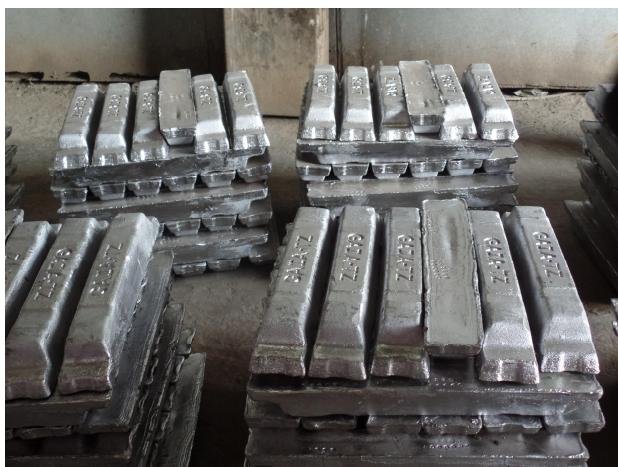
**Photograph 13** Finished ingots before packing
