The Airbus safety magazine

#32

Unreliable Airspeed at Takeoff

Take Care of the Wheel Tie Bolts

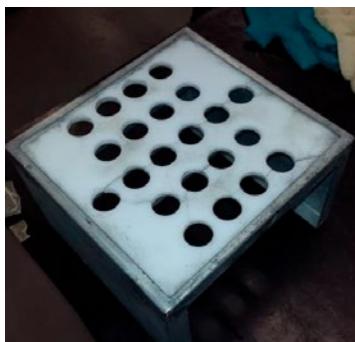
Storage of the tie bolts after removal

The removed wheel tie bolts must not be put together in a box without suitable separation and protection before inspection and reinstallation.

When the bolts are removed from the wheel, they should be handled with care and placed into a box with dedicated compartments for each bolt to ensure that they are not in contact with each other. This prevents contact damage to the bolts.
