The Airbus safety magazine

# Safety first

**Safety first, #36** July 2023. Safety first is published by Airbus S.A.S. - 1, rond point Maurice Bellonte - 31707 Blagnac Cedex/France.  
Editor: Yannick Malinge, Chief Product Safety Officer.  
Concept Design by Airbus MultiMedia Studio  
20230957. Reference: X00D16031905.  
Photos by Airbus, S. Ramadier, H. Goussé,  
G. Estragnat.

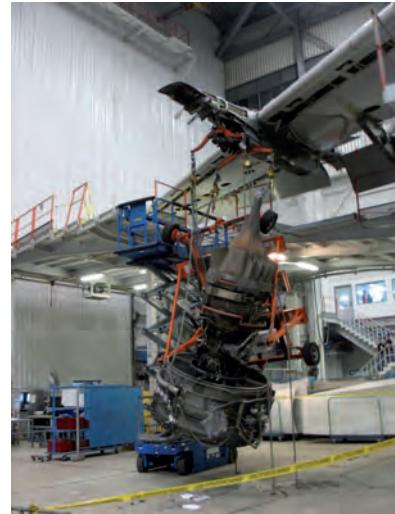
**(fig.1)**

Inspection of the bootstrap equipment on the hanging engine showed that one of its attachments had bent under the load of the engine and it eventually ruptured, which released the engine it was supporting, causing it to be damaged from the fall.

The investigation found that the bootstrap equipment was not compliant with the Airbus technical specifications. The sizing and material of the attachments, which were a part of this equipment, were not correctly sized and this caused the equipment to fail.

Picture of the event

The supplier of the engine bootstrap equipment was not listed in the Airbus Tools and Equipment Manual (TEM). The Operator had found the equipment supplier on the internet. The bootstrap equipment advertised on this supplier's website indicated the same part number as the one listed in the AMM, but its cost was significantly lower than the equipment available from approved suppliers listed in the TEM. ■

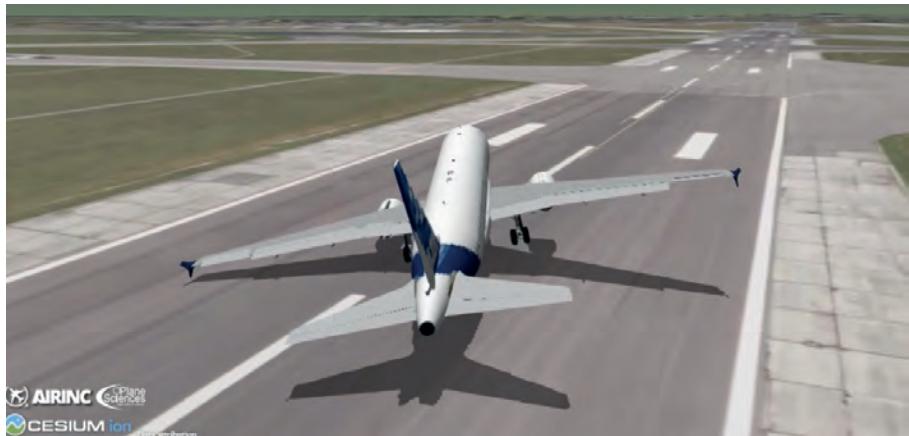
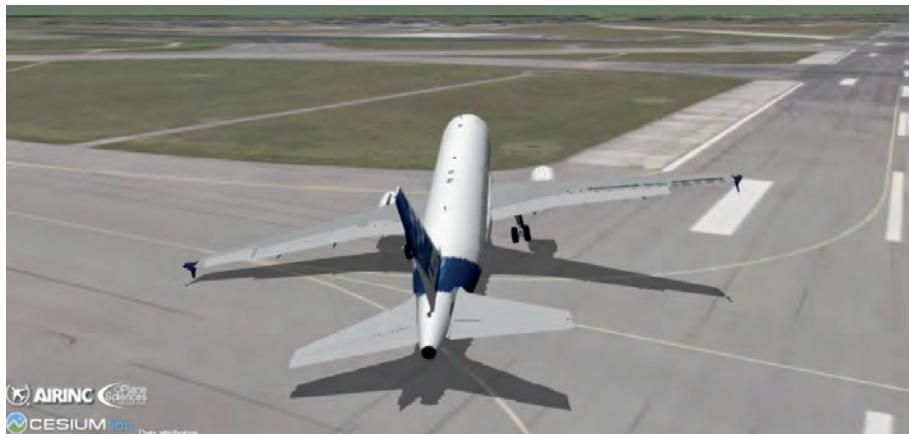
In the initial phase of the go-around, the aircraft attitude went close to wing tip and tailstrike conditions **(fig.5)** but remained within the ground clearance limits. ■

Screen captures from the video reconstitution of the event showing the aircraft attitude in the early stage of the go-around phase (Flight Animation System from APS Aerospace)
