The Airbus safety magazine

#35

Safety first, #35 January 2023. Safety first is published by Airbus S.A.S. - 1, rond point Maurice Bellonte - 31707 Blagnac Cedex/France.
Editor: Yannick Malinge, Chief Product Safety Officer.
Concept Design by Airbus MultiMedia Studio
20221995. Reference: X00D16031905.
Photos by Airbus, S. Ramadier, H. Goussé,
G. Estragnat.

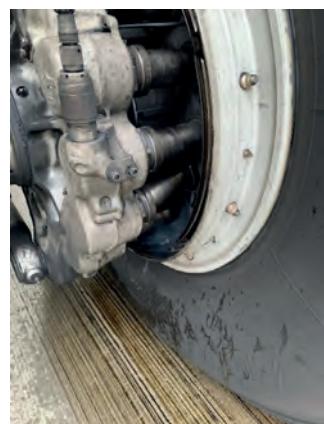
(fig.1)

Shortly after landing, the flight crew of an A330 aircraft heard a strong and unusual noise during taxi-in. When the aircraft reached the parking stand, ground crew observed smoke coming from the area of the left Main Landing Gear (MLG) and informed the flight crew. The fire brigade arrived but did not see any fire. The flight crew noticed a 400 °C temperature on wheel no. 6. Maintenance personnel performed a quick inspection of the landing gear, which revealed that one of the brake pistons of wheel no. 6 had twisted and dislodged from its housing with evidence of a hydraulic fluid leak (**fig.1**). There was no sign of fire on the landing gear structure and components.

Picture of the damaged piston

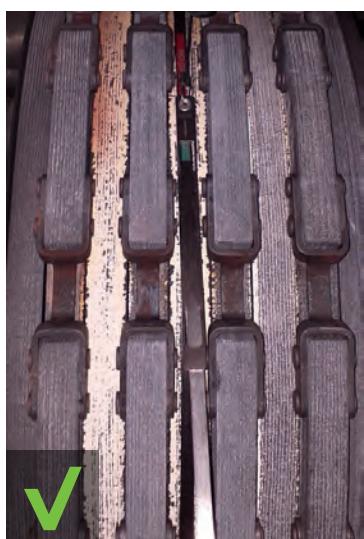
(fig.6)

Examples of non-oxidized and oxidized brakes

No sign of oxidation

Visually inspect the brake assembly at every wheel removal, in accordance with the corresponding AMM/MP procedure, to check that there is no damage or crack on the disks and to check the condition of the brake components. Pay particular attention to any signs of oxidation marks, and if the oxidation is beyond acceptable limits, replace the brake (**fig.6**).

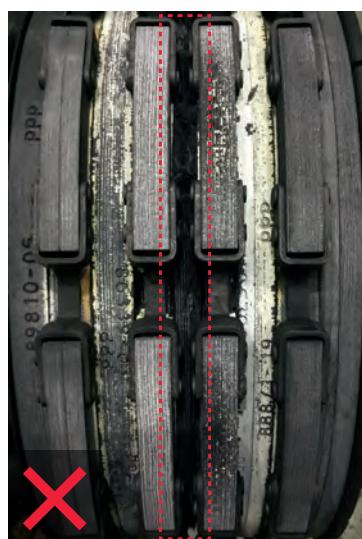
Oxidized stator 3

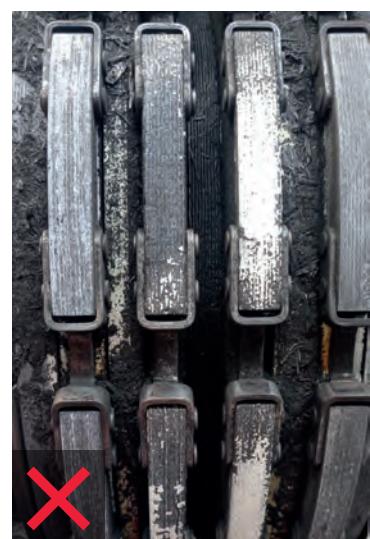
Highly oxidized brake

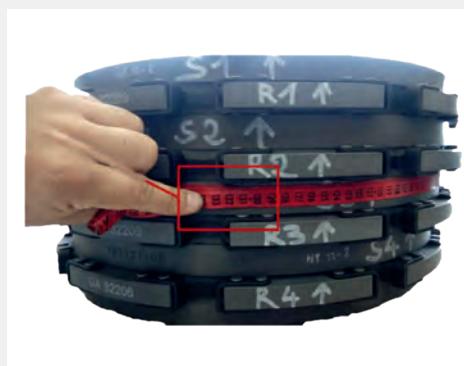
(fig.7)

Optional inspection to measure the perimeter of the central stator on Safran Landing Systems and Messier-Goodrich brakes

Some operators are more exposed to the risk of brake rupture due to their specific operations. Airbus proposes an optional brake inspection with the wheel removed. This inspection was developed together with brake manufacturers and can be added to the AMM procedure by request of the operator. Steps were added to the brake inspection procedure that require measuring the outer perimeter of the central stator (Safran Landing Systems and Messier-Goodrich brakes) **(fig.7)** or the radius of the friction surface (Collins Aerospace brakes) **(fig.8)**. The reduction of this measured value provides an additional indicator of brake oxidation

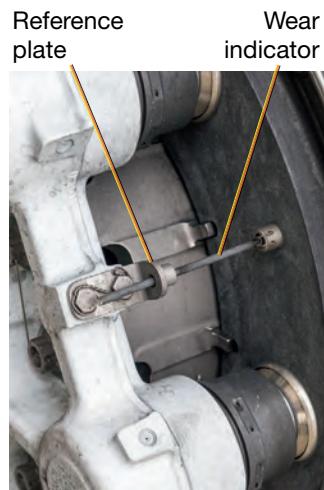
(fig.9)

Brake wear indicator
of an A350-1000 aircraft

A quick check of the brake wear indicator **(fig.9)** during the exterior walkaround will determine if the brakes are worn. If there are only a few millimeters remaining before the indicator is flush with the reference plate, inform maintenance personnel to anticipate and plan for a brake replacement before the wear limit is reached. On A220 aircraft, the flight crew can also check the brake wear status on the EICAS STATUS synoptic page.

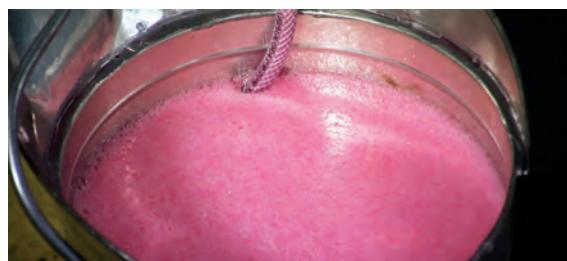
(fig.3)

Foam noticed while compressing the shock absorber.
Hydraulic fluid needs to be added again.

After refilling the shock absorber with hydraulic fluid, it is compressed to check the quantity. There is likely to be foam in the hydraulic fluid released from the shock absorber (**fig.3**). More hydraulic fluid needs to be added and the shock absorber compressed again, repeating these steps until there is no more foam released (**fig.4**). It is harder to inject hydraulic fluid into the shock absorber with the aircraft weight on wheels, and it is more likely to produce foam in the fluid, making the procedure more difficult to perform.
