The Airbus safety magazine

#38

Safety first, #38 July 2024. Safety first is published by Airbus S.A.S. - 1, rond point Maurice Bellonte - 31707 Blagnac Cedex/France.
Editor: Yannick Malinge, SVP - Head of Aviation Safety.
Concept Design by Airbus MultiMedia Studio
20240359. Reference: X00D16031905.
Photos by Airbus, S. Ramadier, Masterfilm - P. Pigere,
P. Masclet, H. Gousse, A. Domenjou.

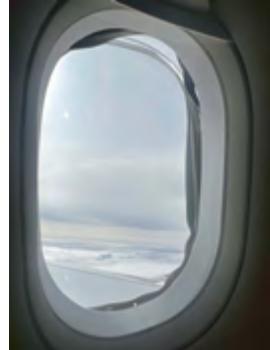
(fig.1)

An A321neo aircraft was performing a positioning flight before several sectors of operations. A limited number of people including some cabin crew members were on board. The aircraft was climbing toward its target altitude. At 10 000 ft, one of the cabin crew noticed an excessive amount of cabin noise and cold temperature while walking toward the empty middle part of the aircraft. He discovered that one of the windows on the left side of the cabin appeared to have slipped down from its usual position and that the window seal was flapping in the outside airflow (**fig.1**). He immediately informed the flight crew who decided to descend to 9 000 ft and to perform an in-flight turnback. The aircraft landed safely and without further incident.

Picture of the window during the event (source: operator)

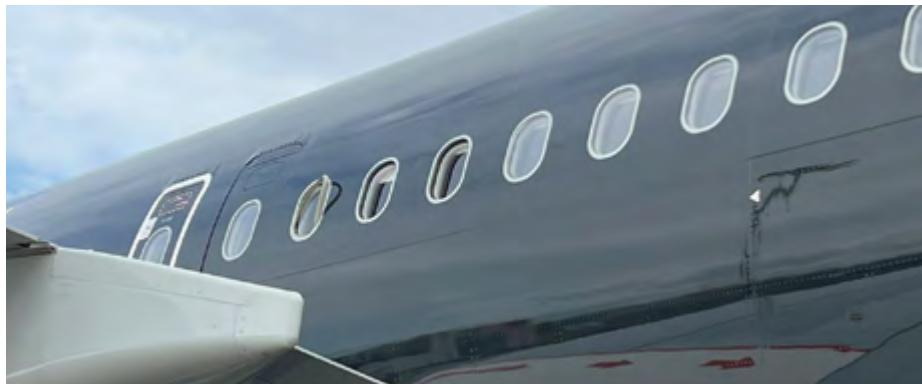
(fig.2)

Picture of the damaged and missing windows after landing (source: investigation board)

When on the ground and with the aircraft parked, the flight crew performed an inspection of the aircraft exterior. They observed that two windows were missing and one was dislodged (**fig.2**). Damage to the lower side of the left stabilizer, probably due to an impact of a departing part, was also noticed. Further inspection revealed that two additional windows were damaged on the left side of the fuselage and one window also showed signs of damage on the right side of the fuselage.

After the filming session or photoshoot is finished, **Airbus recommends performing a visual inspection** of all cabin windows that were exposed to the lightning to check they are free of any damage or distortion before returning the aircraft to service.

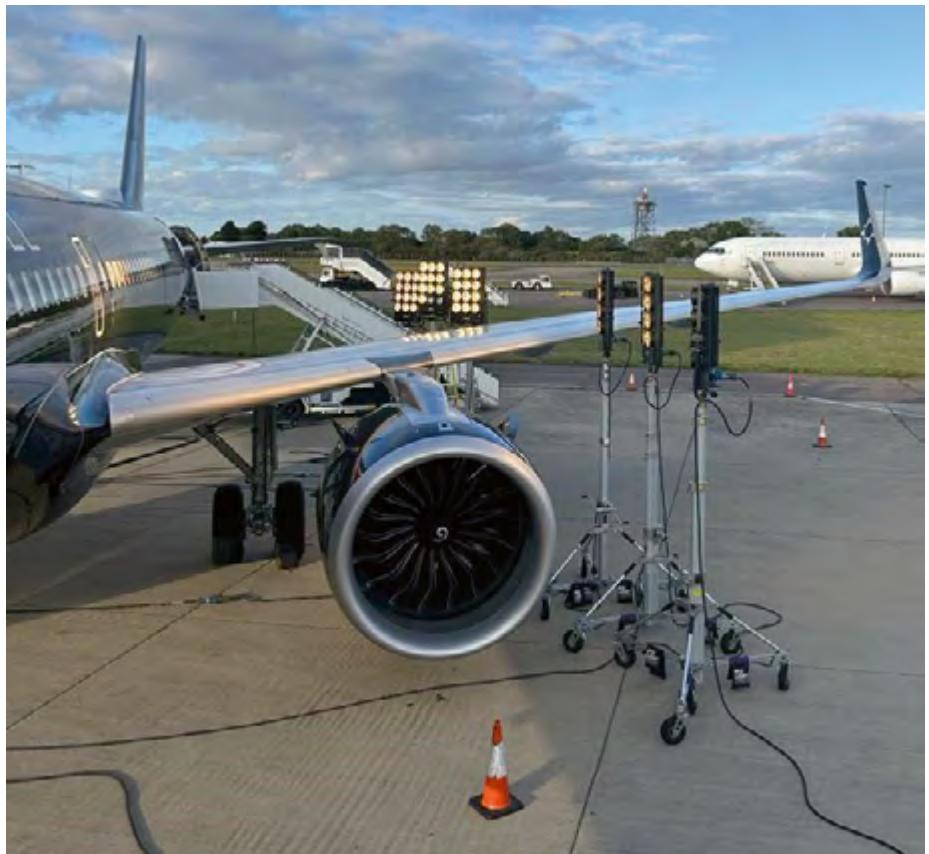
(fig.4)

Picture of the filming session (source: operator)

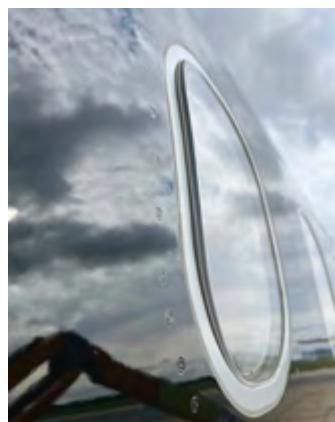
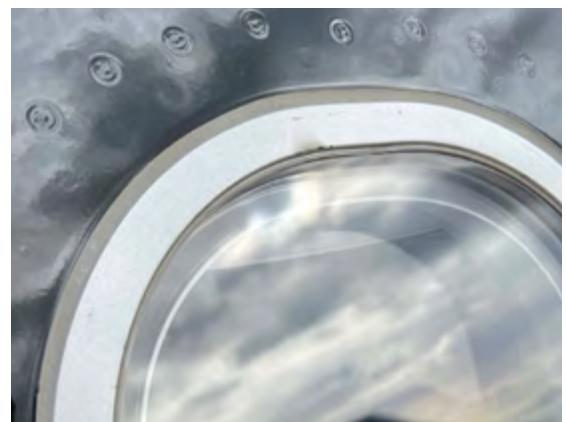
(fig.5)

The combined power of the 6 lamps in the halogen lighting setup was 72 kW. The exposure of the fuselage area to the spotlights lasted more than 4 hours on each side of the aircraft. The heat produced by the infrared radiation from the halogen spotlights damaged several cabin windows. This damage was not detected prior to the next flight.

- Two window assemblies completely missing (one pane was retrieved on the runway)
- One window with missing outer pane
- Deformation of several other window panes
- Window seals in degraded condition
- Visible burn marks
- Melted foam ring at the interface between the window and the cabin lining. ■

Window protrusion due to deformation (left) and burn marks on the top of an outer pane (right)
(source: investigation board)

Airbus recommends not to use high thermal radiation lighting devices, such as halogen (tungsten) or HMI lighting, during photoshoots or filming sessions outside or inside an aircraft. This type of lighting device emits a large amount of thermal energy. **Only use low energy lighting devices, such as LED lights**, which provide good lighting capabilities with low heat emission.

Even though Airbus aircraft materials have been qualified for use in elevated temperature environments, for example, taking into account operations or storage in hot weather regions, Airbus recommendation is to make sure that the surface temperature of cabin and passenger windows, fuselage, interior equipment and all aircraft parts exposed to the lighting sources, **are monitored and do not exceed 55°C**.

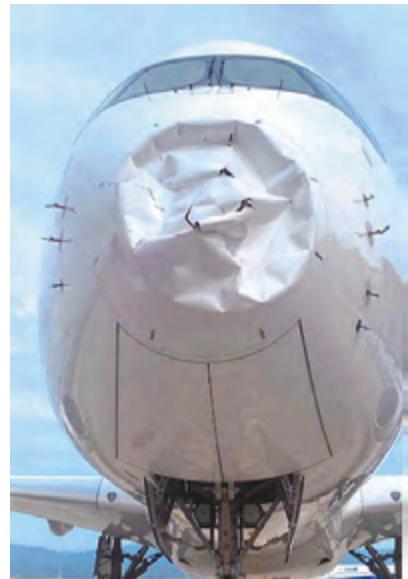
(fig.1)

When the aircraft reached the gate, the ground crew observed that the nose radome had collapsed onto the radar (**fig.1**).

The aircraft technical logbook revealed that the aircraft had a bird strike on the left side of the radome one month prior to the event. The technical logbook stated that an inspection was performed in accordance with the MP A350-A-05-51-14-00001-282A-A - Inspection of the Aircraft after a Bird Strike and that traces of bird strike were found on the outer surface left side of the radome, but there was no damage detected. The logbook did not specifically mention if the inner surface of the radome was also inspected. Therefore, it is not possible to confirm if a complete inspection of the radome was performed.

View of the collapsed radome (source: operator)

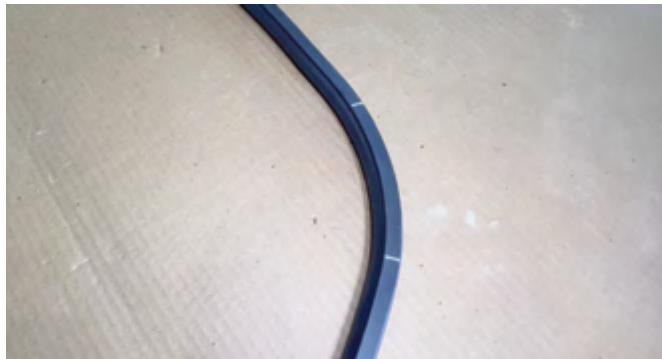
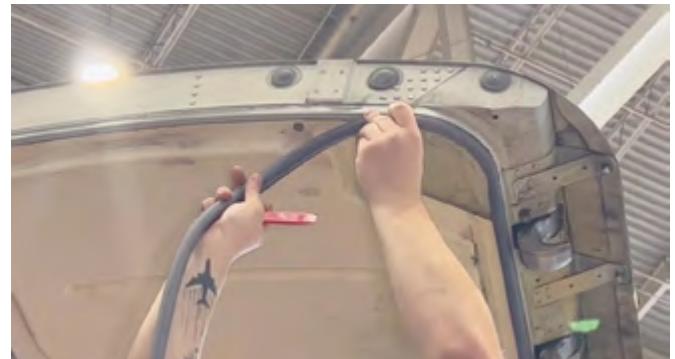
(fig.5)

Installation of the pre-formed corners before the straight sides ensures correct installation of the seal along the door frame

Maintenance personnel should install the four pre-formed corners first to ensure the seal is in the correct position and to prevent wrinkles. White alignment marks help to identify and correctly position the pre-formed corners (**fig.5**).

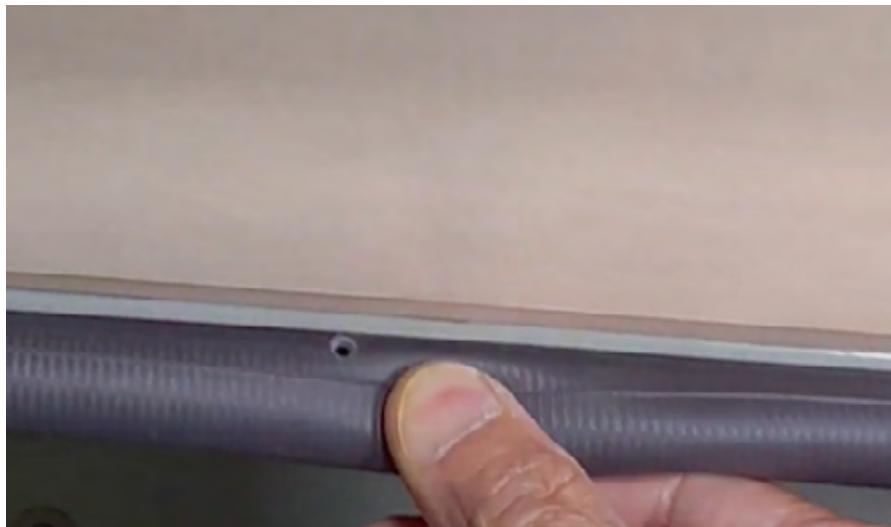
(fig.6)

Slightly bending the seal enables the maintenance personnel to check the inflation holes are facing towards the inner surface of the door, which is the cargo side

A careful inspection of the seal as per AMM is required to ensure correct seal installation. The maintenance personnel must inspect the entire circumference of the cargo door seal. They must ensure the seal is not twisted and check that the inflation holes are facing towards the inner side of the cargo door by gently bending the seal (**fig.6**).
