## AS2870      Site Classification

**Proposed New Office Building.**  
Lot 44 (SP140243)  
Stanwell Power Station.  
Power Station Road, Stanwell.

CQ29760

19/12/2025

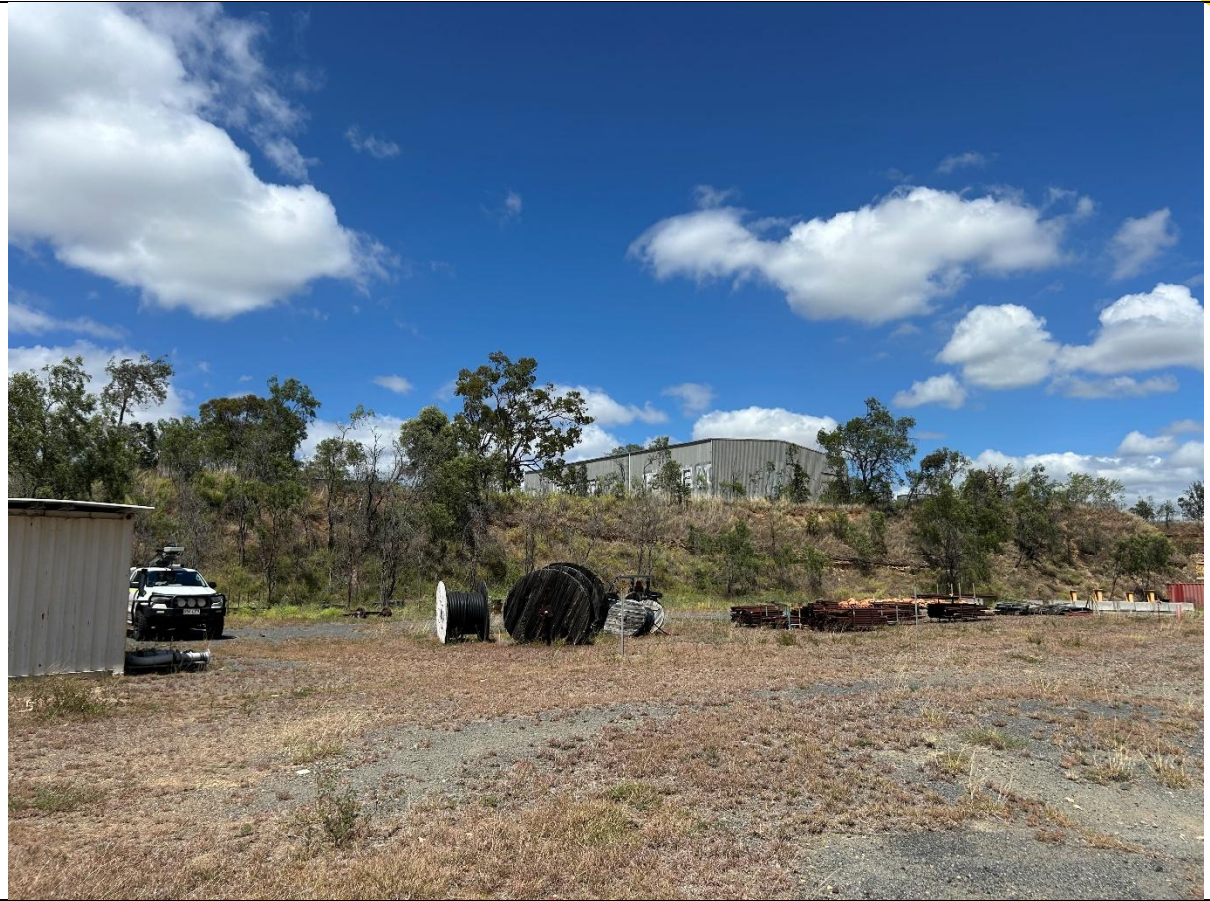
**Image 1** – Proposed construction site

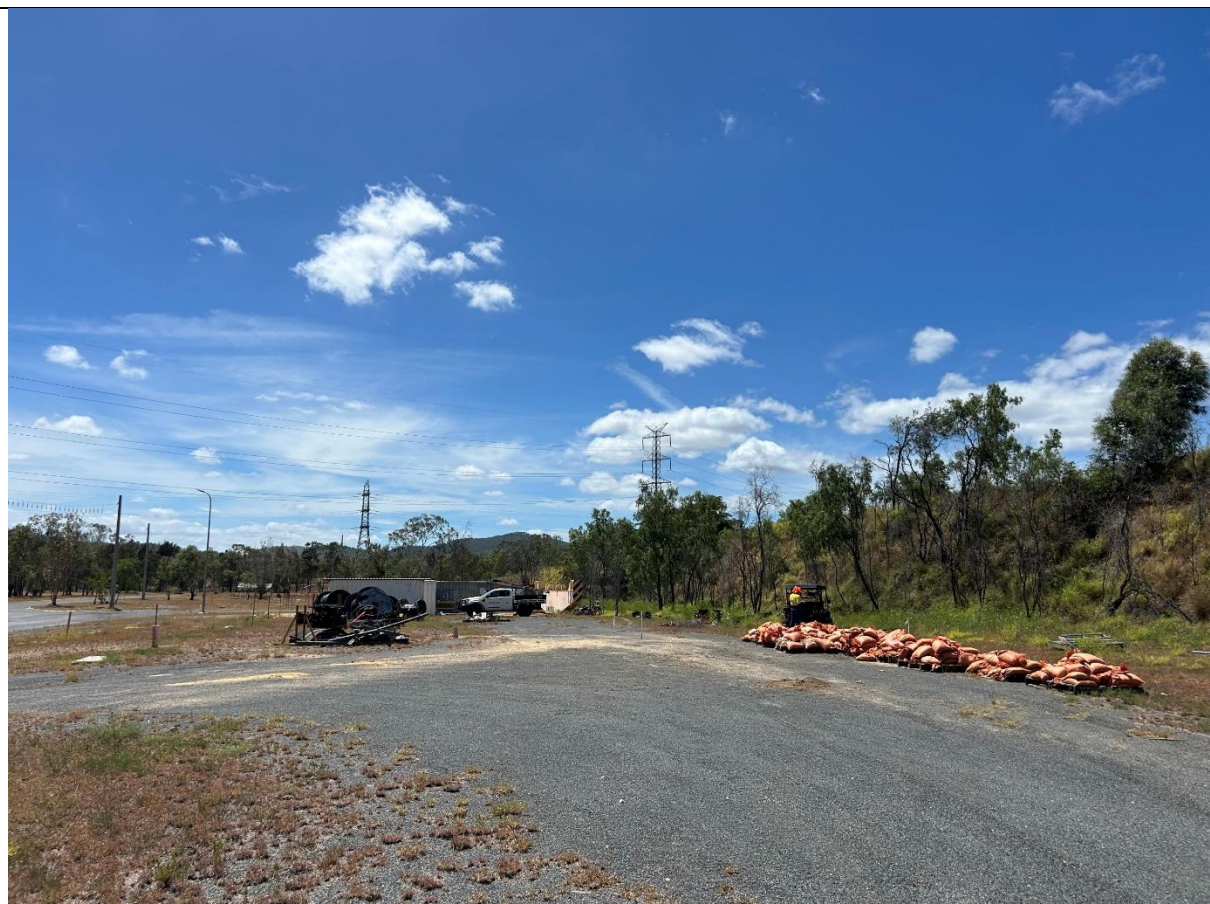
**Image 2** – Proposed construction site
