# Photo Report

SALTHILL CAPITAL  
1001-130 BLOOR STREET WEST /  
TORONTO, ON  
TORONTO, ONTARIO M5S 1N5

| FACILITY: Royal Oak Park | ROOF SECTION: 1.6.1 Daycare | TITLE: Cut Tests_Sept 17_25 | DATE: 09/17/2025 |

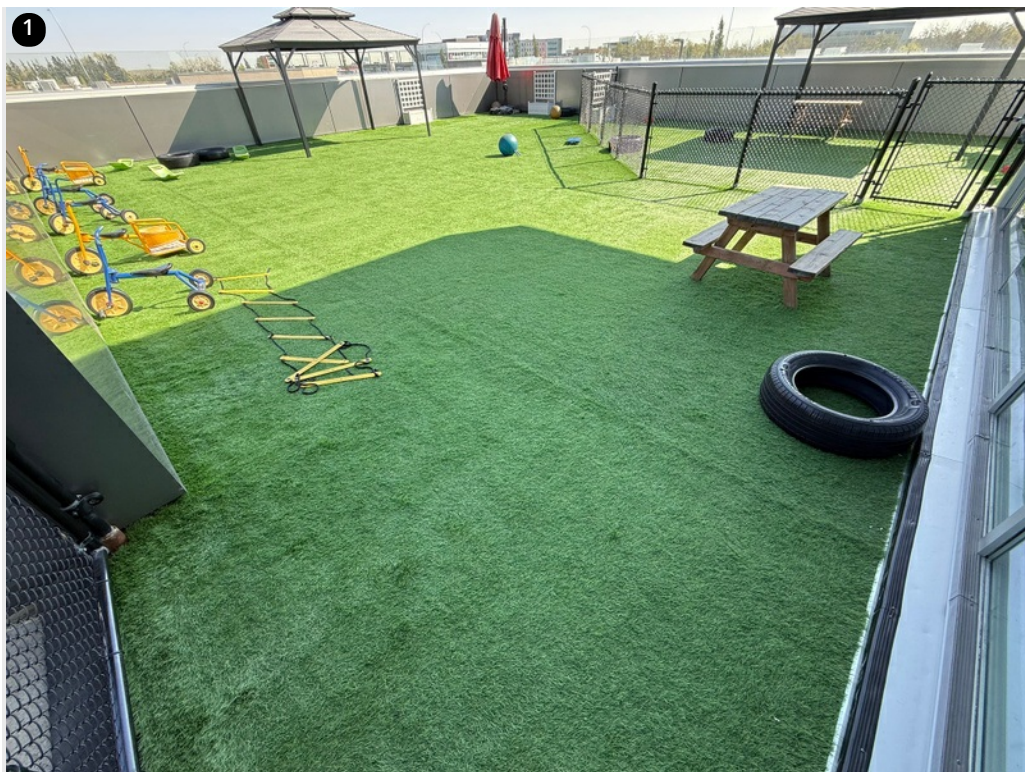
Overview photo of the roof.

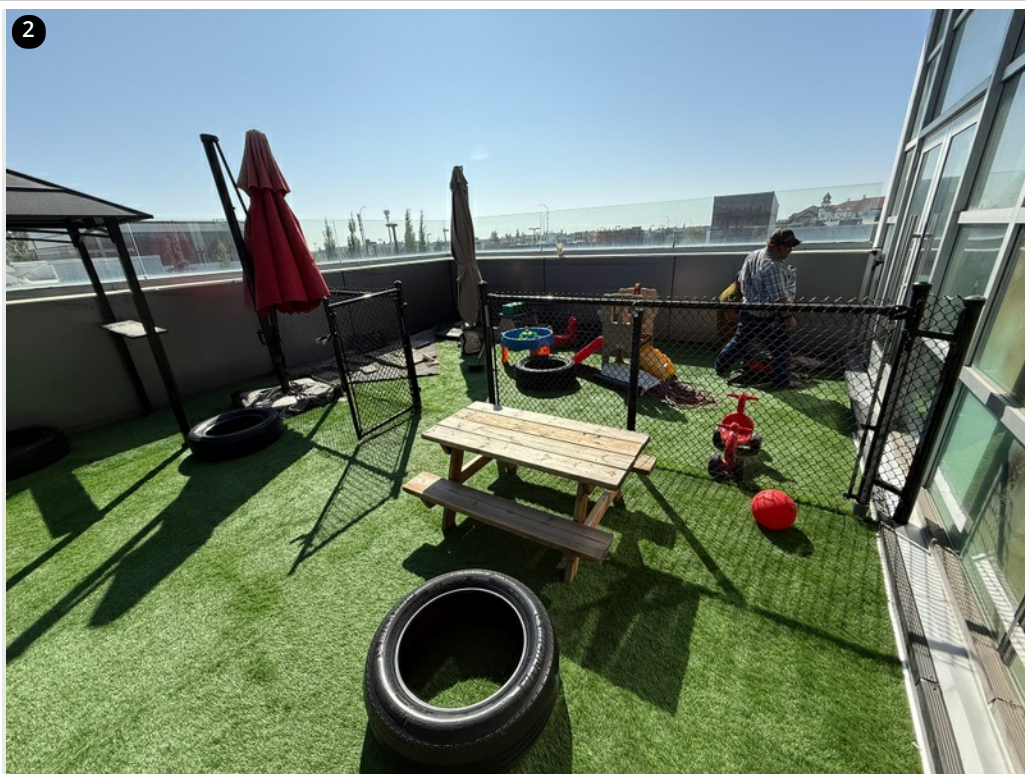
Overview of SE roof area.

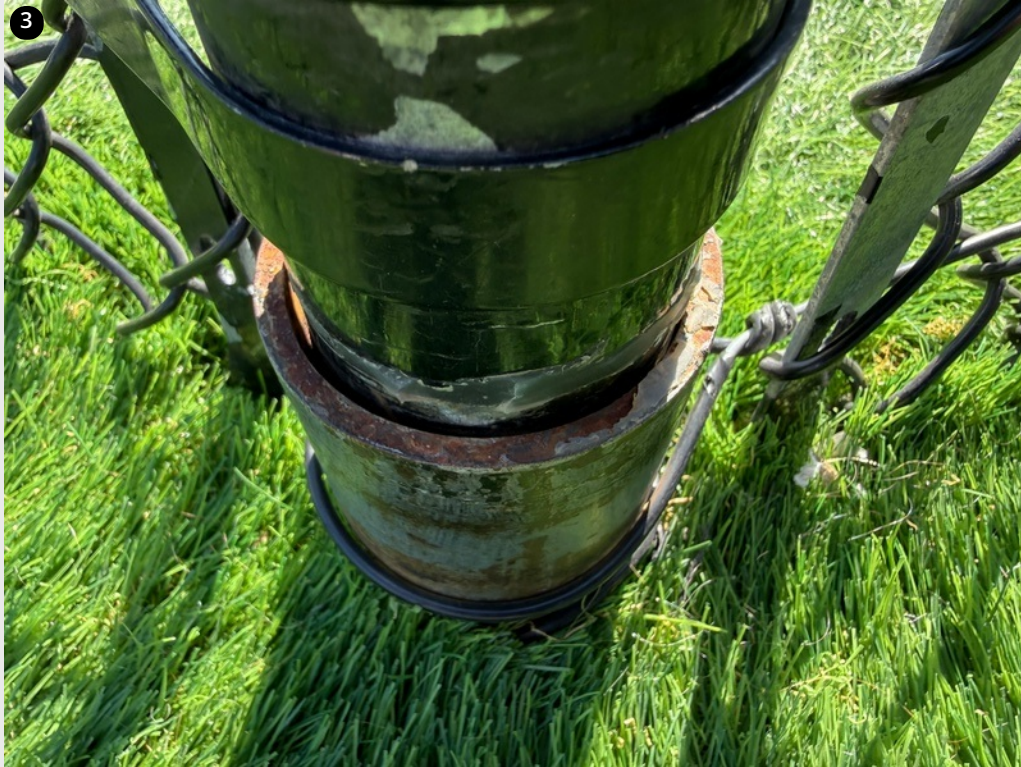
Close up of the fence post. Sealant is failed where the post enters the support sleeve.

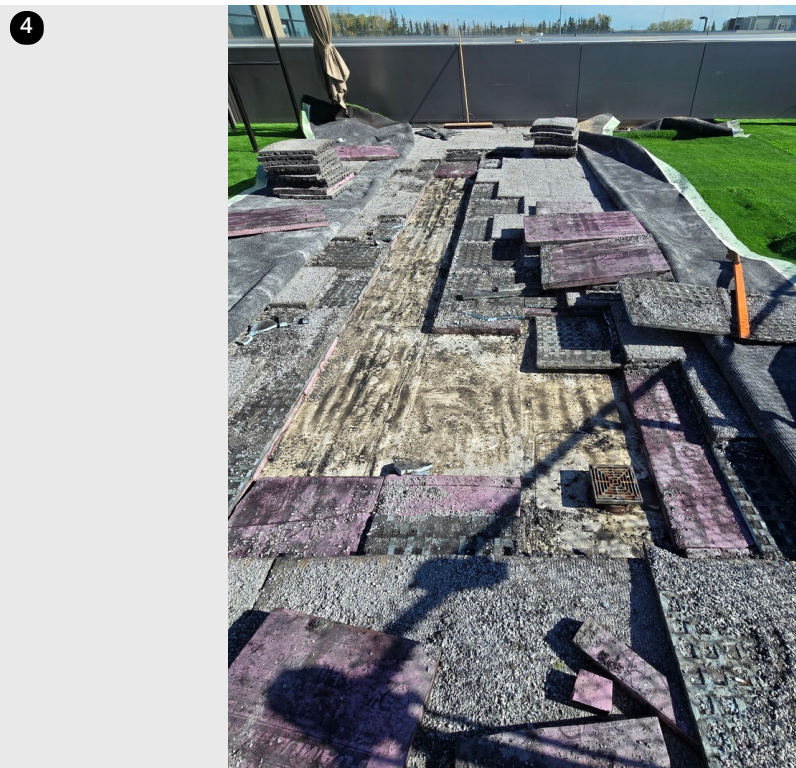
Photo of previous leak investigation completed by Flynn, prior to Salthill ownership.

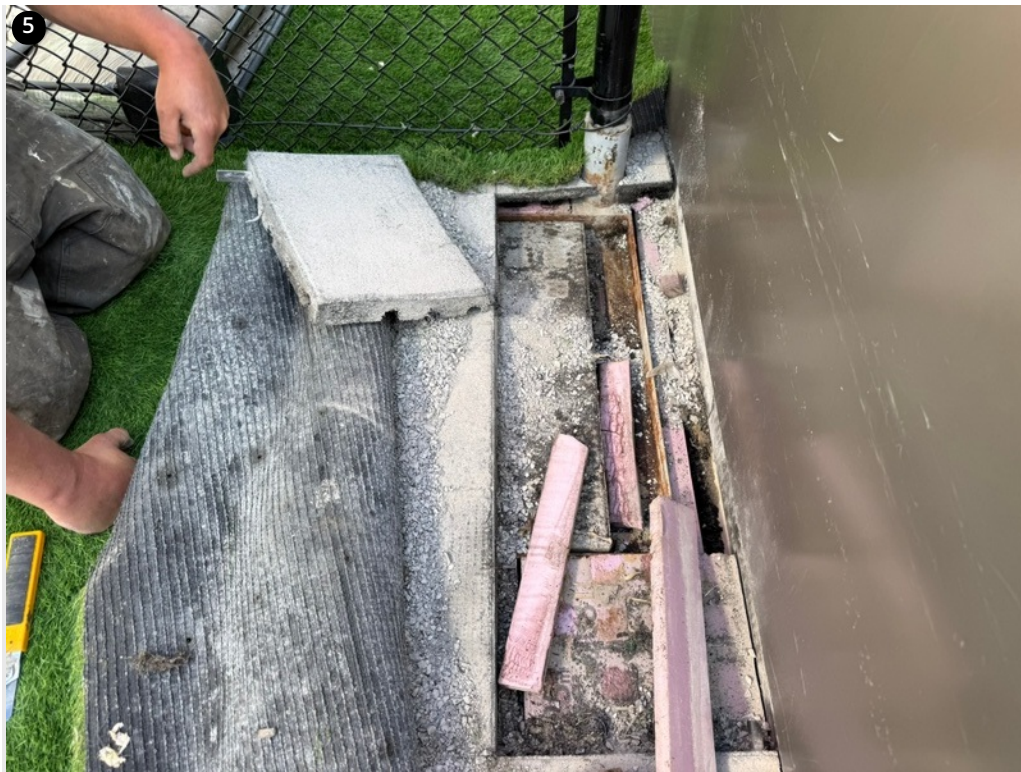
Overview of the exposed substrate against the east wall and adjacent to a fence post. Each post appears to have a metal stand, with a sleeve to the fence post welded to it. A paver sits in the stand (or frame) to weigh it down.

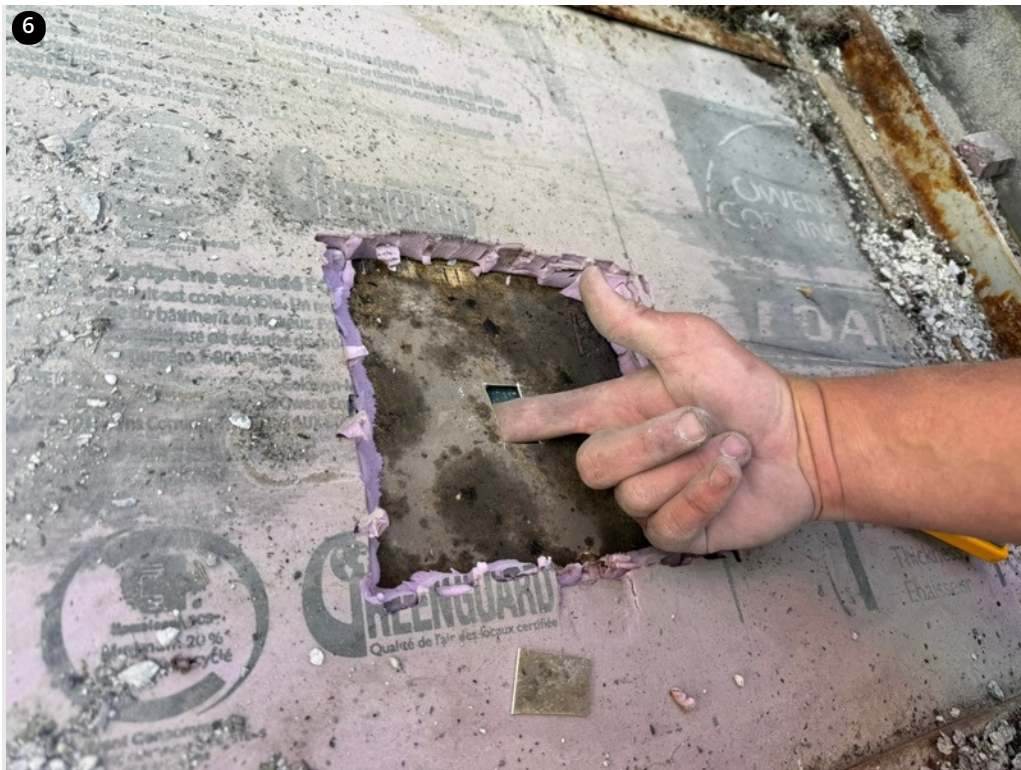
TPO membrane was observed to be loose laid.

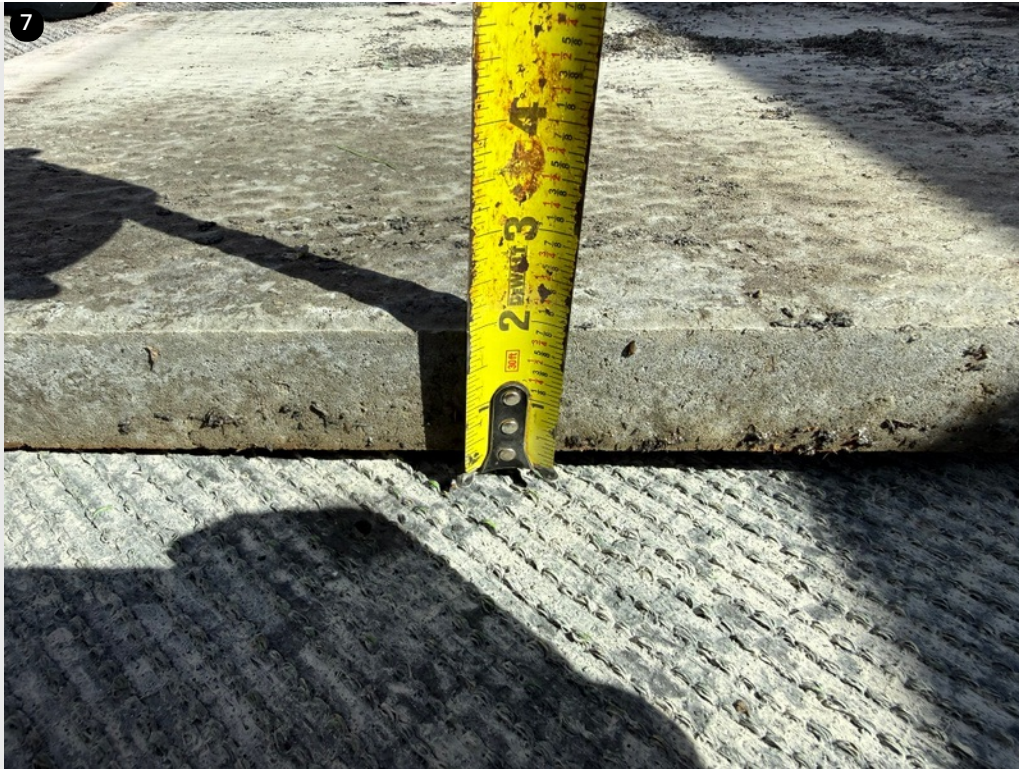
2" thickness pavers on either side of each fence post.

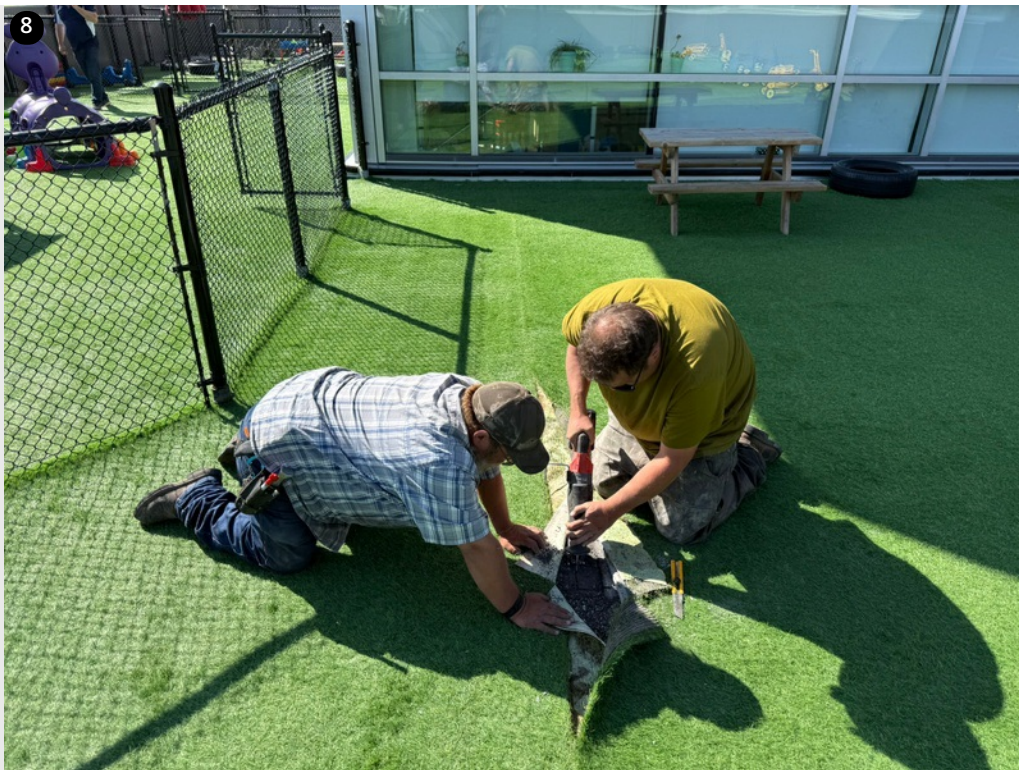
A cut test was also completed in the area of the drain. Same composition and insulation thickness was observed.

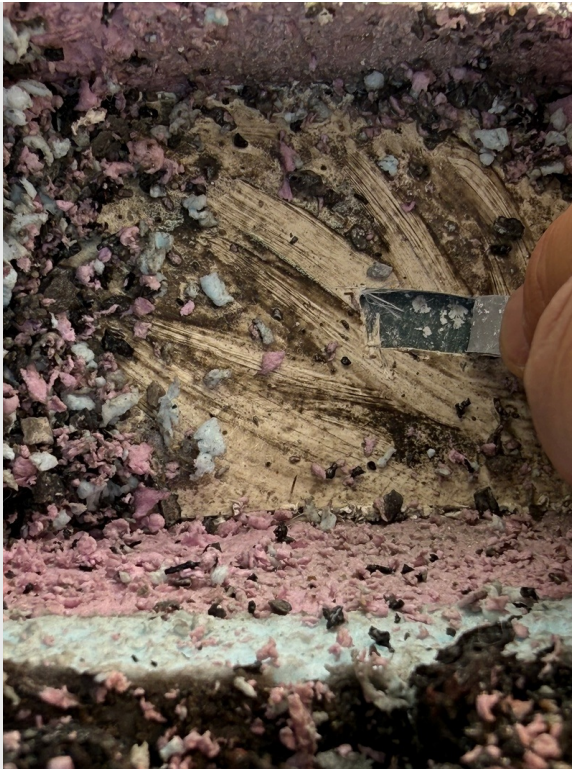
9

TPO membrane loose laid on gypsum board.

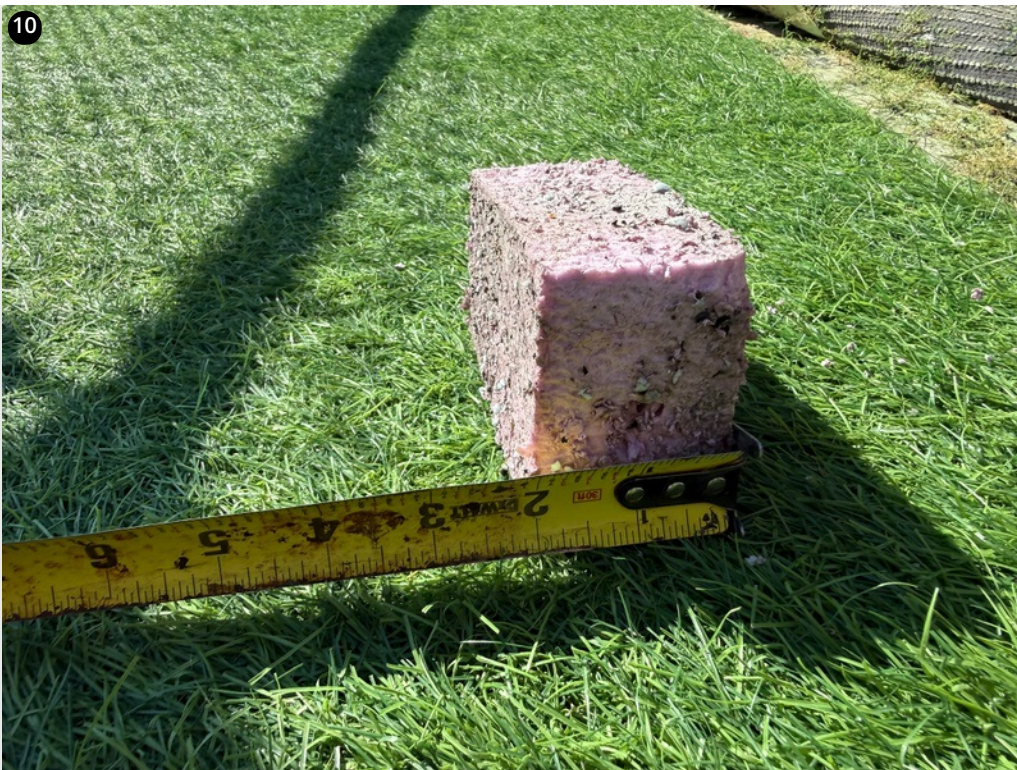
10

2" XPS.

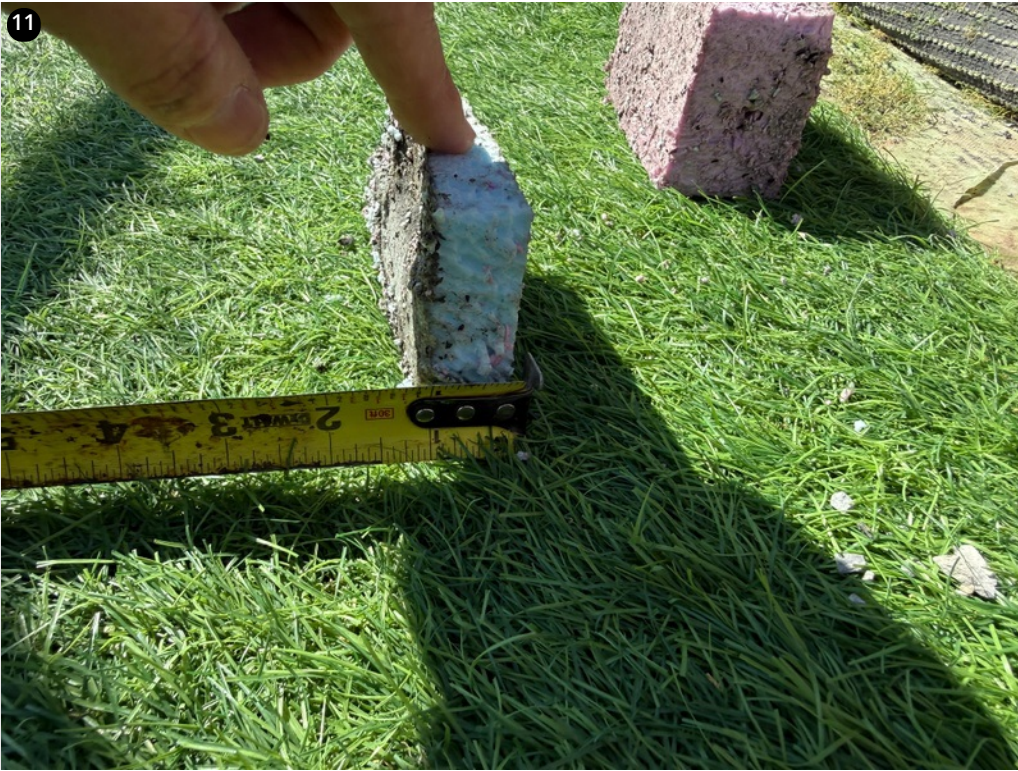
11

1" Roofmate.

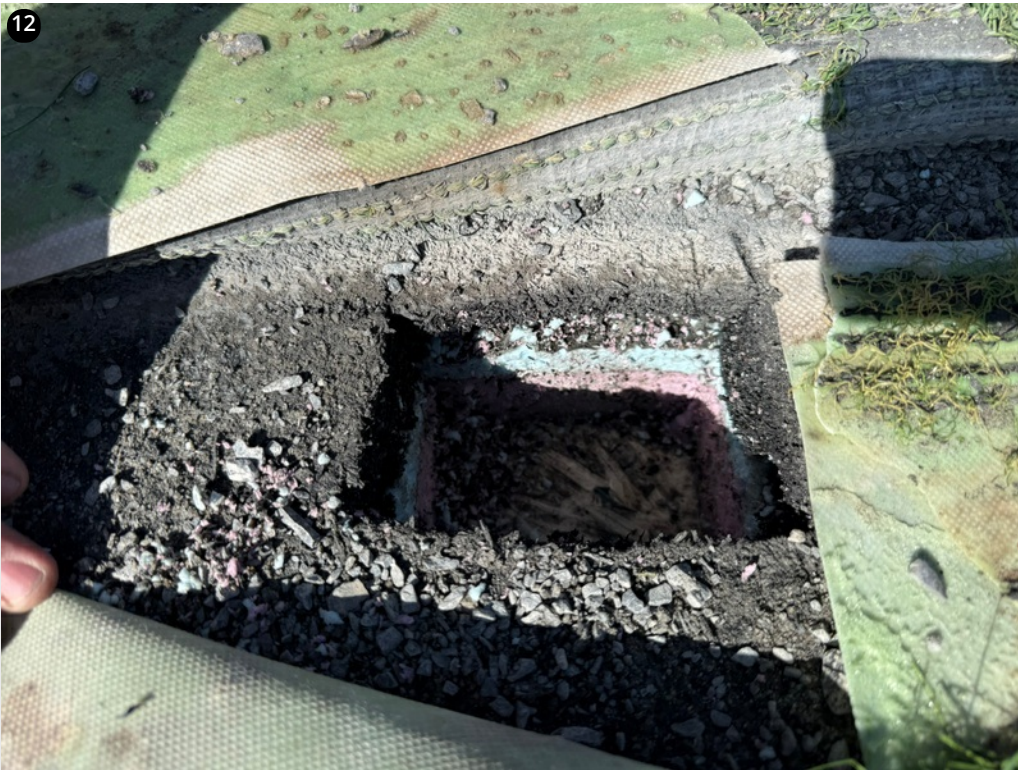
13

Overview photo.

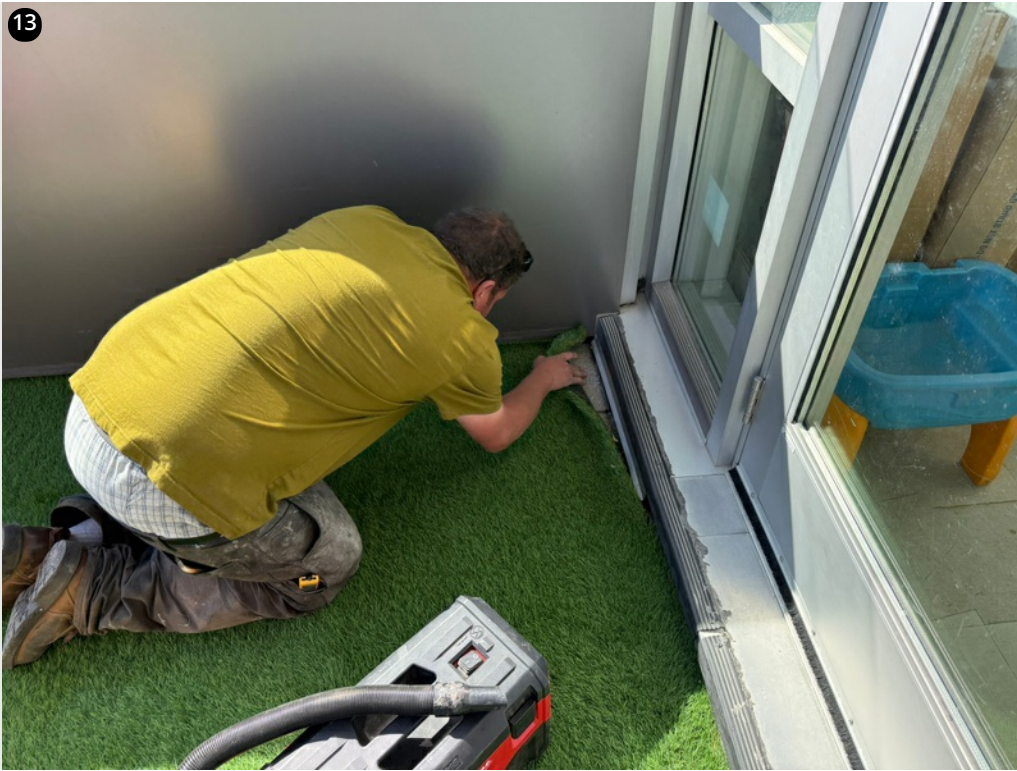
Cut test was completed in the corner in the area of the window sill and wall. Same composition.

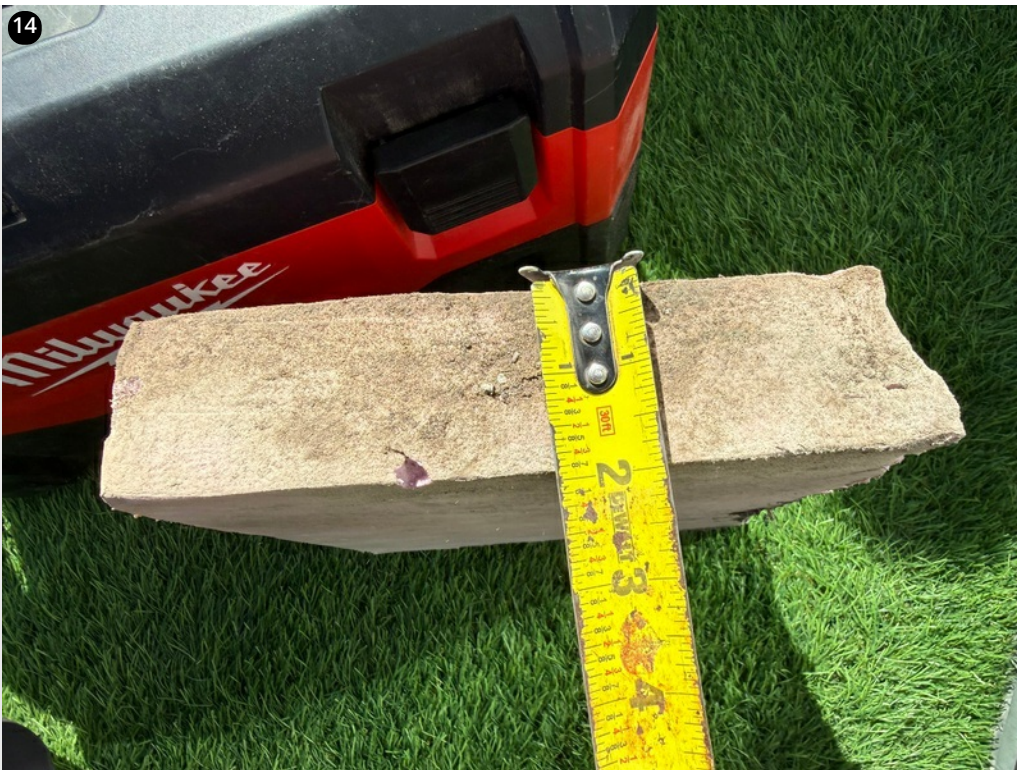
14

2" insulation + 1" insulation (see next photo).

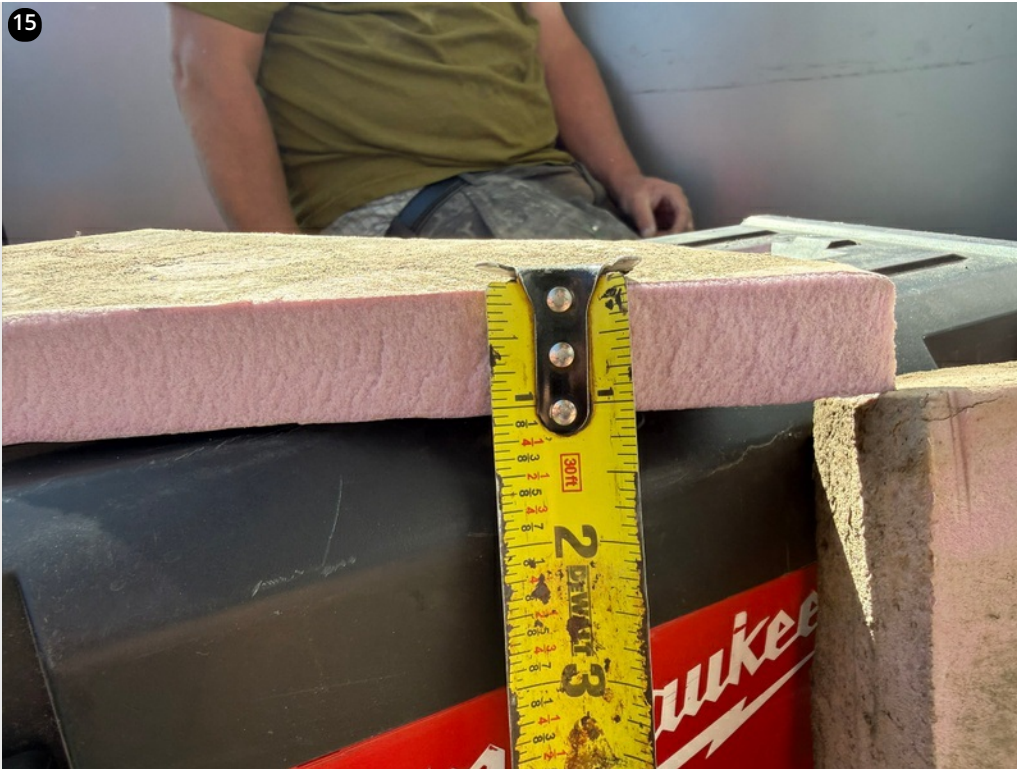
15

1" layer of insulation.

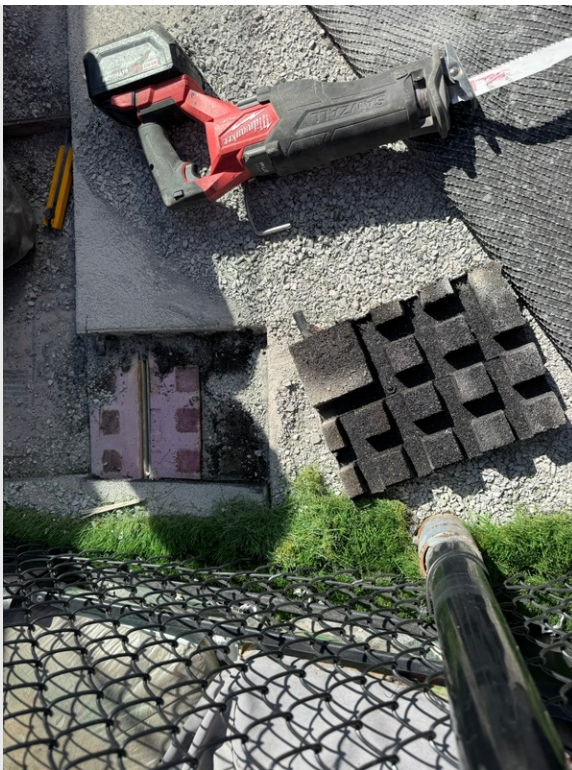
16

Example of the mat laid beneath the grass and gravel.
