- CBCT/CT 503 QA Test -

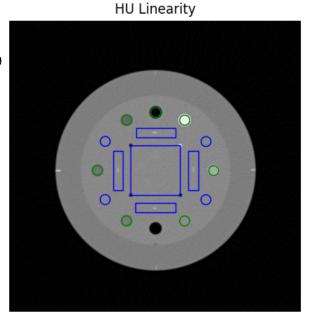
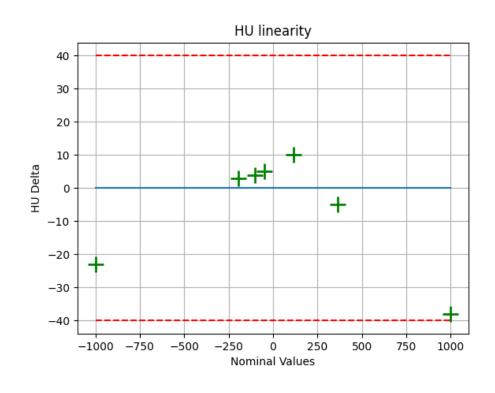
- CTP 404 Results -

HU Linearity tolerance: 40

HU Linearity ROIs: Air: -1023.0, PMP: -193.0, LDPE: -100.0, Poly: -42.0, Acrylic: 125.0, Delrin: 360.0, Teflon: 962.0

HU Passed?: True

Low contrast visibility: 3.09

Geometric Line Average (mm): 50.04

Geometry Passed?: True

Measured Slice Thickness (mm): 1.439

Slice Thickness Passed? True
