- CBCT/CT 503 QA Test -

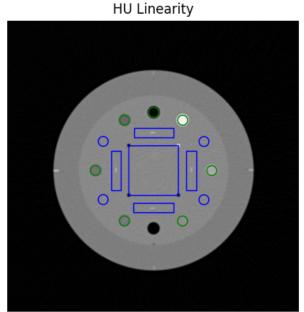
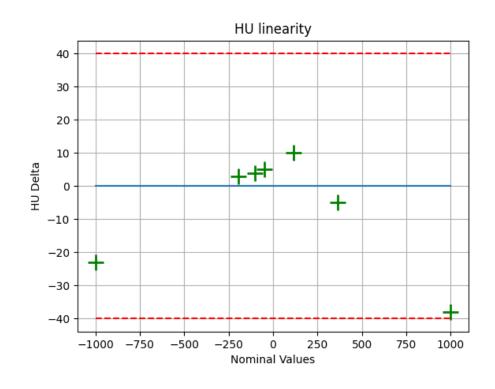
- CTP 404 Results -

HU Linearity tolerance: 40

HU Linearity ROIs: Air: -1023.0, PMP: -193.0, LDPE: -100.0, Poly: -42.0, Acrylic: 125.0, Delrin: 360.0, Teflon: 962.0

HU Passed?: True

Low contrast visibility: 3.09

Geometric Line Average (mm): 50.04

Geometry Passed?: True

Measured Slice Thickness (mm): 1.439

Slice Thickness Passed? True

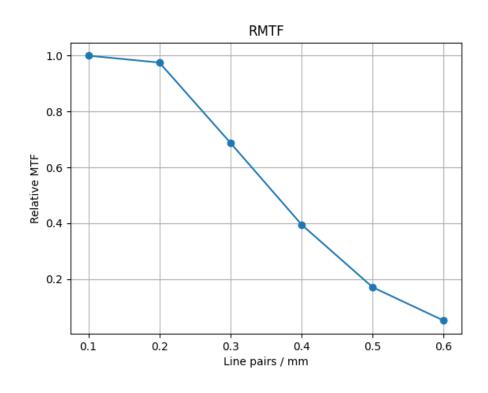
- CTP486 Results -Uniformity tolerance: 40

Uniformity ROIs: Top: 9.0, Right: 9.0, Bottom: 10.0, Left: 9.0, Center: 13.0

Uniformity index: -0.395

Integral non-uniformity: 0.0020 Uniformity Passed?: True
