# CV Public Transport Accessibility Assessment Report

## DSAPT Compliance Evaluation

| <b>Project Name</b> | CV Accessibility of Public Transport |

| <b>Date</b> | 10/05/2026 |

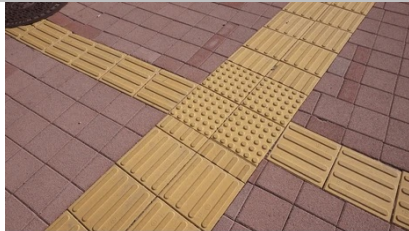
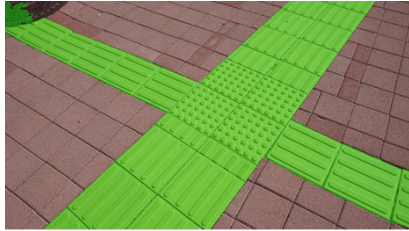
| <b>Accessibility Feature Detected</b> | Accessibility Feature Detected: Tactile flooring |
| <b>DSAPT Compatibility</b> | 0% |
| <b>Notes</b> | Tactile flooring was detected, but the estimated luminance contrast is 25.20%. This is below the minimum selected DSAPT contrast level of 30%, so it is not considered compatible based on contrast. |
