# Termite Inspection Report

Client: Demo data - privacy protected · Residential timber pest inspection  
Visit Date: 28 September 2026, 1:00 PM – 1:50 PM  
Generated by: AI report assistant, from a Preserver field export

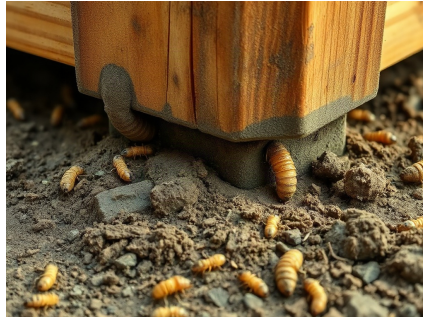
**Rear deck — termite mud tubes**

| Category | Observation | Status | Action Required |
|---|---|---|---|
| Deck Post Base | Active mud termite tubes on one post | High Priority | Schedule treatment |

Active mud termite tubes observed running up a deck post base from the soil.

| Time | Type | Transcript / Note |
|---|---|---|
| 1:08 PM | Voice | "Got active mud tubes on the back deck post, that's live termite activity — needs treatment booked in." |

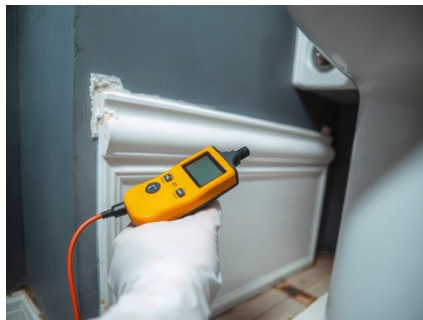
**Bathroom wall — moisture check**

| Category | Observation | Status | Action Required |
|---|---|---|---|
| Bathroom Wall | Elevated moisture reading, conducive condition | Attention | Investigate moisture source |

Elevated moisture meter reading on the bathroom skirting board, a conducive condition for termite activity.

| Time | Type | Transcript / Note |
|---|---|---|
| 1:22 PM | Voice | "Moisture meter's reading high on the bathroom skirting, that's a conducive condition worth flagging to the owner." |

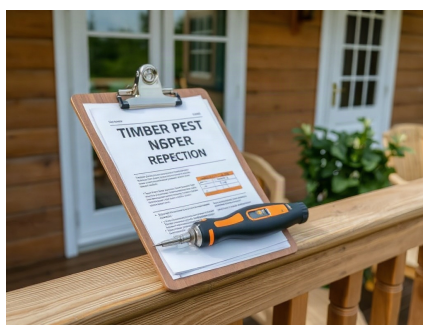
**Exterior — probe and report sign-off**

Timber probe and inspection report completed on the rear deck railing at the end of the visit.

| Time | Type | Transcript / Note |
|---|---|---|
| 1:42 PM | Text | Full property probe complete, no further live activity found elsewhere. |
