# Plumbing Job Report

Client: Demo data - privacy protected · Residential leak callout

Visit Date: 28 September 2026, 1:15 PM – 1:52 PM

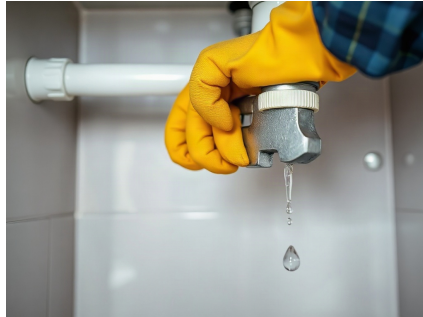
### ***Kitchen sink — pipe joint leak***

Slow drip visible at the supply pipe joint under the kitchen sink, consistent with a worn compression fitting.

| Time | Type | Transcript / Note |
|---|---|---|
| 1:19 PM | Voice | "Got a slow drip here at the supply joint under the sink, looks like the compression fitting's worn out. Simple fix, going to note it for replacement." |

| Category | Observation | Status | Action Required |
|---|---|---|---|
| Kitchen Sink | Slow drip at supply pipe joint, worn compression fitting | Attention | Replace fitting |

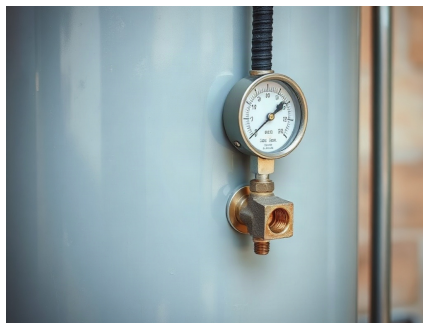
### ***Hot water heater — fitting condition***

Pressure gauge and fitting on the hot water unit show early-stage corrosion, flagged for monitoring.

| Time | Type | Transcript / Note |
|---|---|---|
| 1:33 PM | Voice | "Hot water unit's fitting has got a bit of early corrosion starting, nothing urgent but worth keeping an eye on at the next service." |

| Category | Observation | Status | Action Required |
|---|---|---|---|
| Hot Water System | Early corrosion at heater fitting | Monitor | Recheck next service |

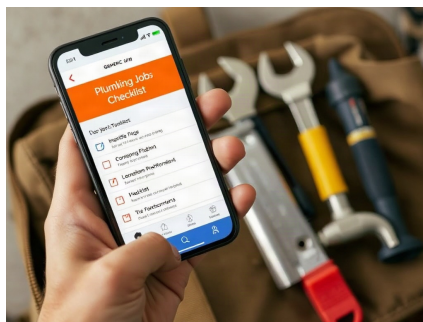
### ***Field tablet — job checklist***

On-device checklist confirming the leak repair recommendation and heater fitting follow-up.

| Time | Type | Transcript / Note |
|---|---|---|
| 1:46 PM | Text | Leak repair recommended for kitchen sink fitting. Hot water heater fitting flagged for monitoring at next scheduled visit. |
