# Property Mould Assessment Report

Site: 14 Narel Street, Albion QLD 4010  
Inspection Date: 28 September 2026, 12:14 PM – 12:21 PM  
Generated by: AI report assistant, from a Preserver field export

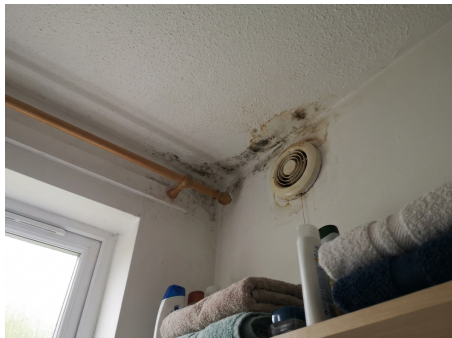
**Bathroom ceiling — extractor fan surround**

| Location | Finding | Severity | Est. Affected Area |
|---|---|---|---|
| Bathroom ceiling (fan) | Active mould, water staining | High | ~0.3 sq m |

Visible water staining and dark mould spotting around the extractor fan housing, consistent with inadequate ventilation during showering.

| Time | Type | Transcript / Note |
|---|---|---|
| 12:15 PM | Voice | "Ceiling above the shower, right where the fan is — you can see the staining spread out from the housing, and it's damp to touch." |

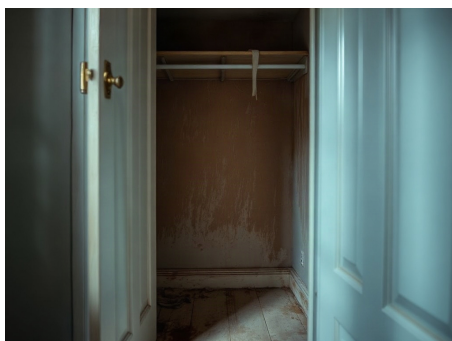
**Bedroom closet — baseboard**

| Location | Finding | Severity | Est. Affected Area |
|---|---|---|---|
| Bedroom closet | Mould on baseboard, musty odour | Moderate | ~0.15 sq m |

Musty odour noted on entry. Mould staining visible along the lower baseboard, extending approximately 40cm along the rear wall.

| Time | Type | Transcript / Note |
|---|---|---|
| 12:18 PM | Voice | "Closet smells musty as soon as you open it. Mould along the bottom of the wall, looks like it's been sitting a while." |

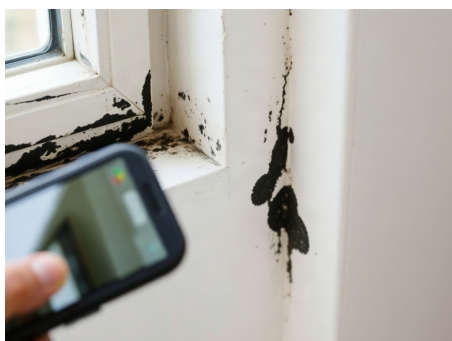
**Living area — window frame corner**

| Location | Finding | Severity | Est. Affected Area |
|---|---|---|---|
| Window corner (living) | Surface mould, condensation marks | Low–Moderate | ~0.1 sq m |

Surface-level mould at the wall/window junction with condensation marks, likely linked to a thermal bridge at the frame.

| Time | Type | Transcript / Note |
|---|---|---|
| 12:21 PM | Text | Window corner — condensation build-up most mornings per tenant. Surface mould only at this stage. |
