# Structural Inspection Report

Client: Demo data - privacy protected · Site structural inspection  
Visit Date: 28 September 2026, 7:30 AM – 7:52 AM  
Generated by: AI report assistant, from a Preserver field export

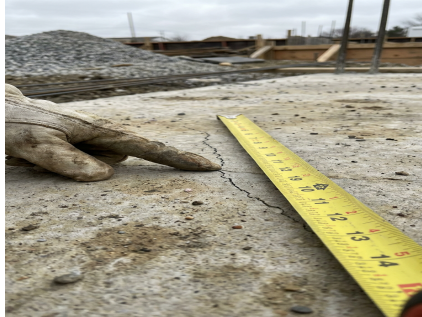
-27.4623, 153.0102 · 28 Sep 2026, 7:34 AM

| Category | Observation | Status | Action Required |
|---|---|---|---|
| Foundation Crack | Hairline crack, 0.3mm width, measured and marked | Monitor | Re-inspect next visit |

**Foundation crack — measured hairline crack**

Hairline crack in the foundation slab measured at 0.3mm width and marked for ongoing monitoring.

| Time | Type | Transcript / Note |
|---|---|---|
| 7:34 AM | Voice | "Found a hairline crack in the foundation slab, measuring about zero-point-three millimetres. Marking it here for monitoring, nothing urgent." |

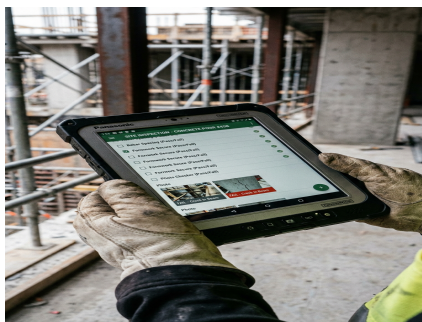
-27.4623, 153.0101 · 28 Sep 2026, 7:48 AM

**Site checklist — structural inspection sign-off**

On-device structural checklist for the site visit, completed and signed off with no outstanding items.

| Time | Type | Transcript / Note |
|---|---|---|
| 7:48 AM | Text | Structural checklist completed for this section — no outstanding items, site clear for next phase. |
