# ELECTRICAL SURGE INCIDENT RESPONSE

## Hardware Failure Diagnosis, Component Isolation & Micro-ATX Rebuild

Analyst: Bryan Sykes | August 2026 | Hardware Incident Portfolio Project

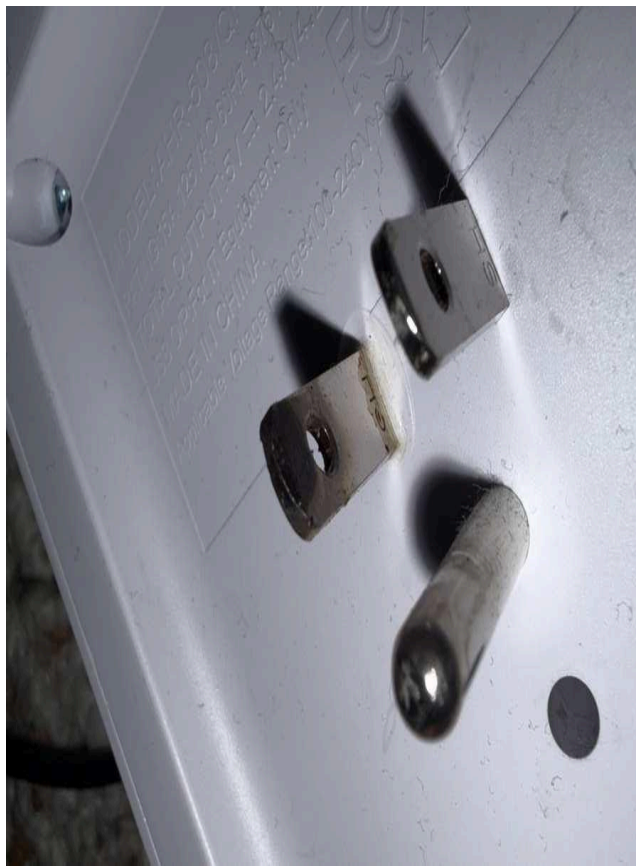
- The original DeepCool 1000W PSU delivered standby power (fans/LEDs active) but the system still failed to POST.
- A second, brand-new MSI PSU was substituted as a control test. The identical failure persisted, clearing the PSU as the root cause.

**Fig. 2** — *Fried damage from the wall surge protector*

- PSU cleared as a factor. The control unit was returned for a full refund.

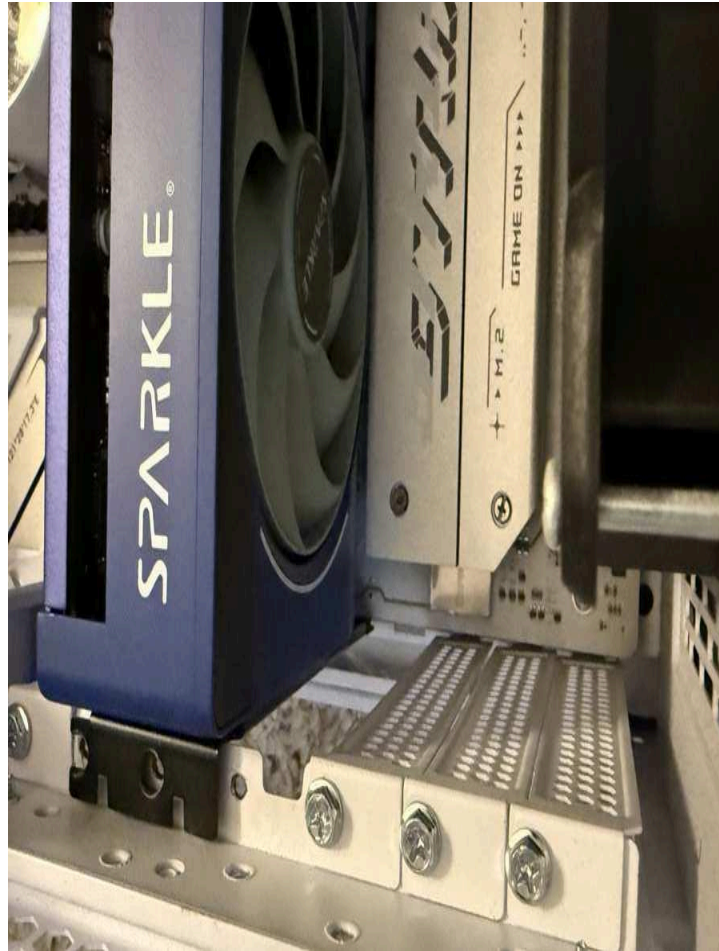
**Fig. 4** — *Known-good Sparkle Intel Arc B570 GPU installed in the same PCIe slot. The identical diagnostic LED failure occurred, ruling out both graphics cards as the cause.*

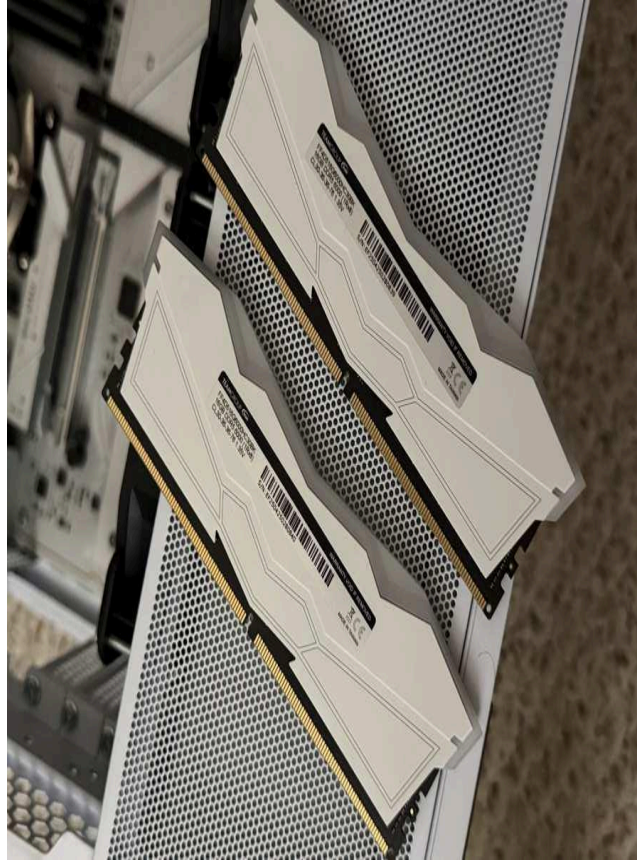
**Fig. 6** — *Single memory module inspected at the contact edge. No damage or discoloration present.*

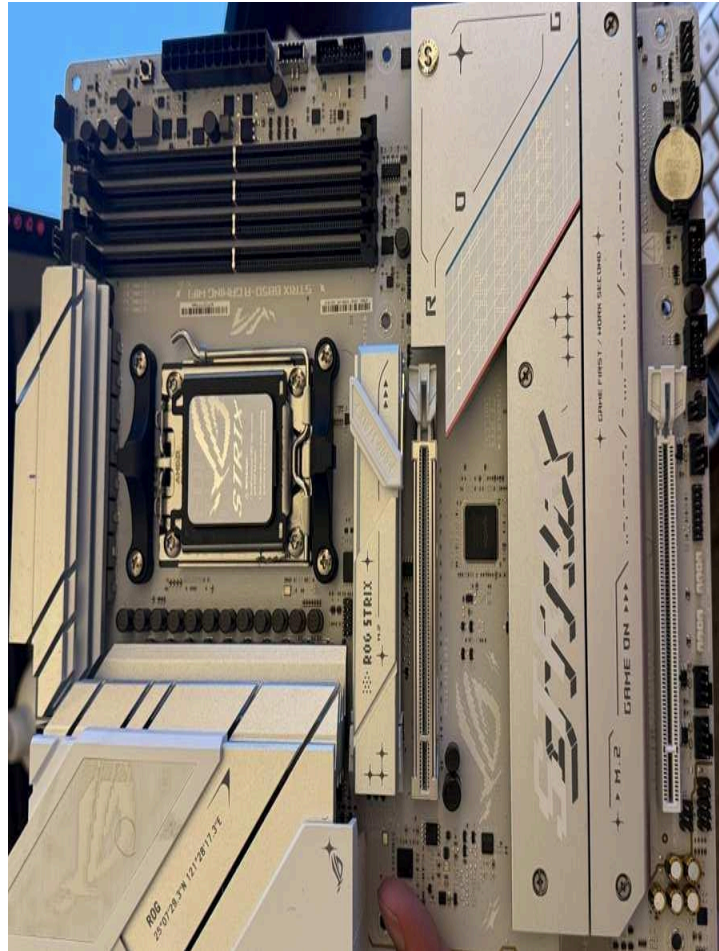
**Fig. 10** — *ROG Strix B850-A Gaming WIFI Motherboard determined to have a fried PCIe slot and fried VGA capabilities, rendering the system unable to successfully go through the Power-On-Self-Test sequence (POST).*

The system POSTed and booted successfully on first power-on with the replacement board. This confirmed the motherboard as the sole component damaged by the electrical surge. Every other tested component (PSU, both GPUs, RAM, and all 4 SSDs) was verified fully functional, avoiding unnecessary replacement spending on parts that did not need it.

A new ASUS ROG Strix B850-A Gaming WiFi motherboard was sourced and installed using the original CPU, RAM, and GPU.

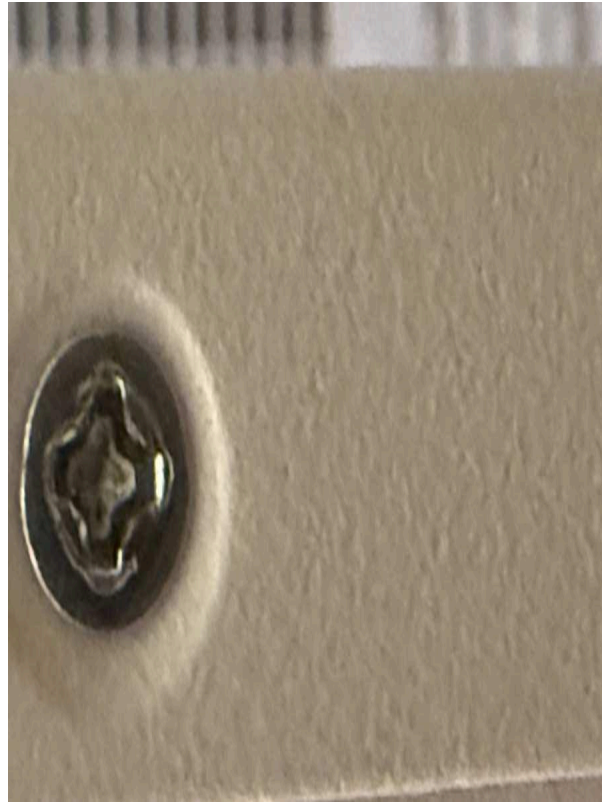
**Fig. 12** — *First stripped screw discovered — PSU mounting bracket. Cross-slot pattern shows visible rounding consistent with over-torqued factory assembly.*

- Diagnosed as factory over-torquing during assembly, not user error confirmed by comparing against undamaged front-panel screws from the same case.

- All 6 screws were removed via rubber-band-and-driver friction technique.
- Correct replacement thread spec (6-32 pan-head) identified before sourcing new screws, after an initial mismatch with a countersunk-head screw from a spare parts bag was caught and corrected.

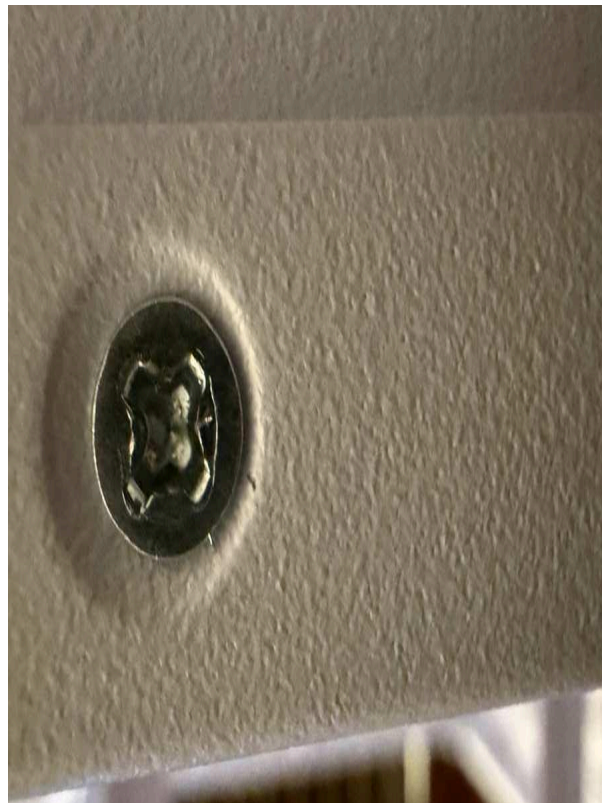
**Fig. 13** — *Second PSU bracket screw — more significant stripping, cross pattern nearly smoothed over.*

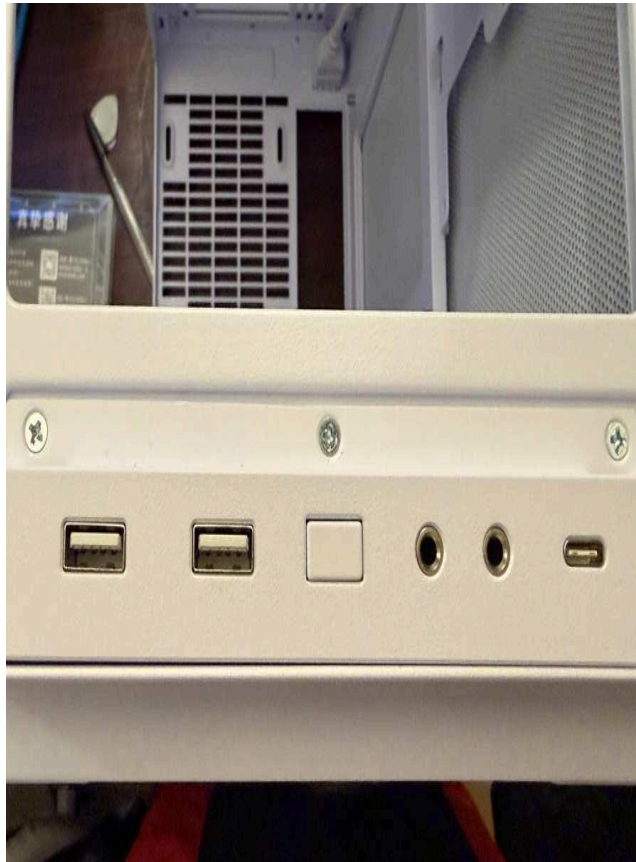
**Fig. 14** — *Front I/O panel screws inspected for comparison — cross-slot patterns intact and undamaged, confirming the stripping defect was isolated to specific mounting points, not case-wide.*

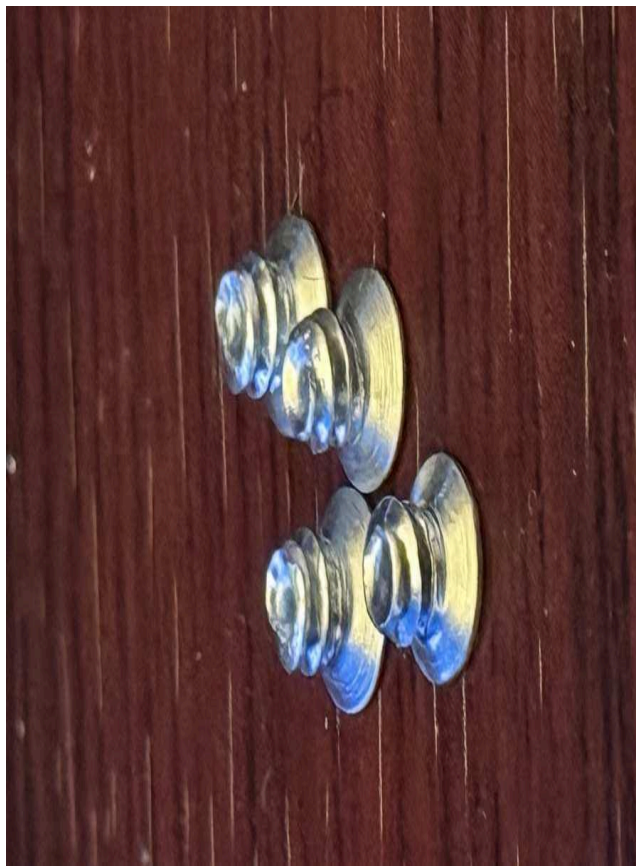
**Fig. 15** — All 6 affected screws laid out together after removal — each was successfully extracted using a rubber-band-and-driver friction technique.
